CK-2019

CAYOOSE 0.1km

2019 Inspection

| Crossing Name | Skagit River | | |

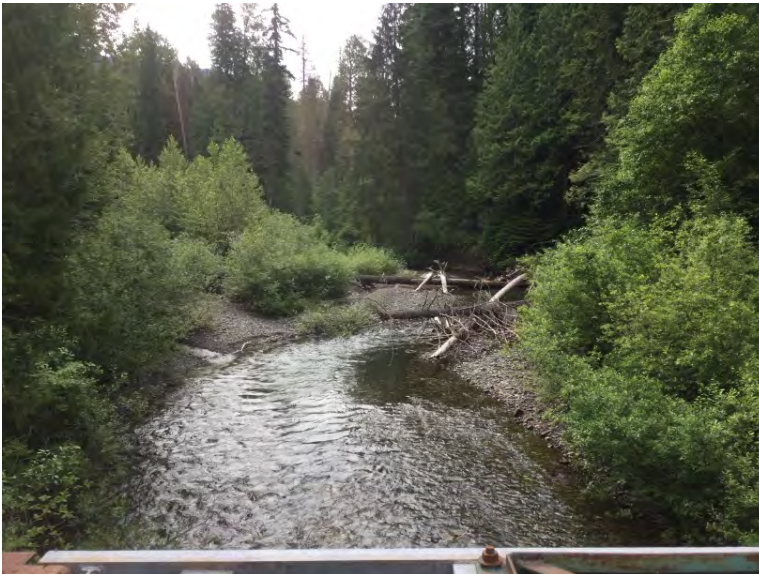
Upstream from Crossing

Comments Debris accumulations noted 30m upstream on low gradient stream

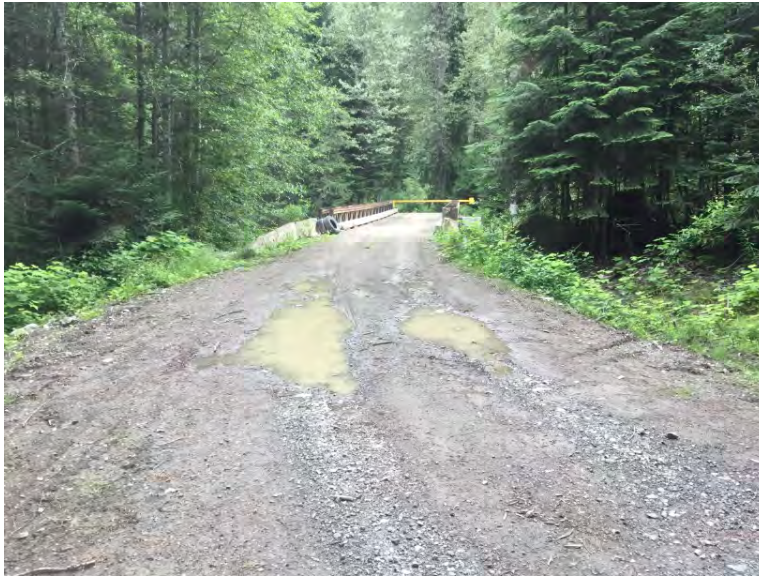
Approach from Left Bank when facing downstream

Curb Rail/Blocks/Posts      Fair      Left approach slight damage and missing hardware

| Item | Priority | Repair Description |
|---|---|---|
| 2 | Medium | Replace missing delineators at left approach, and grade both approaches |

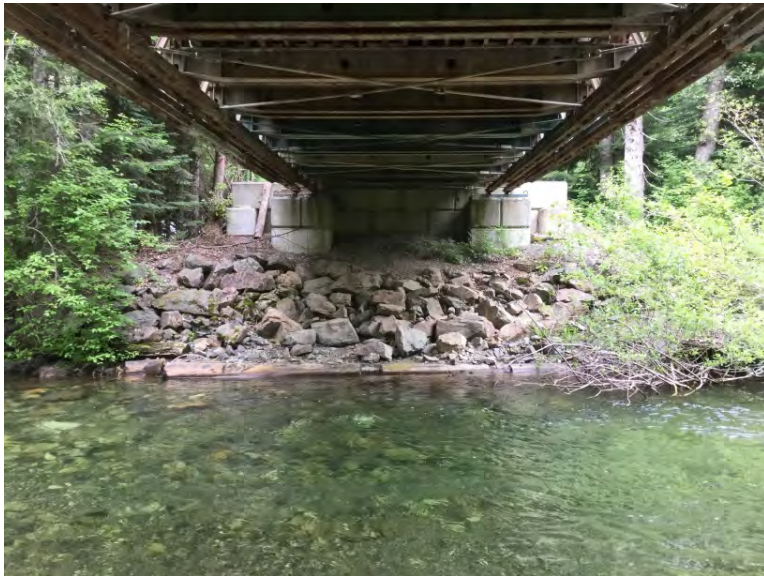
Right Bank Abutment when facing downstream

Lock block columns at each corner and spalling

| Item | Monitor Description | Frequency |
|---|---|---|
| 2 | Spalling concrete | Routine Inspection |

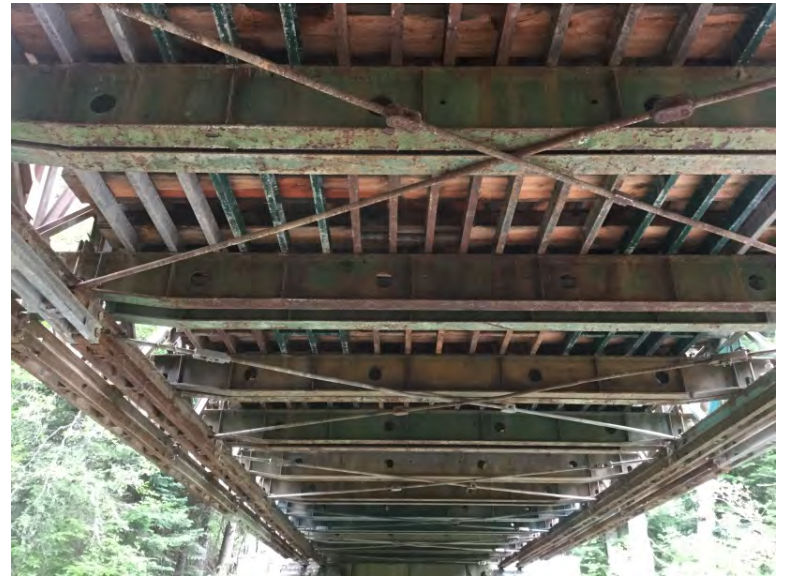
Superstructure

Double single reinforced Acrow/Bailey with corrosion on all components, minor damage noted on some components

Some swaybracing loose

Still missing some cotter pins and some transom set bolts/fasteners loose

| Item | Priority | Repair Description |
|---|---|---|
| 3 | Medium | Replace missing cotter pins, tighten loose swaybraces and transom set bolts/fasteners |
