CK-2022

CHEHALIS 15.2km

2019 Inspection

Crossing Name Statlu Creek

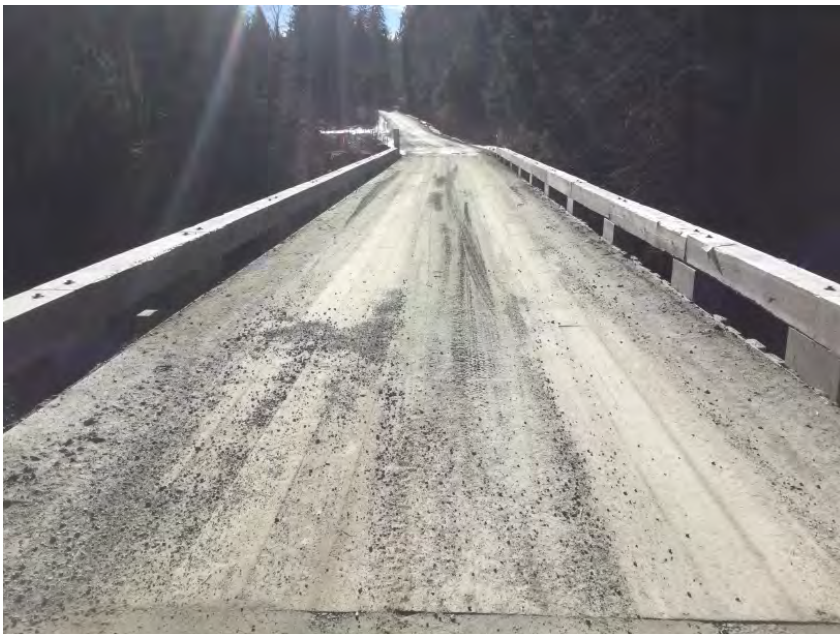
Overall Deck Condition      Good

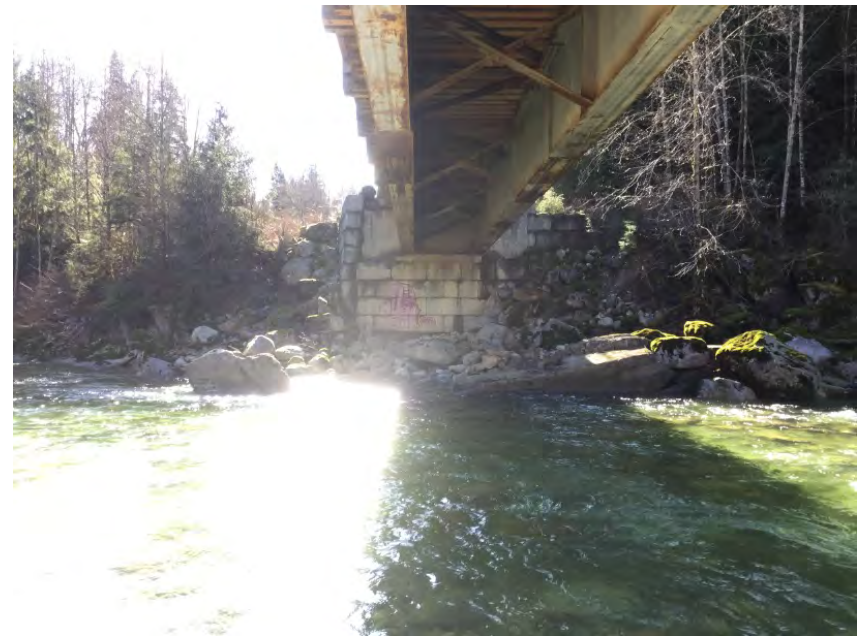
Right Bank Abutment when facing downstream

Caps or Sills Fair Concrete cap right bank is good, log left bank is old and in fair condition

Ballast Wall Fair Concrete right bank in good condition, logs left bank
