CK-2087

DEWDNEY 5.2km

2019 Inspection

| Crossing Name | Cedar Flat Creek |

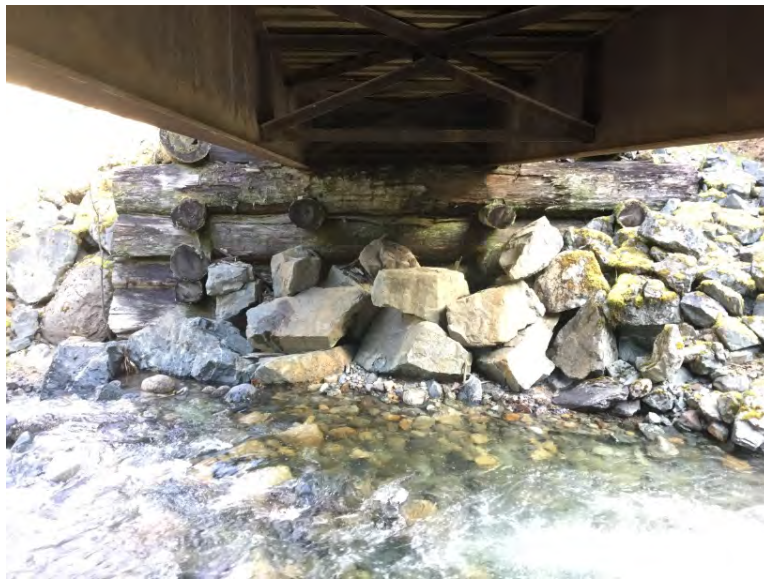
Right Bank Abutment when facing downstream

The girders at right bank appear to be settling, most likely due to the deteriorating crib condition. Monitor.

Post bridge ahead signs and monitor the crib and riprap condition. The current load rating of L60 or 54 tonnes to continue.
