CK-2109

HARRISON EAST 35.3km

2019 Inspection

| Crossing Name | Hornet Creek |

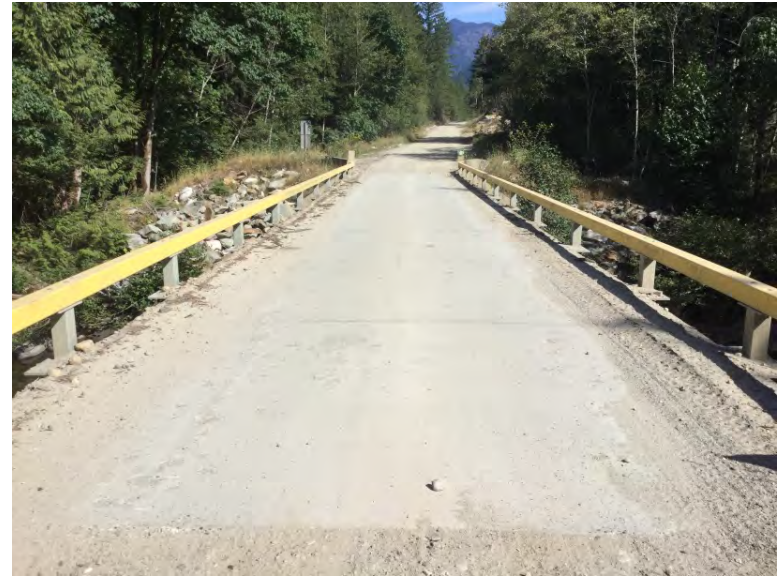
Concrete Deck      **Fair**      Some damage from walking tracked equipment overGrout Pockets      **Good**Deck Joints      **Good**
