CK-2157

HUNTER 2.2km

2019 Inspection

| Road Name | HUNTER | | |

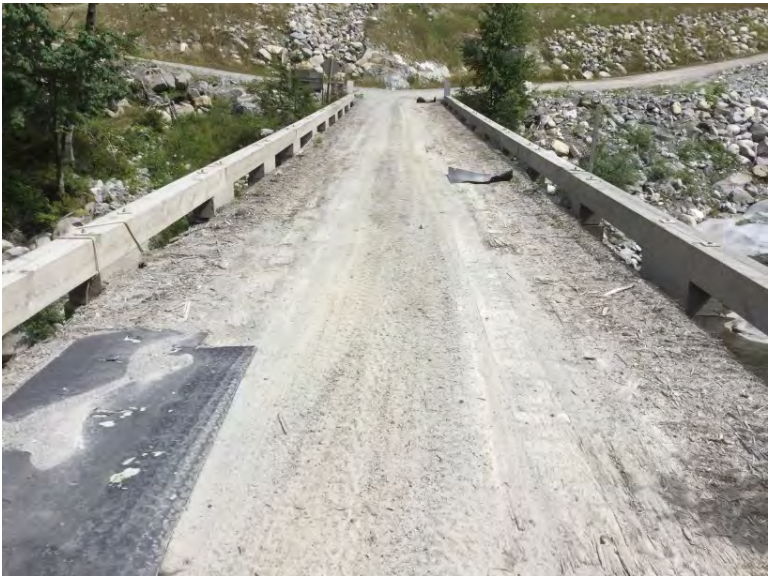
Deck

Due to plank condition

| Item | Priority | Repair Description |
|---|---|---|
| 1 | Medium | Replace running planks if sustained industrial traffic required |
