CK-2207

MOWHOKAM 15.7km

2019 Inspection

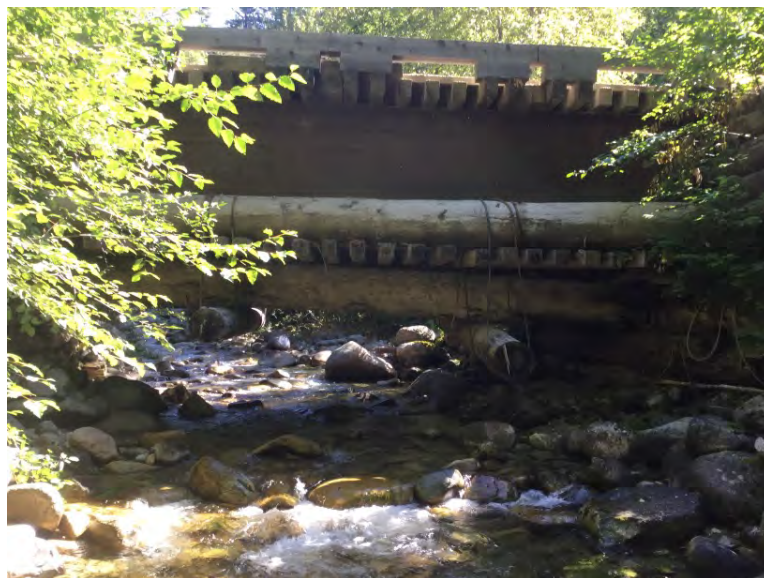
Downstream Profile

The timber deck and steel girder structure is supported by a log stringer bridge underneath. All the log stringers are rotten and a risk to failure. Also, the log stringer structure may be affected by high stream flows which puts the steel girder and timber deck bridge at risk.

Due to the poor condition of the structure I recommend replacing it with a single new structure or blocking access until it's required. The current load rating of 0 tonnes to continue. Please update load rating sign and block access to traffic until all works are completed.
