CK-2293

UZTLIUS 19km

2019 Inspection

| Crossing Name | Uztlus Creek |

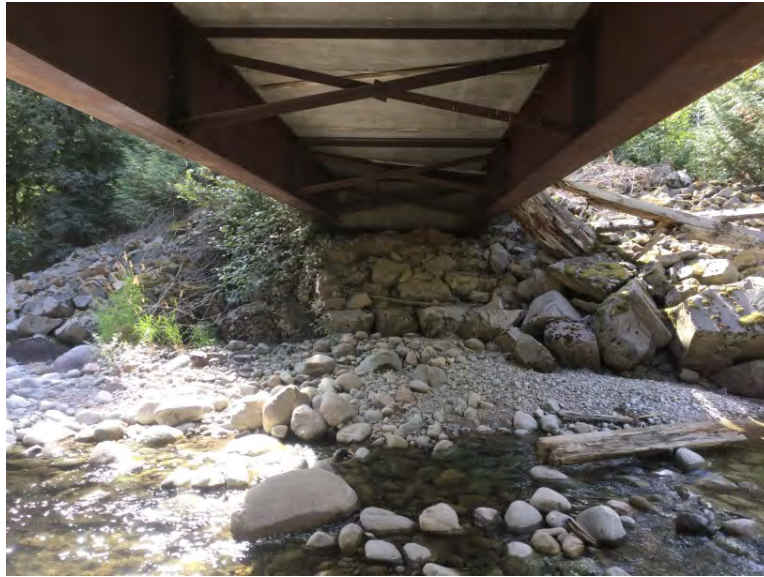
Right Bank Abutment when facing downstream

Minor damage to top of ballast wall and panel 1 at right bank

Replace all delineators and monitor the condition of the ballast wall and the first deck panel on the right bank. Add material to each approach and grade in. The current load rating of L75 or 68 tonnes to continue.
