CK-2298

UZTLIUS 27.5km

2019 Inspection

| Crossing Name | Uztlus Creek | | |

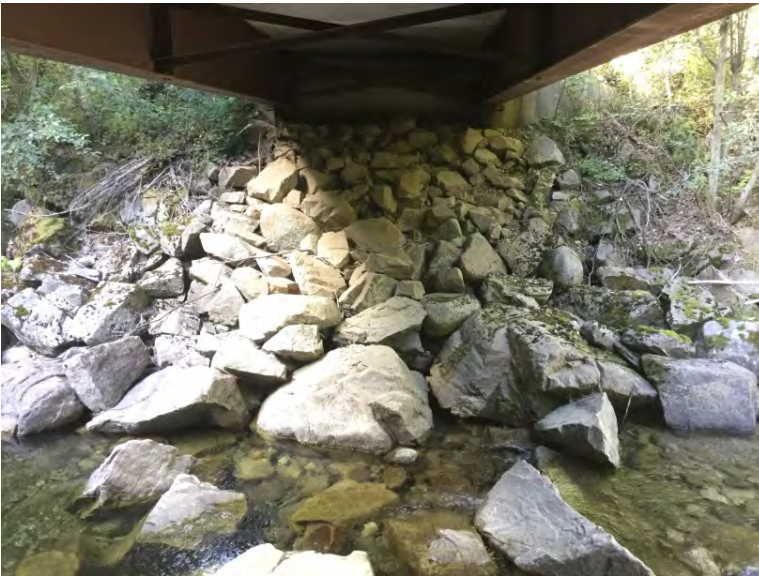
Right Bank Abutment when facing downstream

Ballast Wall Fair Minor damage noted at right bank

Minor damage noted to top of ballast wall and panel 1 at right bank
