CK-2299

UZTLIUS 28.1km

2019 Inspection

| Crossing Name | Uztlus Creek | | |

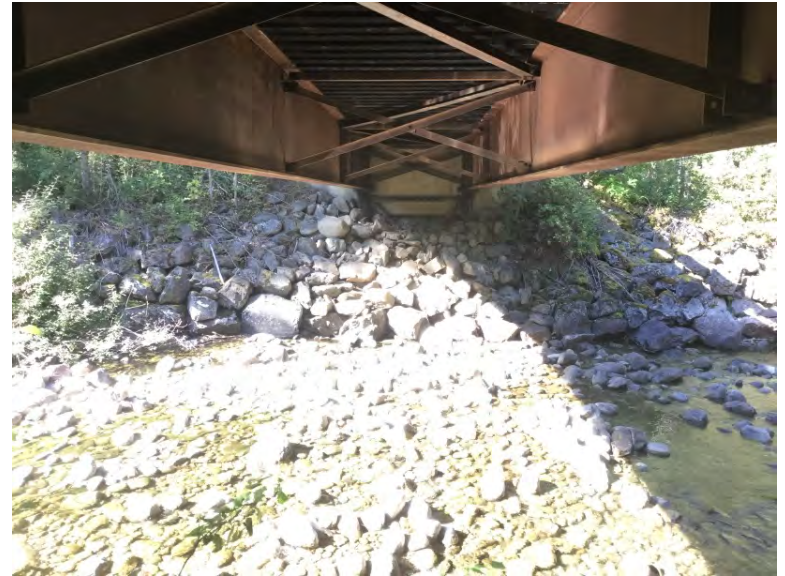
Left Bank Abutment when facing downstream

Hairline cracks noted on left bank

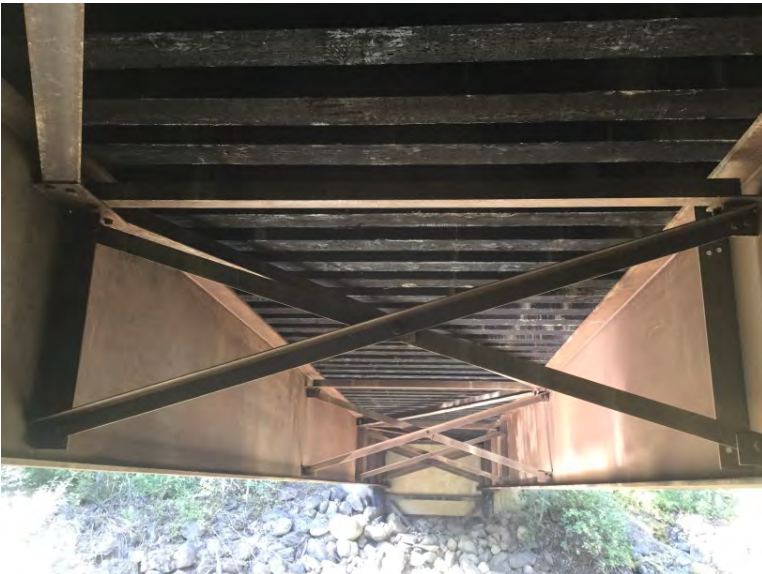
Superstructure

Hardware Fair Only a single nut noted to be missing

| Repair | | Repair Description |
|---|---|---|
| 1 | Low | Hammer down protruding nails and replace missing bracing washer and nut |
