CK-2406

PITT RIVER 18.5km

2019 Inspection

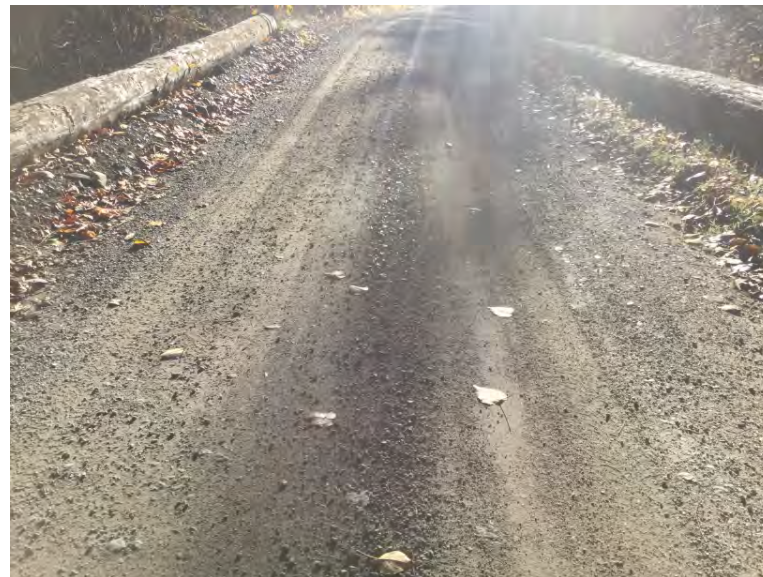
Overall Deck Condition **Good**

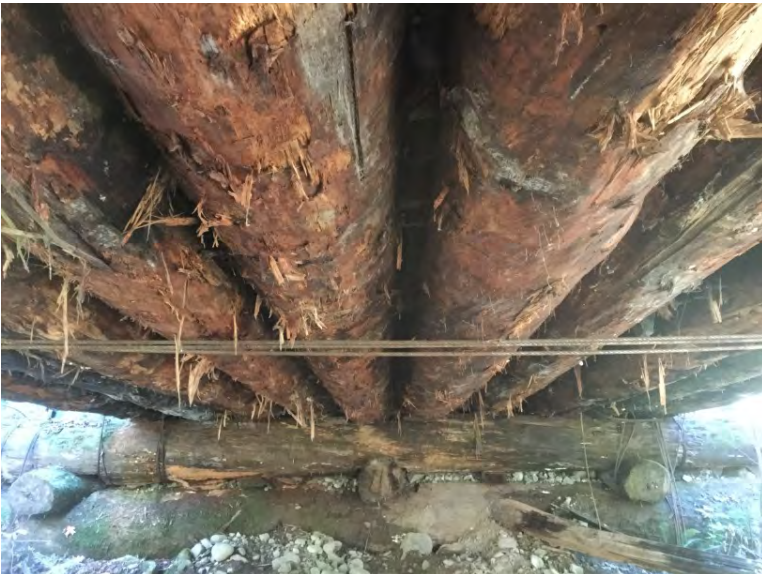
Stringers 3 - 8 are relatively new  
Stringers 1, 2, 9, 10 are old, in poor condition but not load bearing  
11.4m span upstream  
11.5m span downstream
