CK-2519

GARNET 9400 3.5km

2019 Inspection

| Crossing Name | East Fork Garnet Creek |

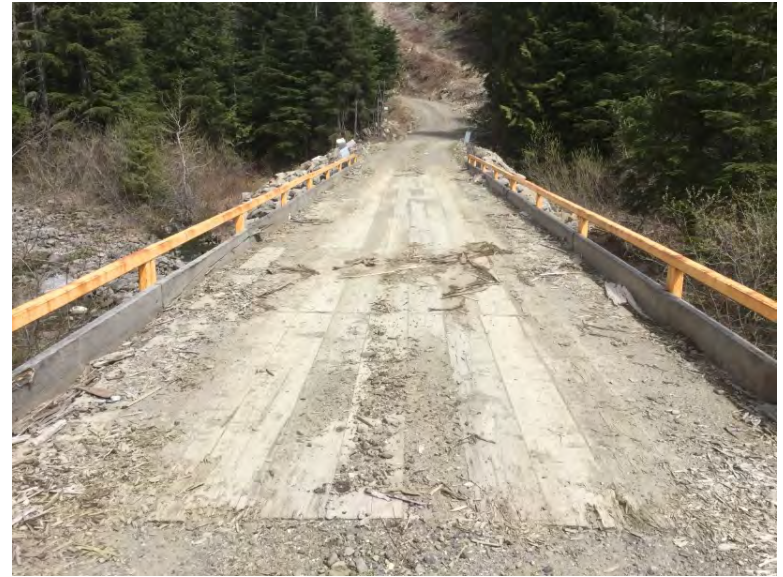
Deck

| Running Planks | Fair | Poor in some locations along wheel path |

| Repair | | Repair Description |
|---|---|---|
| 3 | Medium | Replace wear planks |
