CK-2007  
CK-2007

ANDERSON 13000 0.1km

2020 Inspection

Crossing Name Anderson River

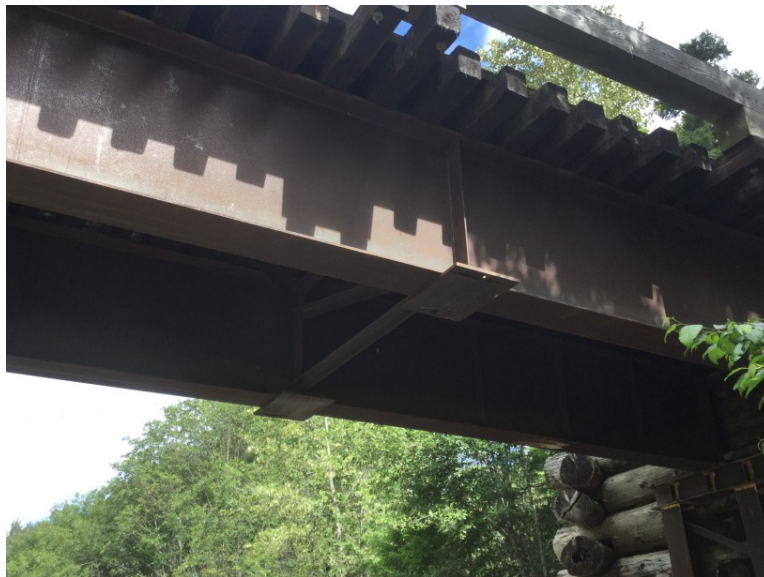
Log cribs only for fill retention. Range of diameters (400mm - 800mm) of face logs with ranging heart rot noted.

Typical face log condition at ends

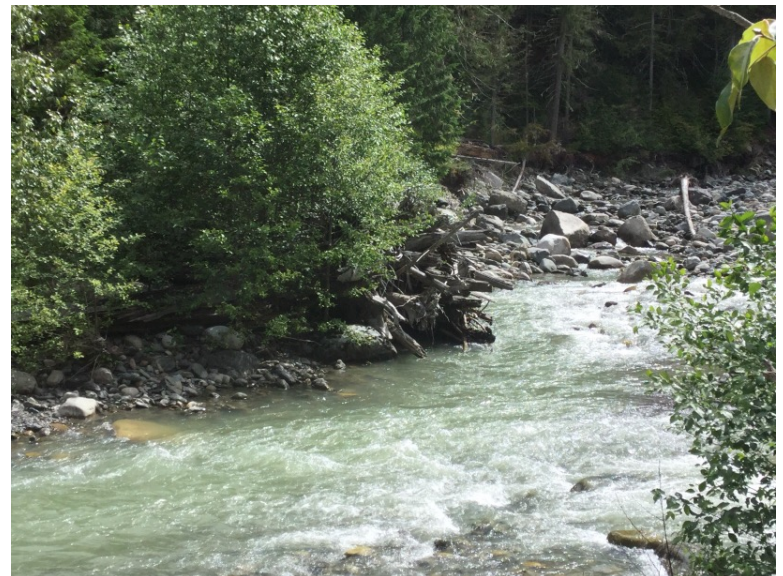
Organics in stream
