CK-2108  
CK-2108

HARRISON EAST 30.7km

2020 Inspection

CBR iPad Offline Ver 0.33

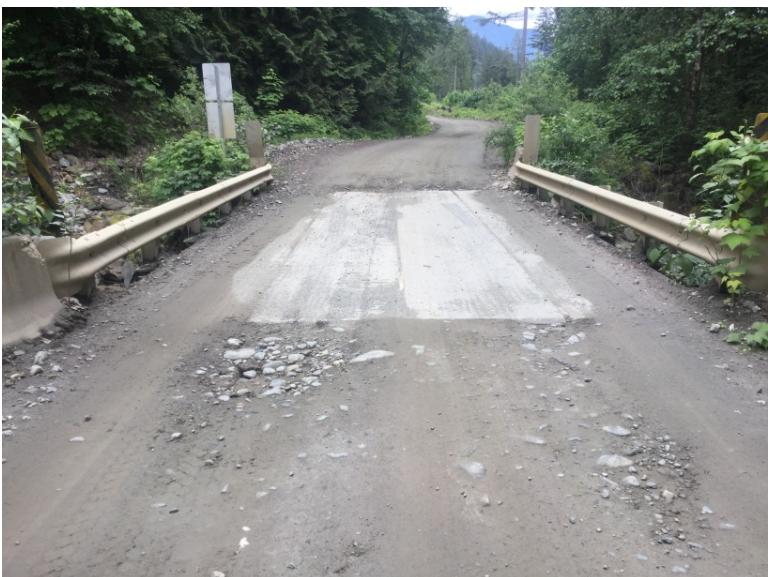
Overall Deck Condition      Fair

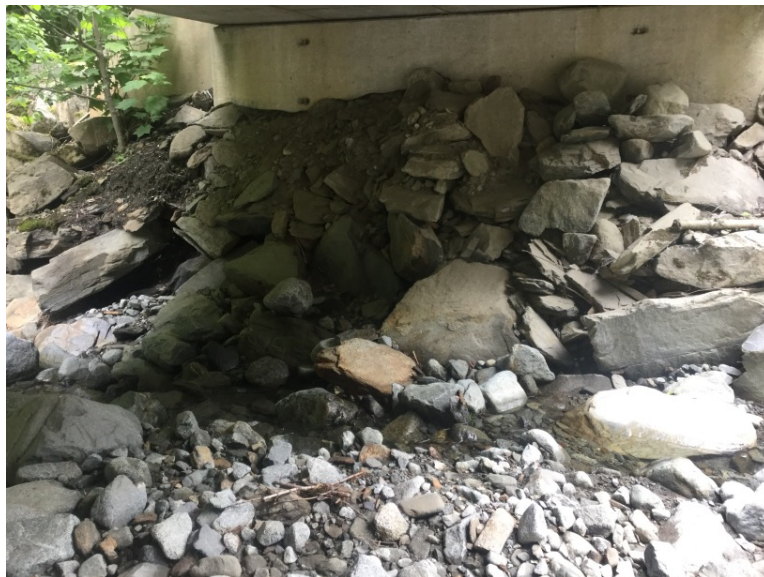
Right Bank Abutment when facing downstream

Riprap Fairr Both banks have now scoured and require repair and monitoring

| Repair Item | Repair Description |
|---|---|
| 3 Channel. Add Riprap (placed). m <sup>3</sup> . Priority:High | Repair scoured riprap at both abutments |
