CK-2111  
CK-2111

HARRISON EAST 47.2km

2020 Inspection

Crossing Name Big Silver River

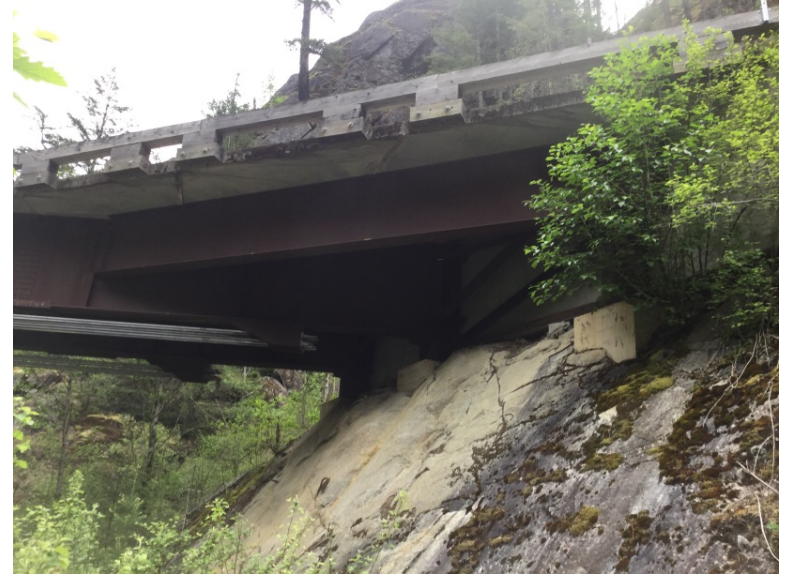
Left bank flared girder

Bearings Fair Bearing bolts on bearings 1 and 2 are slightly bent towards stream side on left bank, bearing 3 on flare is in good condition left bank; right bank has steel keepers and in good condition
