CK-2112  
CK-2112

HARRISON EAST 50.2km

2020 Inspection

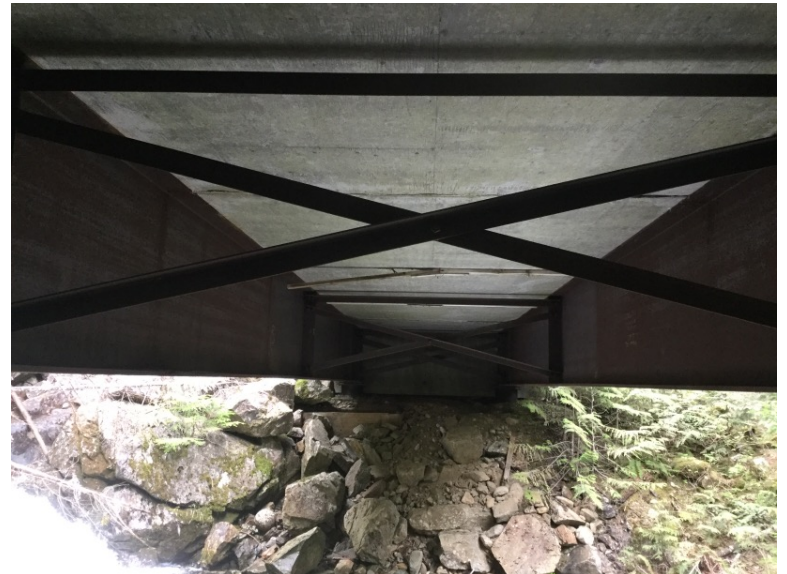
Superstructure

| Item | Monitor Description | Frequency |
|---|---|---|
| 1 | corrosion on top flanges | Every routine inspection |

Install 6m long x 600mm diameter log fenders at both upstream banks. Monitor the corrosion noted on the top flanges. The current load rating of L150 or 136 tonnes to continue.
