CK-2134

STS'AILES (WEST) 23.5km

2020 Inspection

| Crossing Name | Hale Creek | | |

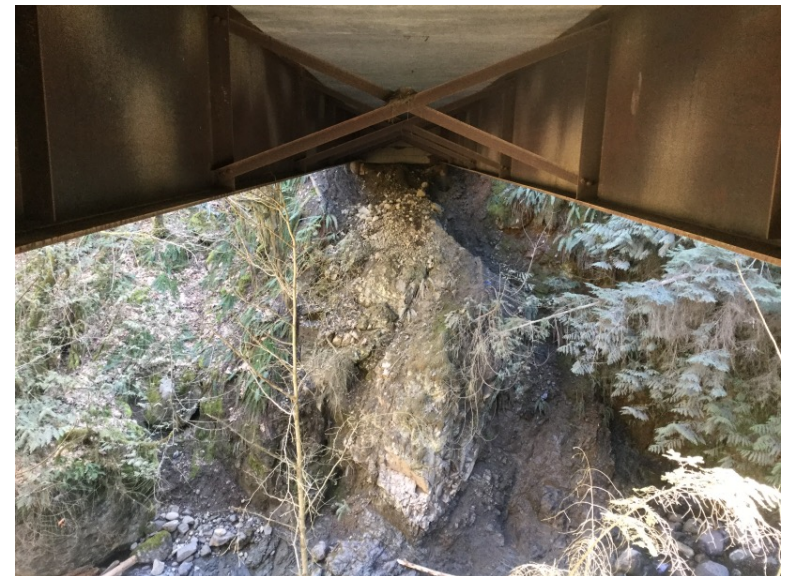
Right Bank Abutment when facing downstream

covered with sediment at left bank, corrosion right bank

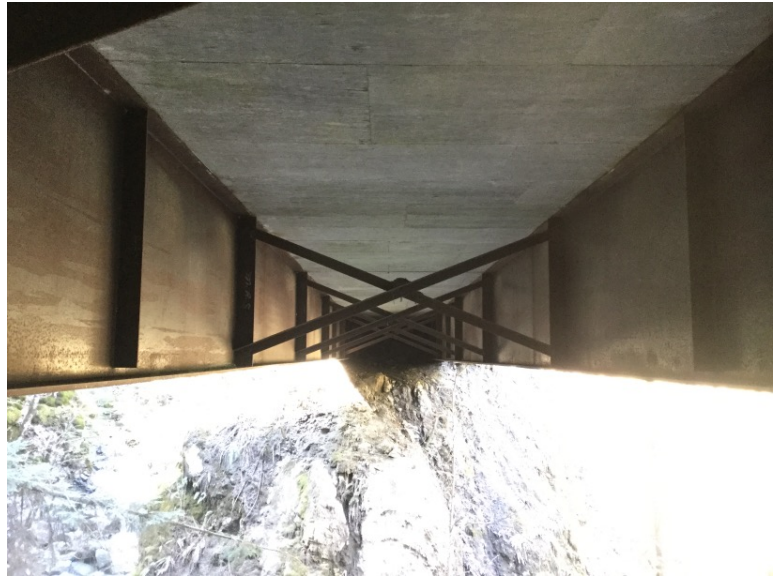
Superstructure

Girders Fair corrosion noted at both banks

Diaphragms Fair 7 bolted bays with minor corrosion noted

Bracing Fair minor corrosion noted
