CK-2157  
CK-2157

HUNTER 2.2km

2020 Inspection

| Crossing Name | Hunter Creek |

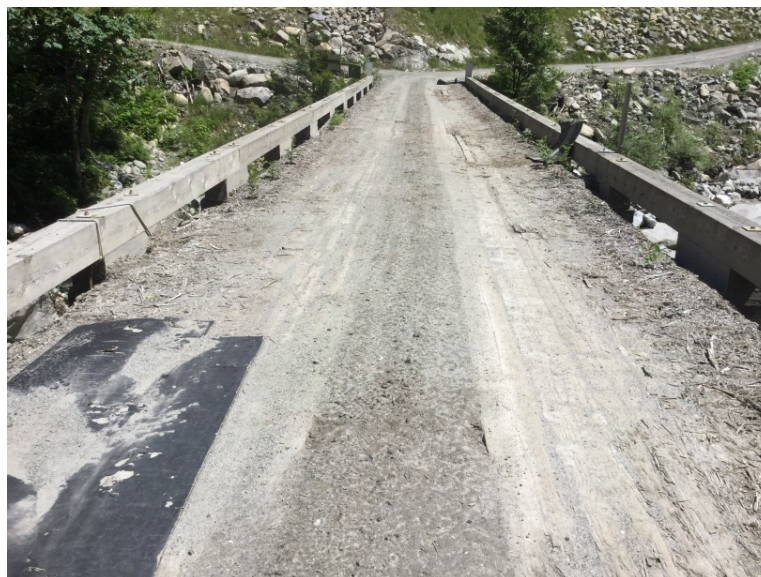
## Deck

Pulled 2 small sections of planks out to view subdeck condition. Minor rot noted along these sections. From underneath the subdeck appears to be in fair condition. At time of plank replacement thoroughly inspect subdeck condition and replace poor materials.

Replace the wear planks and thoroughly inspect the subdeck at that time - replace poor subdeck materials. Replace the downstream right approach boulders with a log fender, min 6m length x 600mm diameter.
