## Permanent Bridge Inspection Report

| Structure #: | CK-2213 | Site #: | CK-2213 | Road Name: | PEERS | Inspection Date: | 2020/06/21 |
| KM: | 0.20 | User km: | 0.20 | Crossing Name: | Coquihalla River | Next Inspection Date: | 2021/06/21 |

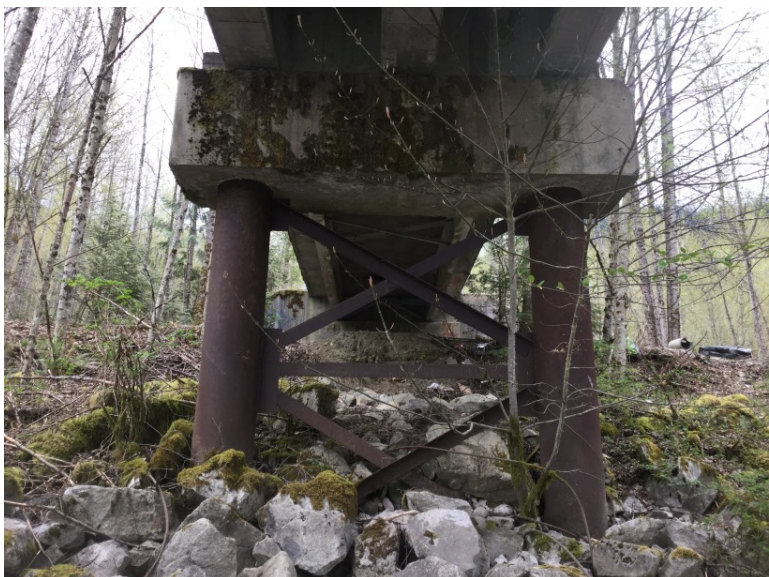
Left bank pier right face

| Caps | Fair | minor spall with water staining and moss growth | | | | | |

| <b>GENERAL</b> | <b>PEng's Comment:</b> | Tighten loose rail bolts throughout all 3 spans. Monitor the concrete cap condition at each pier and the scour under pier 2. The original structural design noted L60 or 54 tonnes capacity; however a structural analysis of the girders was completed by Associated Engineering noting they have capacity to support the CL-625 vehicle. The concrete decks do not show signs of deterioration and there aren't any signs of settlement or distress in the substructure. Increasing the vehicle loads slightly to accommodate highway legal traffic presents a low risk to the Ministry, and as such the load rating can be increased to CL-625 or 63 tonnes. Inspect again next year to ensure no signs of distress are occurring. | | | | | | | | |

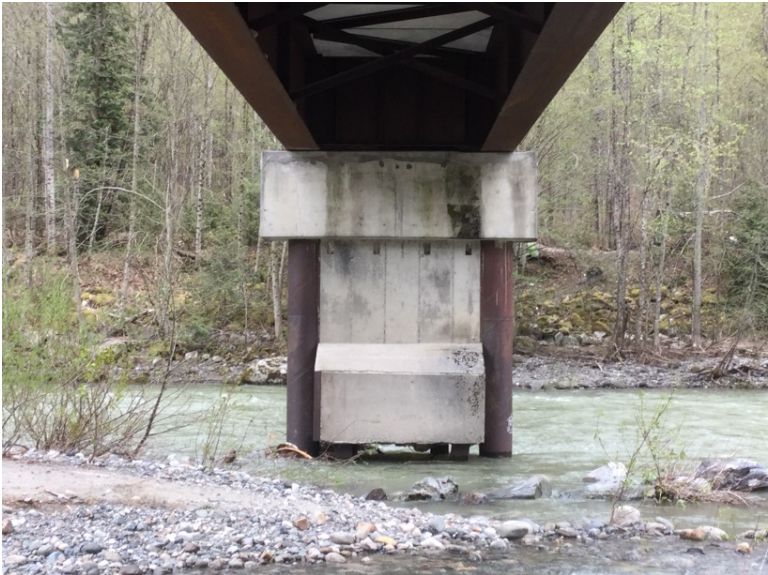
Right pier right face

| | <b>Comment:</b> | Scour noted under pier 2 | | | | | | | | |

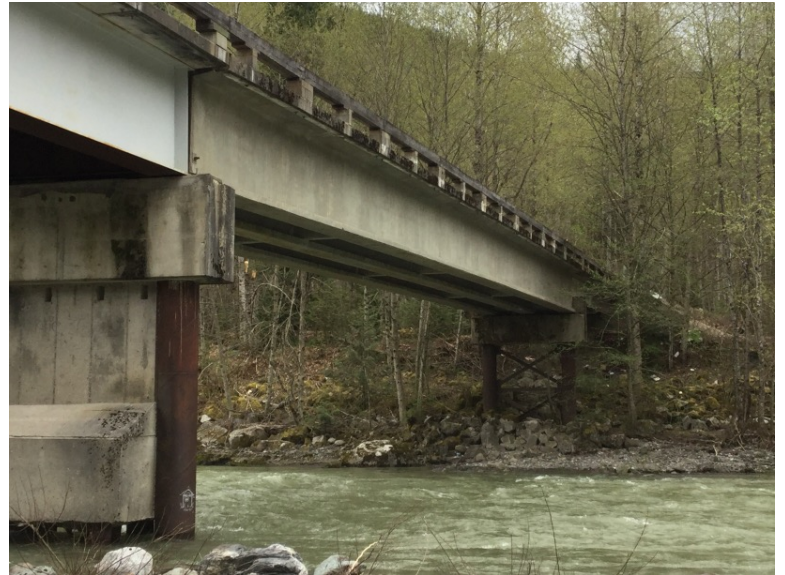
Center span supstructure

| Girders | Fair | girder 2 has hairline crack in bottom flange with efflorescence present, no change from what has been previously noted | | | | | |
