CK-2278  
CK-2278

## SUMALLO 1.4km

2020 Inspection

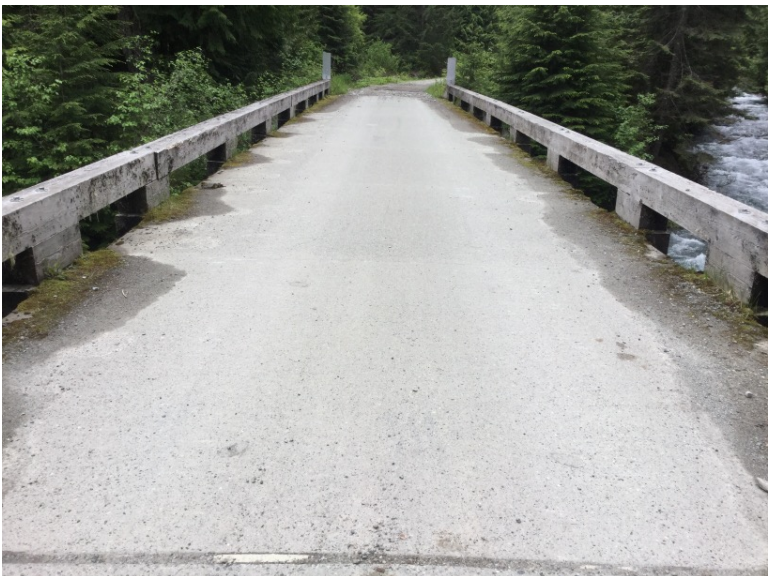
Hardware      Poor      Loose rail bolts

Overall Deck Condition      Poor      Due to rail condition

Replace guardrail, risers and blocks. Brush and grade approaches when active and post bridge ahead signs. The current load rating of L75 or 68 tonnes to continue.

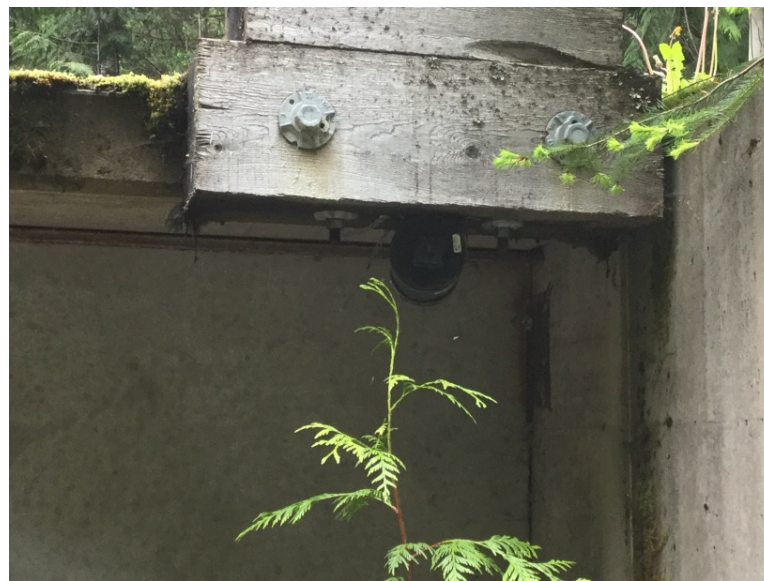
Traffic counter at upstream right bank
