CK-2401

NESAKWATCH LAKE 1.64km

2020 Inspection

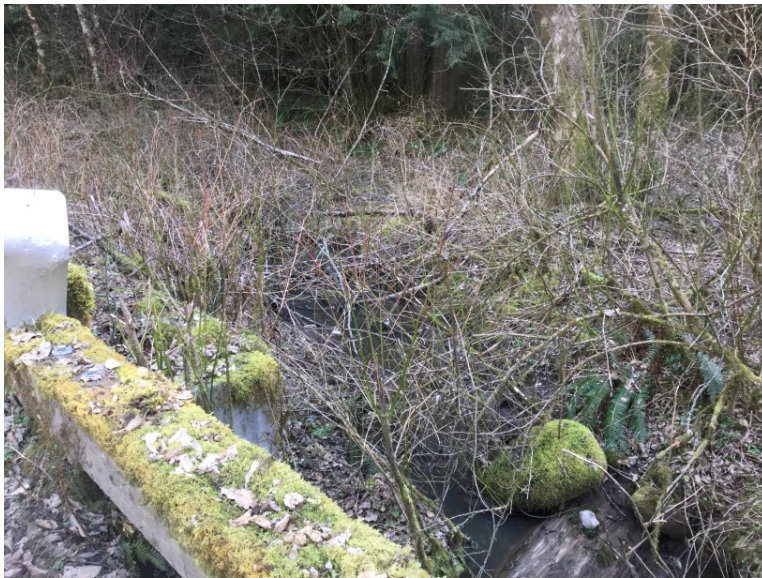
Curb Rail/Blocks/Posts      Poor      Rotten and failed

Hardware      Poor      Loose rail bolts

Guard Rail

| Repair Item | Priority | Repair Description |
|---|---|---|
| 1 | High | Replace guardrail, risers and blocks |
