CK-2452  
CK-2452

NORRISH 7.1km

2020 Inspection

Crossing Name Rose Creek

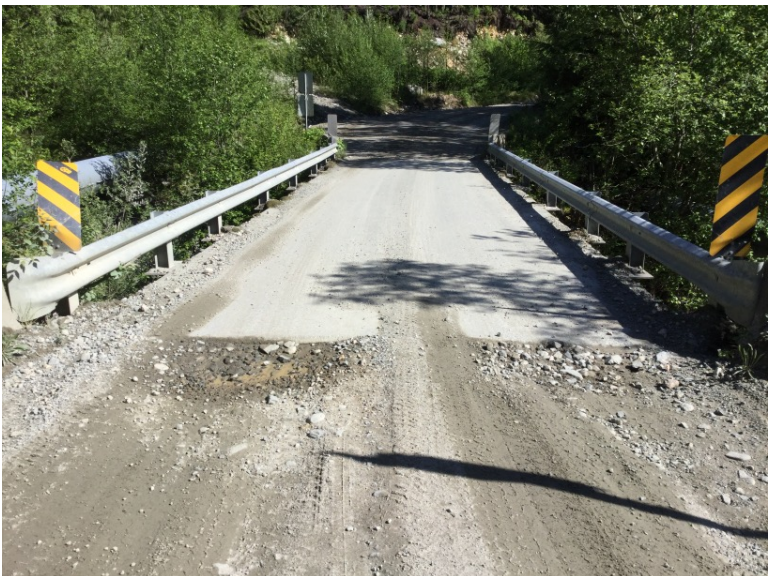
Concrete Deck      Fair      wear on wheel path

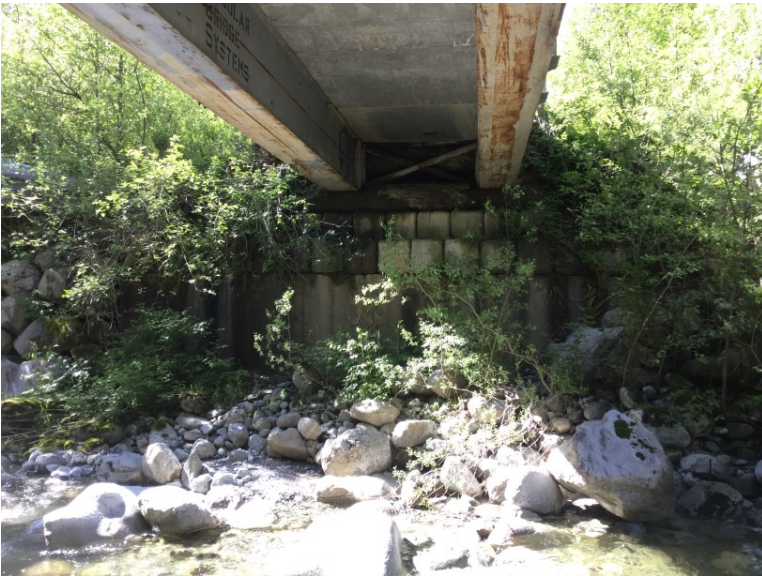
Right Bank Abutment when facing downstream

Concrete Fair CIP left bank with vertical crack under the upstream girder - no apparent change from old inspections. Lock blocks on right bank - some have spalls and others have visible cold joints

Reattach the upstream right bank bull nose to the concrete barriers. Brush and grade approaches. Monitor the condition of both abutments. The current load rating of L165 or 150 tonnes to continue.

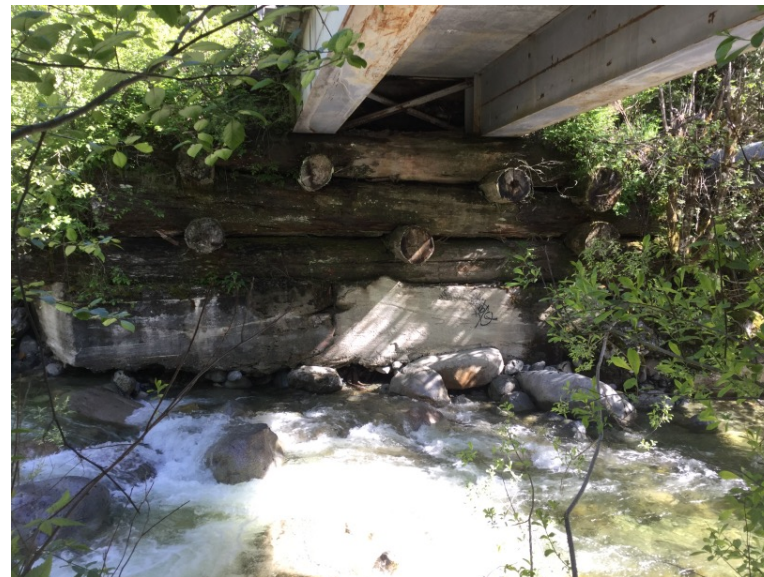
Left Bank Abutment when facing downstream

Log/Timber Cribs Fair 3x face logs with up to 50mm sap rot onto top of CIP on left bank
