CK-2459

HORNET 0.4km

2020 Inspection

| Structure Class | Temporary Bridge |

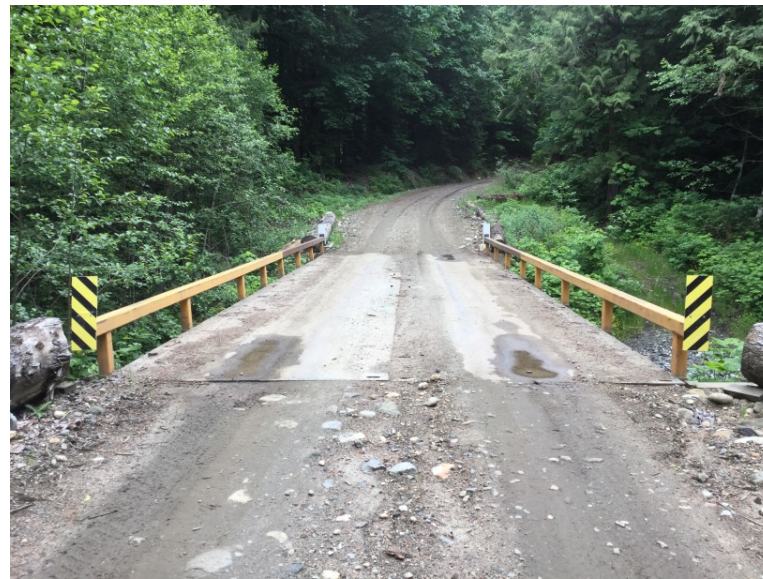
Deck

Damage noted to sections of both upstream and downstream girders at deck edges. Steel has deformed in these locations as noted in previous inspections

Missing rail hardware where deck damage noted

| Repair Item | Priority | Repair Description |
|---|---|---|
| 1 | Medium | Replace missing hardware for HSS rail at damaged deck location |
