CK-2479  
CK-2479

## Grizzly Creek 2.0km

2020 Inspection

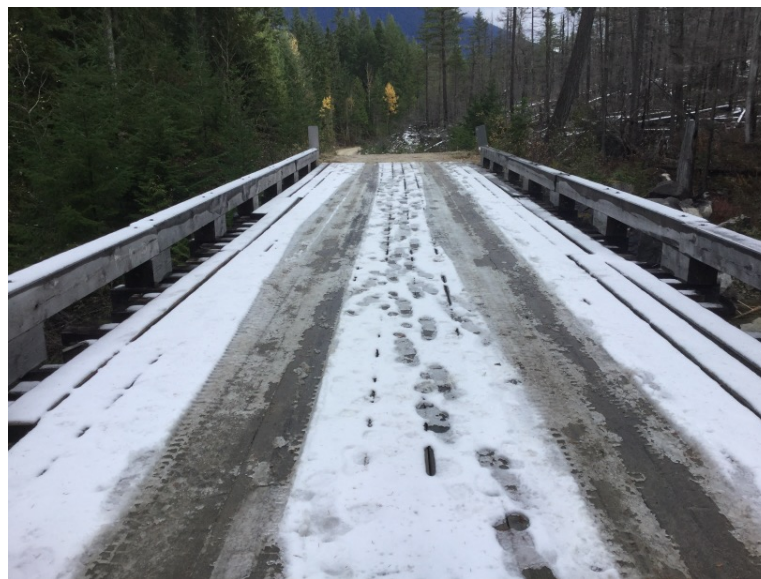
Deck

The creosote subdeck material have been removed since last inspection and replaced with untreated materials. This will likely cause the cross ties to deteriorate quicker. The deck only has running planks now
