CK-2525  
CK-2525

BIG SILVER 2.5km

2020 Inspection

Crossing Name Side Creek

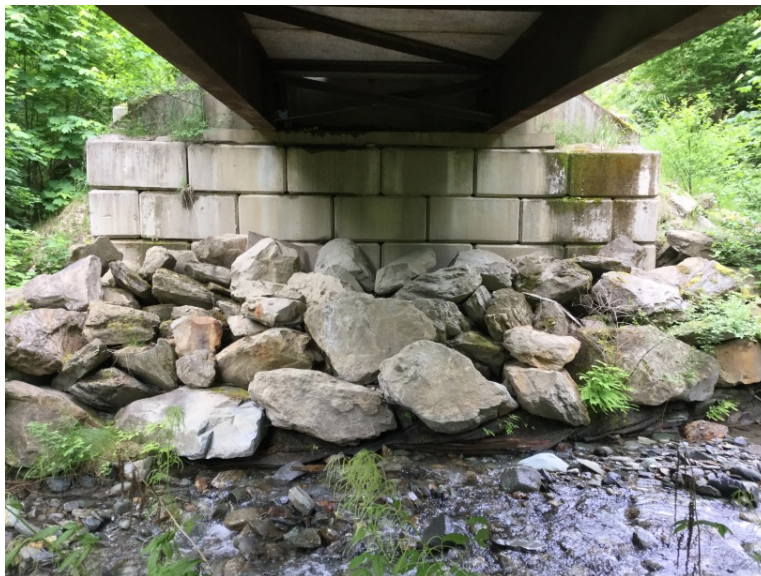
Right Bank Abutment when facing downstream

Riprap Fair Scour noted at right bank

| Repair Item | Repair Description |
|---|---|
| 5 Medium | Repair scoured riprap at right abnk |
