CK-2533  
CK-2533

DEWDNEY 6000 0.03km

2020 Inspection

| Crossing Name | Dewdney Creek |

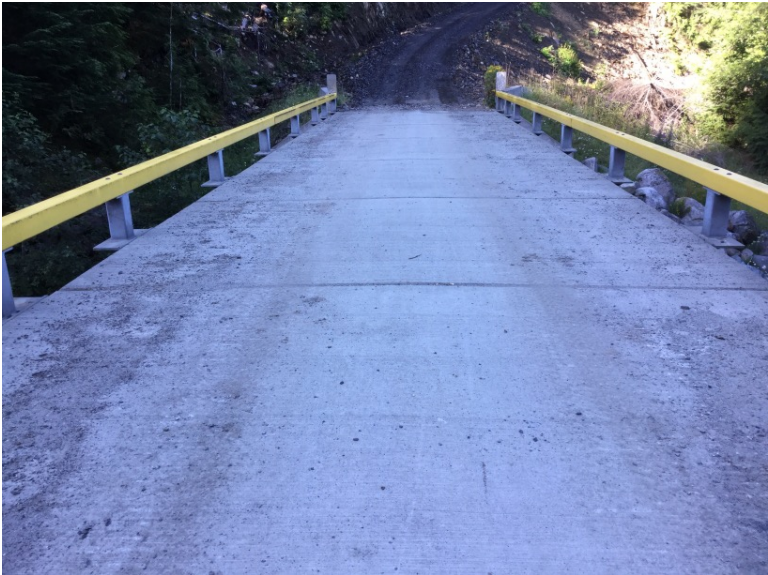
Concrete Deck      Good      2 small damaged sections noted - underside of both end panels

Repair damage to the underside of both end panels (upstream right bank and downstream left bank) consistent with the Concrete Repair Guide for Concrete Bridge Components (MFLNRO 2017). The current load rating of L100 or 91 tonnes to continue.

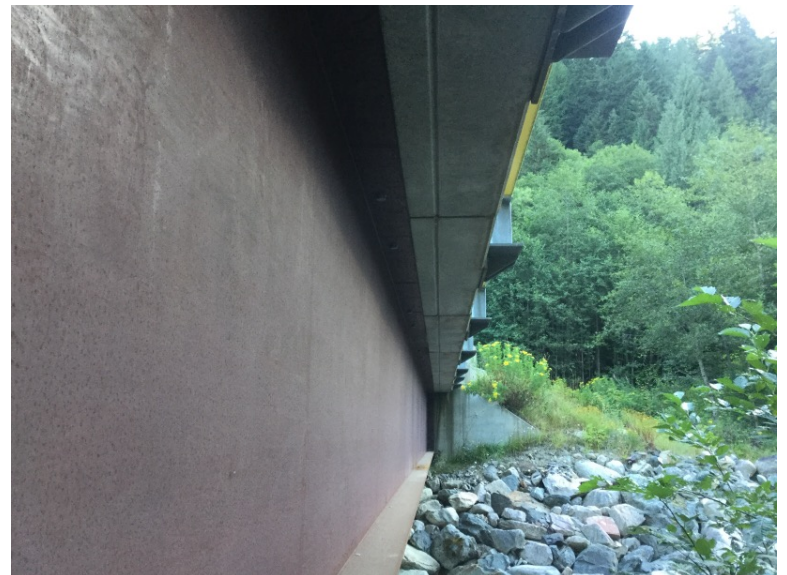
Downstream left bank deck damage

Repair damage noted to deck panels
