CK-2547

EIGHT MILE km

2020 Inspection

| Structure Class | Temporary Bridge | | |

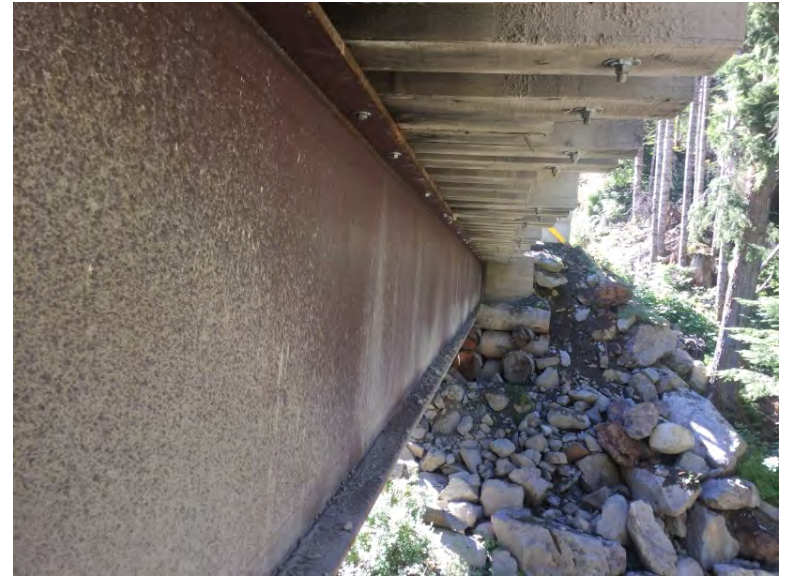
There is a hole in the deck located in the first panel, downstream right bank that requires a single 3300mm long x 100mm thick x 250mm wide (10' long x 4" thick x 10" wide) replacement deck plank (Douglas fir). I recommend replacing this ASAP or premature wear to the cross ties will commence. Also, the fill slope at the downstream left bank is eroding and a tension crack was noted on the very outside edge of the road. While this is not a safety issue at present the fill slope will continue to erode and may extend into the running surface over time. I recommend replacing this material ASAP. The current load rating of BCL-625 (63 tonnes) can continue as long as the above noted repairs are completed. Monitor the fill slope and deck plank condition until the works are completed.

Hole in deck

| Repair Item | Repair Description |
|---|---|
| 1 Structure. Minor redecking (wearing surface). 100mm x 250mm x 3300m. Priority:High | Replace 3.3m length of deck plank (100mm x 250mm) at right bank, first panel |
