CK-2158  
CK-2158

HUNTER 4.9km

2021 Inspection

Crossing Name East Fork Hunter Creek

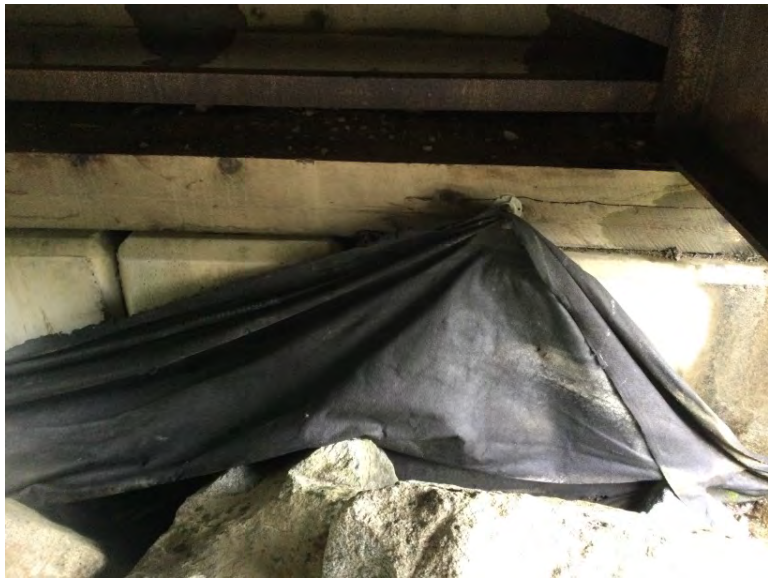
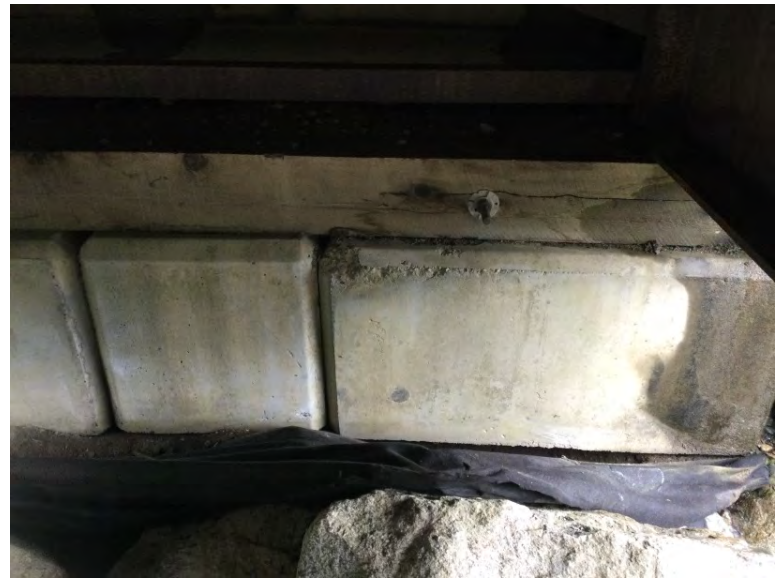
Left bank abutment

Foundational material under the lock block directly under the downstream left bank girder has eroded. The lock blocks are sloping/settling towards the downstream end. Until full bearing can be reinstated limit loading to 30 tonnes. In the meantime I recommend monitoring the site. Post load rating signs.

Good right bank; downstream left bank lock blocks settling due to eroding/settling foundation material, timber cap has been shimmed between it and the downstream lock block

| Repair Item | Repair Description |
|---|---|
| 1 Substructure. Lock blocks<br>- Priority:High<br>Structure. Cross tie<br>maintenance | Reinstall foundational material under left bank lock blocks |
