CK-2075  
CK-2075

BENCH 2.1km

2022 Inspection

Crossing Name Foley Creek

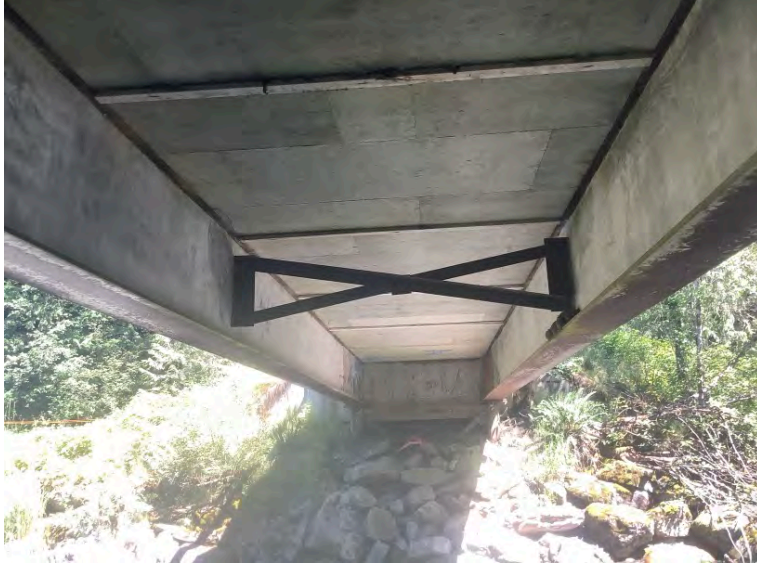
Superstructure

Comments: hairline fractures in girder were identified in last inspection but were not noted this year, continue to monitor, monitor rip rap as well.
