CK-2158  
CK-2158

HUNTER 4.9km

2022 Inspection

Crossing Name East Fork Hunter Creek

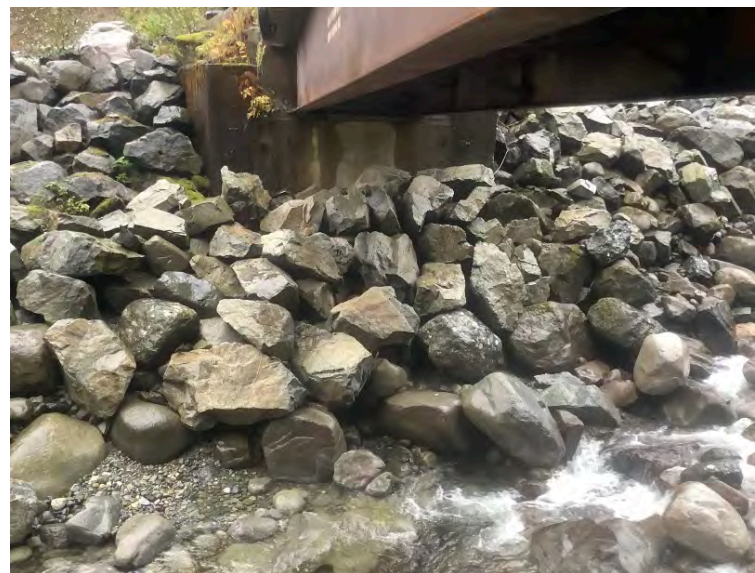
Right Bank Abutment when facing downstream

Cip right good condition. Left blocks settings. Have added material beneath blocks some last inspection. ~~Bringing to fair condition~~

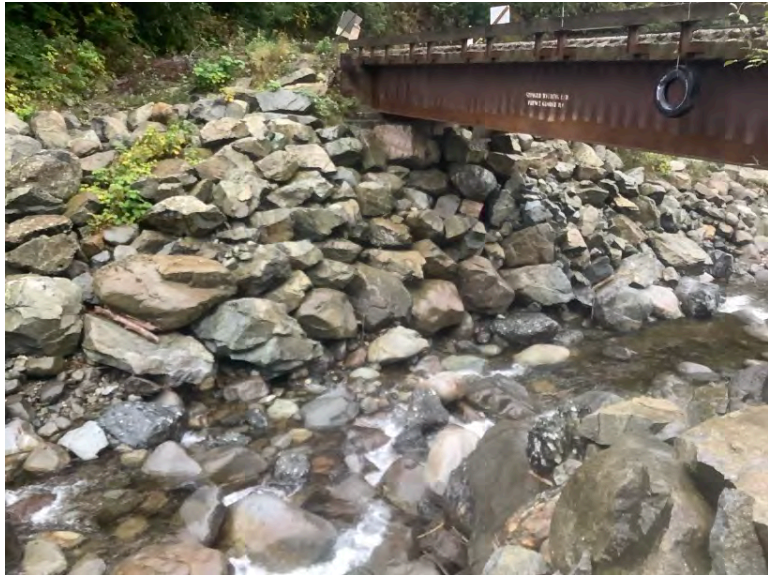
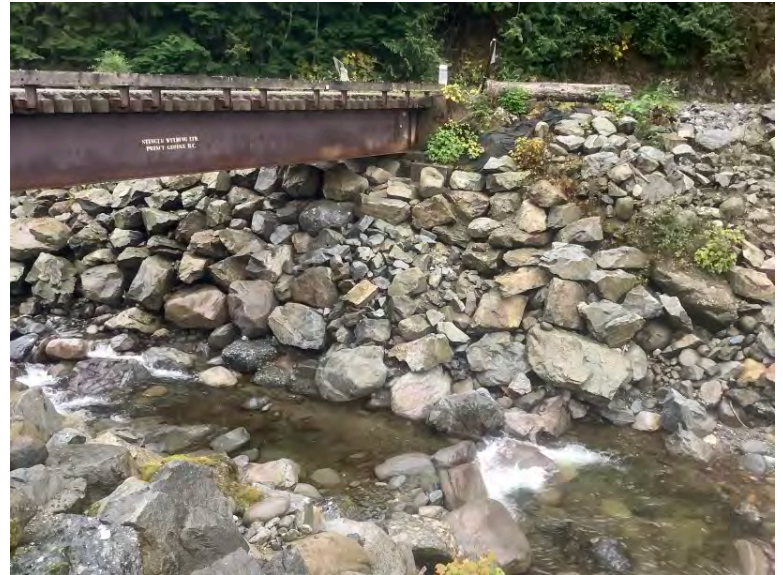
Left Bank Abutment when facing downstream

Minor crushing and a crack on left timber sill. Treated timber right bank fair condition.

They Cut damaged cross tie end and moved rail brace one cross tie over. Sufficient fix. Have added material under blocks on left bank and riprap. Monitor both annually until determined sufficient

Comments: inspect annually to monitor left abutment lock blocks for settling, and timber sill for further cracks, damage, clean sediment off deck.
