CK-2316  
CK-2316

FOLEY 12.7km

2022 Inspection

Crossing Name Foley Creek

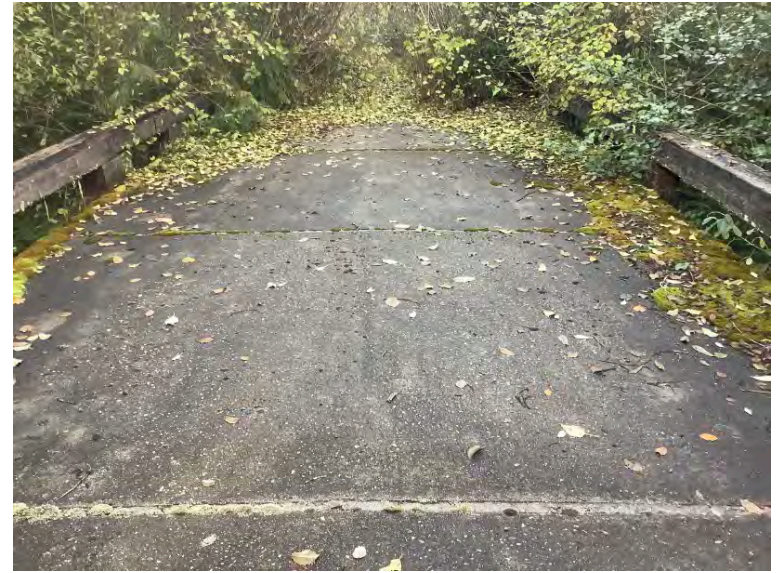
Guard Rail

Hardware Fair Poor-loose

Overall Deck Condition Fair Poor-due to rail condition

Load rated by: MoF Sasha Ward RPF, P.Eng Feb 15 2023  
Load rating: 0 tonnes due to flooding from beaver activity  
Comments: Notify when bridge accessible, complete inspection and replace all timber guard rails components prior to increasing load rating.  
Next inspection: 2024

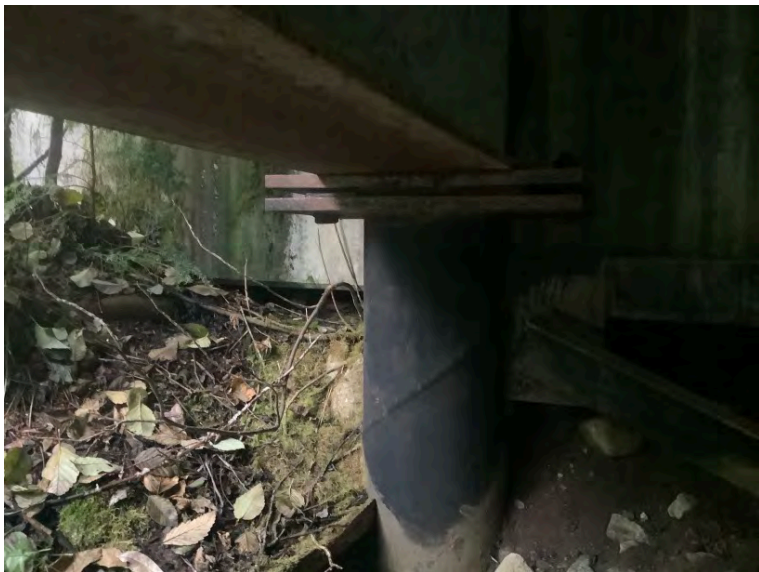
Left Bank Abutment when facing downstream

Left bank has toe scour starting. Large oversized rocks appear to have remained in place. Right bank large rocks do not appear to be keyed in. Slight scour noted.
