CK-2441  
CK-2441

FIFTEEN MILE 1.5km

2022 Inspection

Crossing Name Fifteen Mile Creek

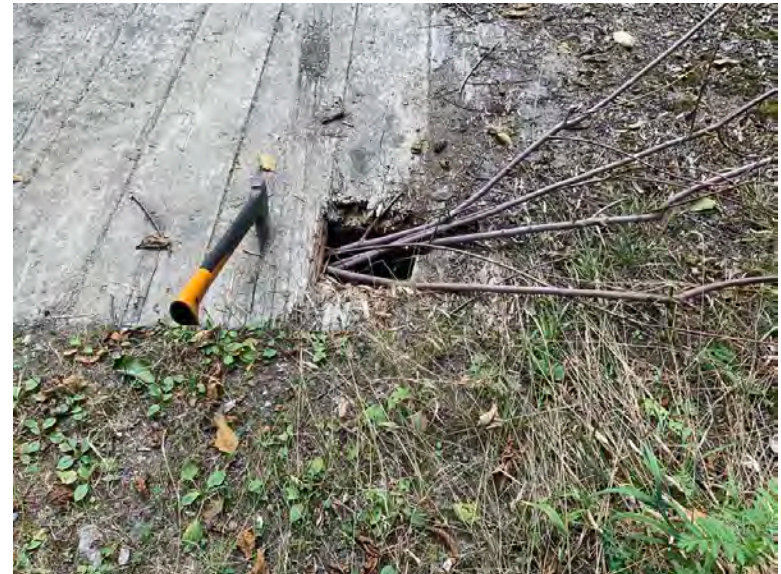
Overall Deck Condition      Poor      Entire deck system requires replacement

| Repair Item | Repair Description |
|---|---|
| 3 Structure. Major redecking (crossties or laminated deck). m. Priority:High | Replace ties and planks prior to industrial activity |
