CK-2452  
CK-2452

NORRISH 7.1km

2022 Inspection

Crossing Name Rose Creek

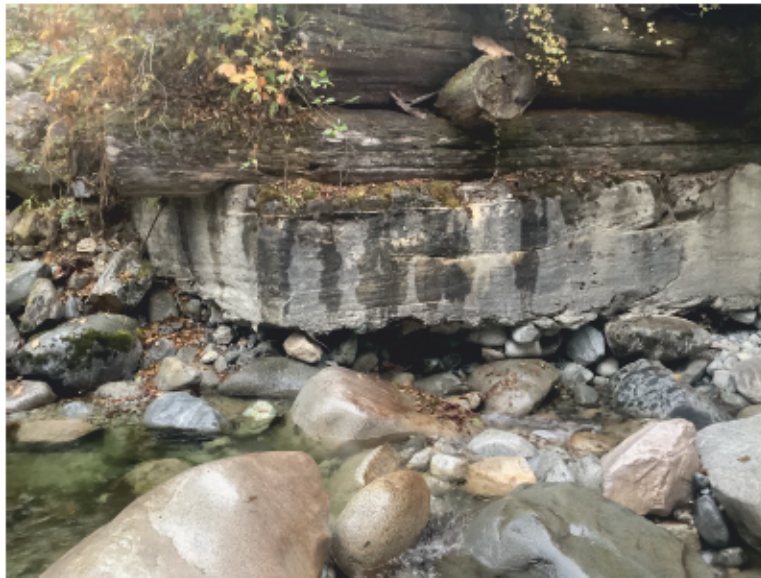
Left Bank Abutment when facing downstream

Concrete Fair Upstream left cip is cracked beneath bearing. And along the upstream side. Also scoured beneath. Could lead to settlement, however appears to be the same as previous inspection.
