CK-2474  
CK-2474

NAHATLATCH 46km

2022 Inspection

Inspection Company Chartwell Resource Group Ltd

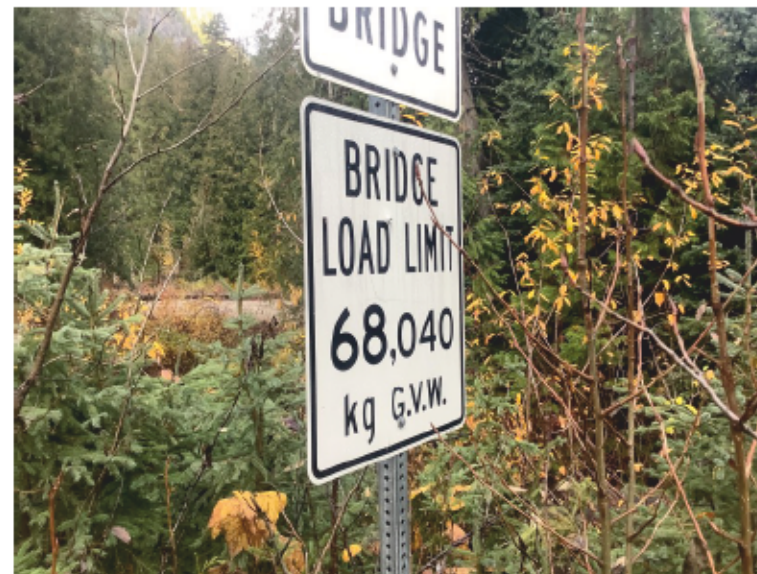
Load Rating Sign

Load Rated by: MoF, M.Lowe, RPF, PEng, February 16, 2023  
Load Rating: 5 Tonnes GVW  
Next Inspection: September 1, 2025  
Comments: Load rating reduced due to guard rail condition. Replace rails to achieve design load rating.
