CK2479  
CK-2479

GRIZZLY 2.1km

2022 Inspection

Crossing Name Grizzly Creek

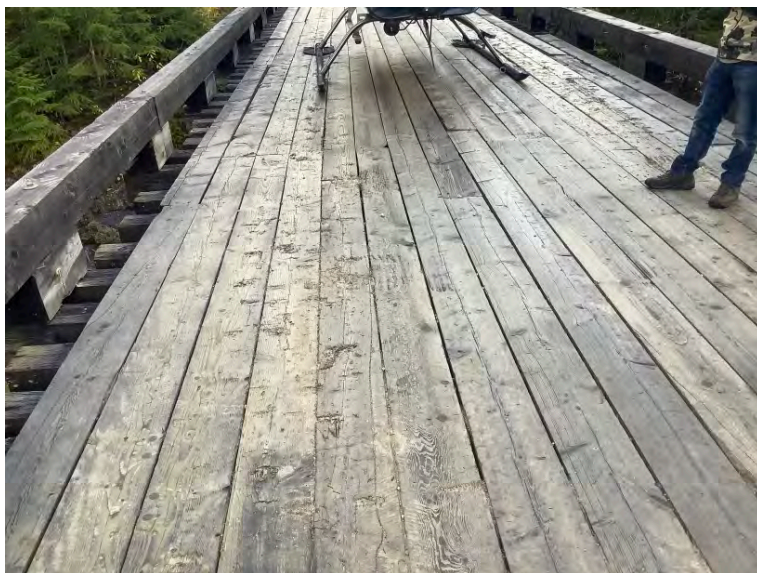
Overall Deck Condition      Fair

| Repair Item | Repair Description |
|---|---|
| 2 Structure. Minor redecking (wearing surface). m.<br>Priority:Medium | Fasten all deck planks to cross ties |

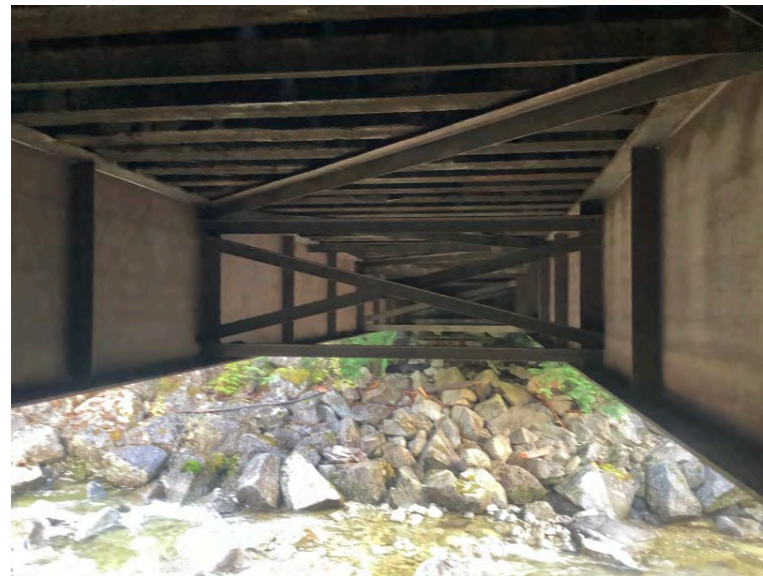
Superstructure

Corrosion Protection **Fair**
