# RWC-1001 2023 Inspection

Army 0.5km

## Retaining Wall Inventory Data

## Retaining Wall Inspection Report

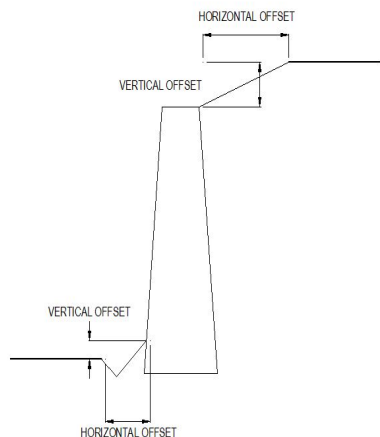
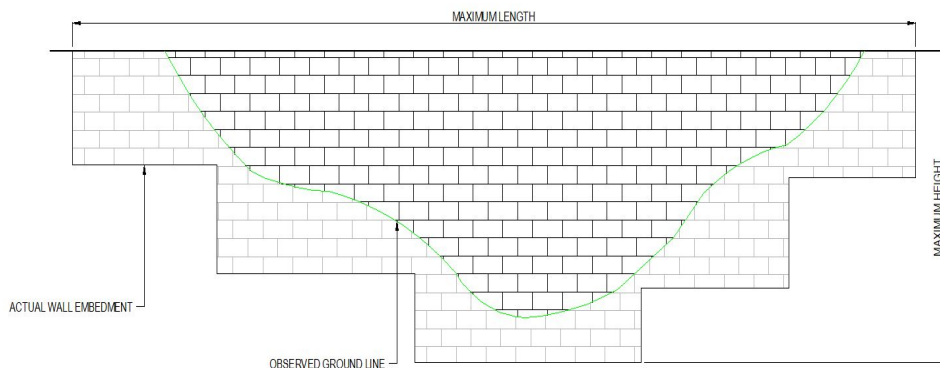
| | Rating | Comments |
|---|---|---|
| Retaining Wall Structure | Good | Well founded GRS wall utilizing galvanized welded wire mesh and geotextile facing. No failed elements observed however there are lots of ferns growing from the wall. |

Face if and ferns. Well founded.

| Item | Status | Priority | Description | Ministry Engineer Comment |
|---|---|---|---|---|
| 1 | Suggested | Medium | Clean garbage and remove ferns. | |
