CK-2157  
CK-2157

## HUNTER 2.2km

2023 Inspection

Crossing Name Hunter Creek

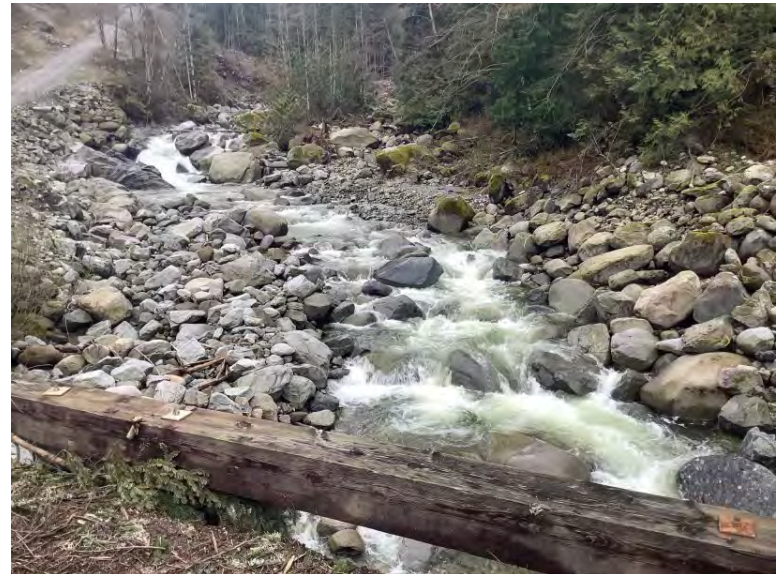
| Overall Deck Condition | Poor | Due to timber deck condition. Deck is also covered in sediment and requires cleaning. |

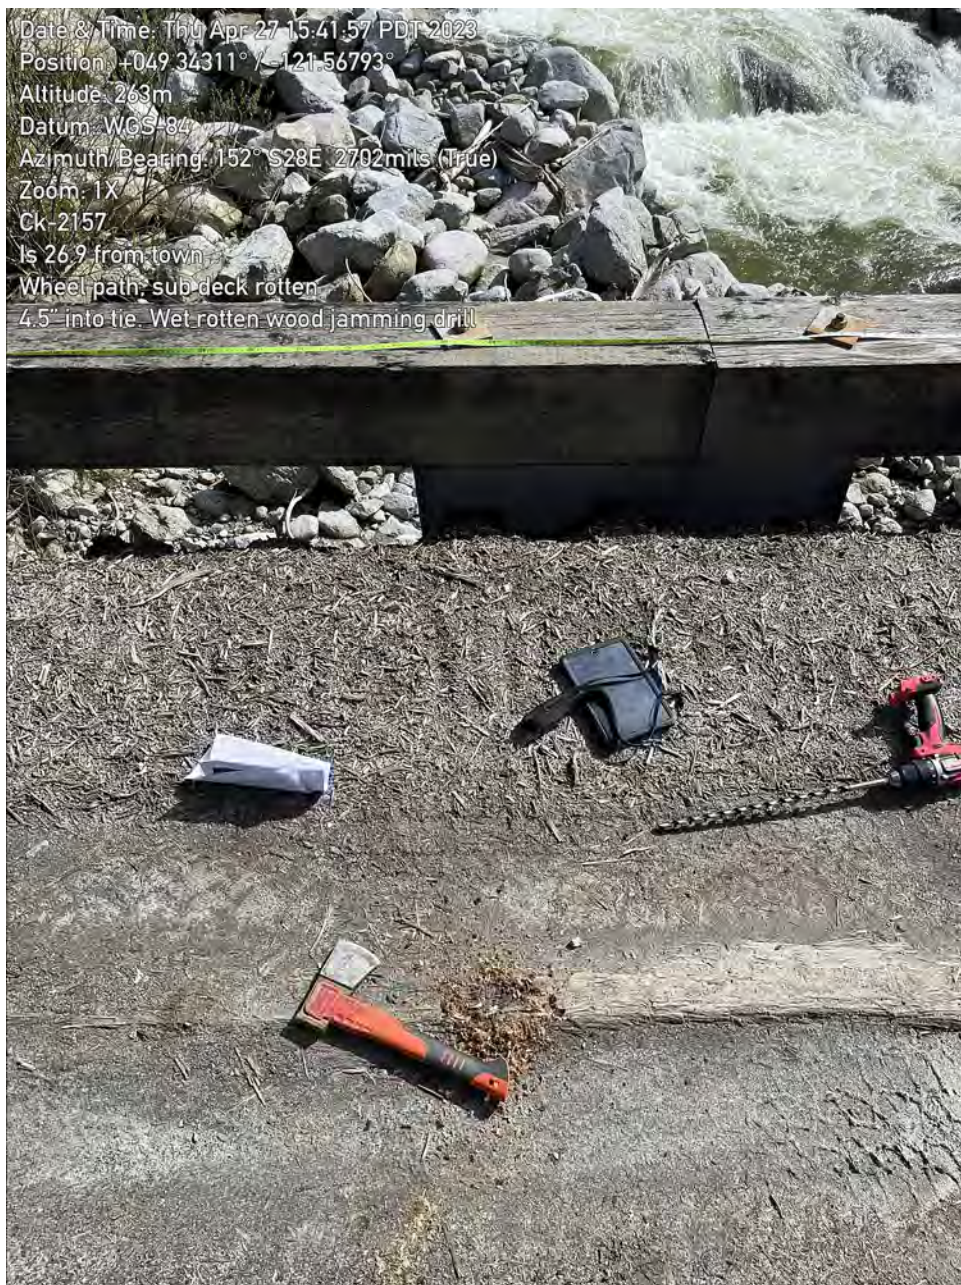
| Ties | Poor | Rotting from the top down. Spot checked 5 locations, 1 sound at interface of sub deck. Rest have over 2" of rot. 2 jammed drill 4.5-5" into tie with wet rotten wood. |

Wheel path: sub-deck rotten

4.5" into tie. Wet rotten wood jamming drill

Replacing the timber deck (cross ties, subdeck and running planks) would result in an increased load rating (BCL-625 or 64 tonnes); however, the structure has not had any sustained log hauling in some years and the crib condition will need to be monitored shortly after the hauling commences. If this approach is considered, I recommend an inspection be completed 1 week after sustained hauling commences and 3 additional weekly inspections thereafter. If any settlement or further deterioration is noted in the abutments the load rating would likely have to be reduced and/or the structure replaced. Please send all inspections (completed by a qualified professional) to the Coast Engineering Group.
