**Re: 2005 As-Built Flood Damage Recovery Works, Lagace Creek, Hatzic Valley  
Final Report**

## 2005 AS-BUILT FLOOD DAMAGE RECOVERY WORKS LAGACE CREEK, HATZIC VALLEY FINAL REPORT

OCTOBER 2005

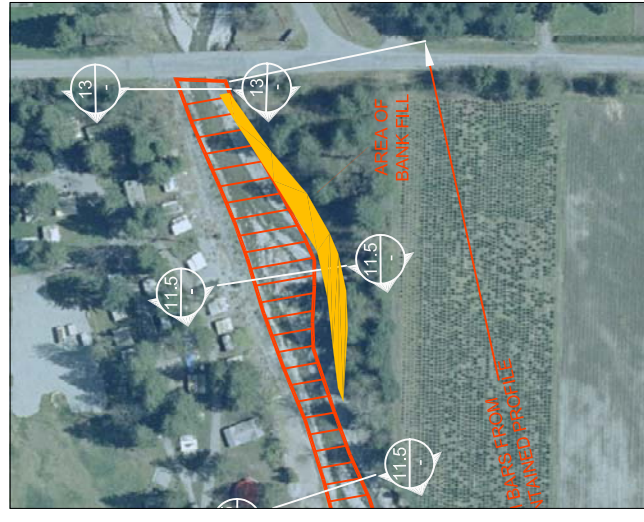
Figure 4. Summary of 2005 works completed in Reach 3.

Figure 4 summarises the 2005 recovery works. Water and sediment were managed in this reach using temporary in-channel diversions. In the lower portion of the reach a low-flow channel was excavated along the edge of the right (north) bank. Upstream of the main trap site, flow was diverted to the north side of the channel with minimal excavation using the existing gravel bars. Following flow diversion, the channel was excavated and re-contoured in isolation of the main flow.

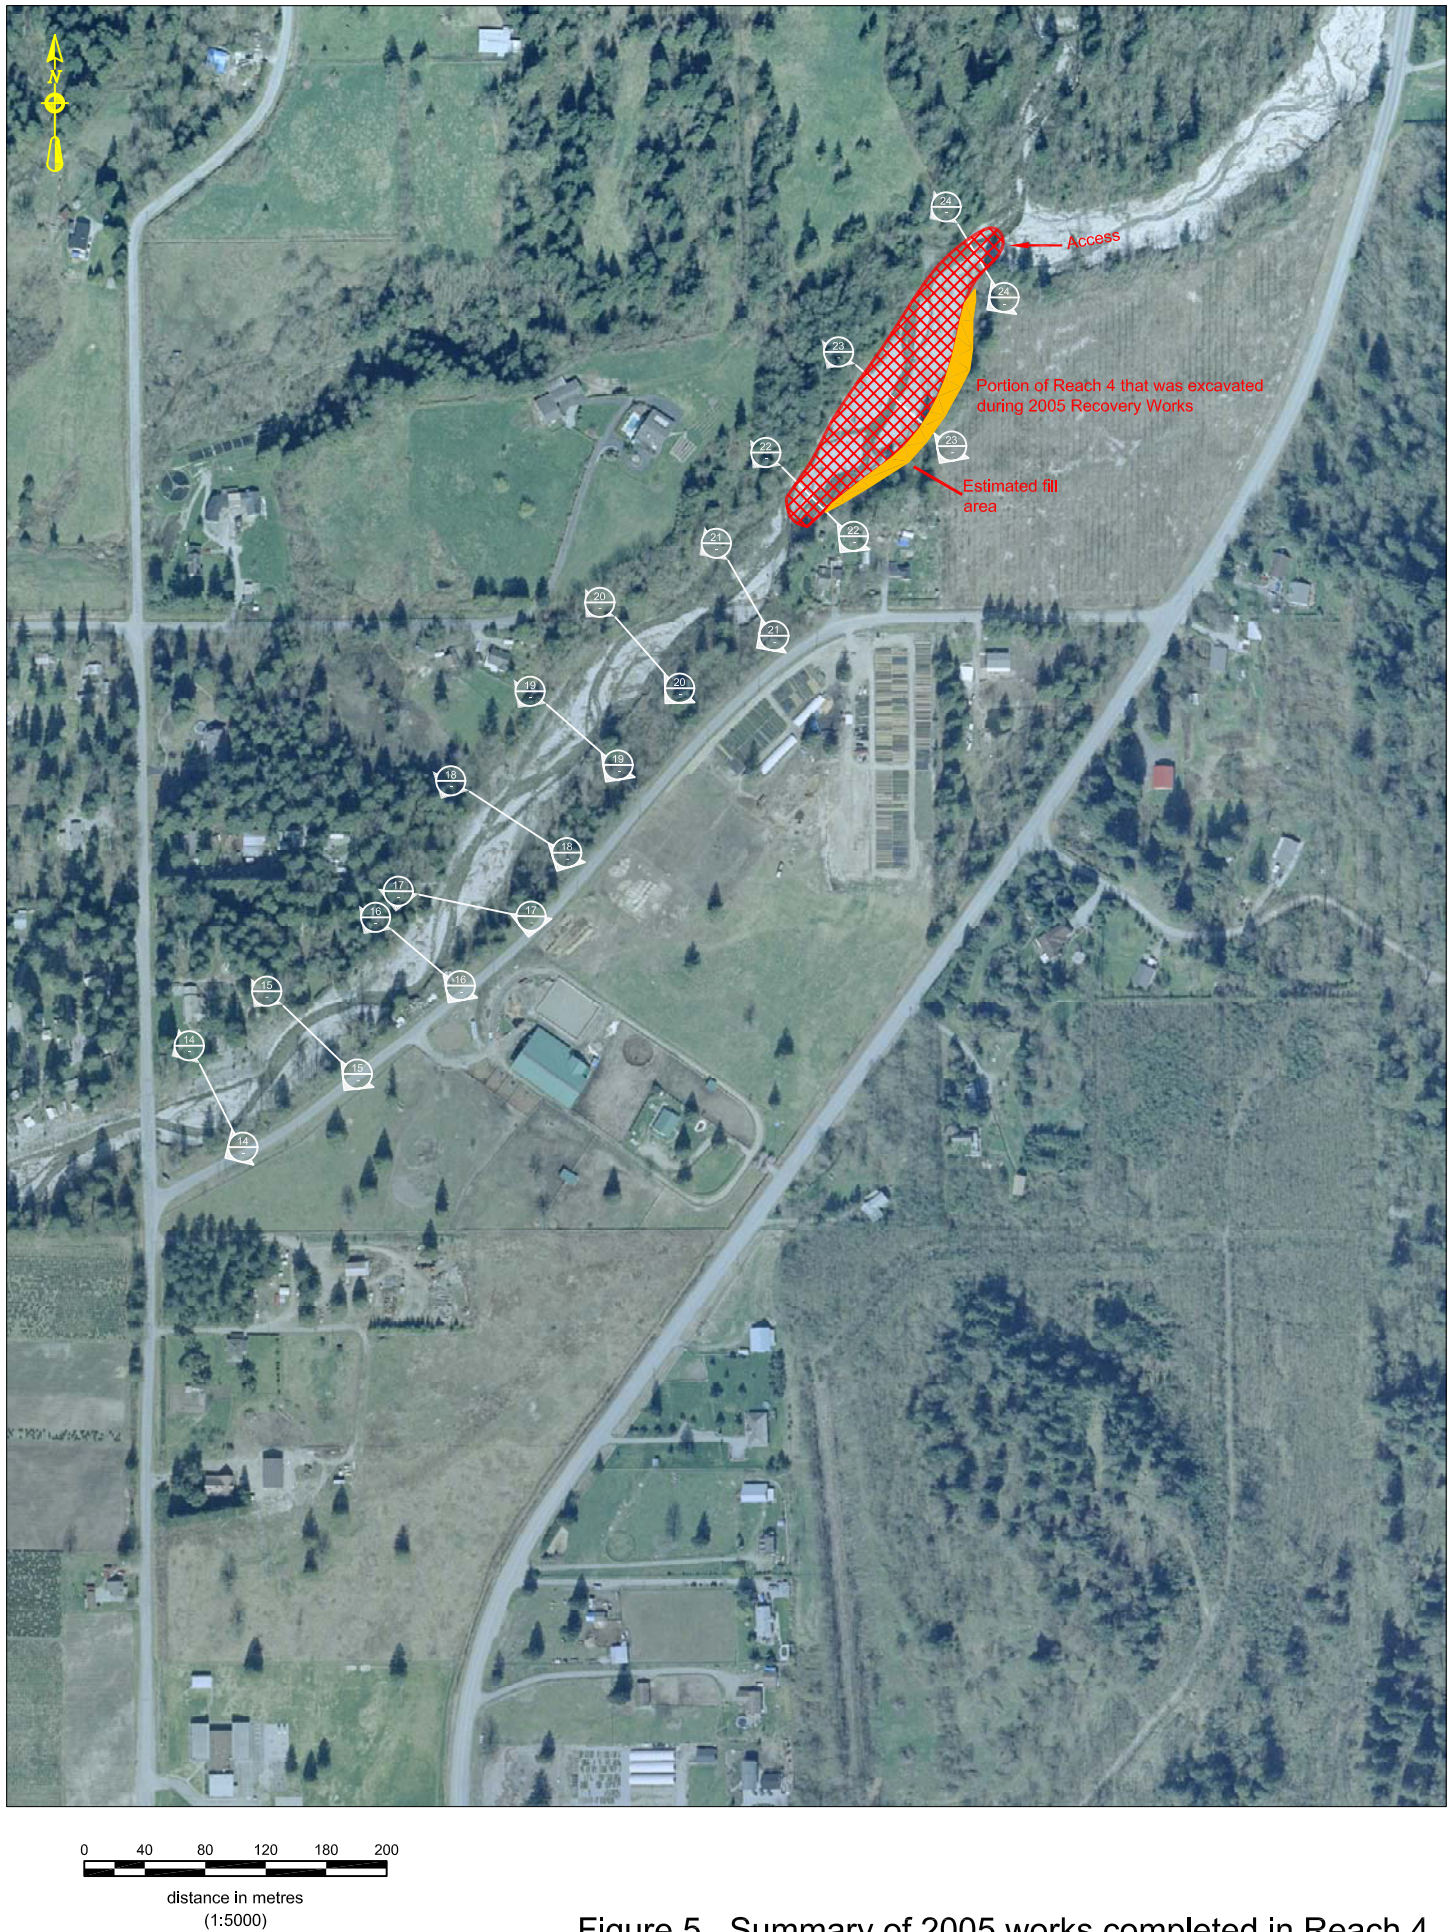
Figure 6. Summary of 2005 works completed in Reach 5.

Figure 6 shows the extent of the completed works, including a comparison of pre- and post-construction surveyed cross sections. A total of 380 m length of the channel was excavated and re-contoured in addition to approximately 350 m of bank that was contoured and armoured. The net volume of material removed from the reach was 13,000 m<sup>3</sup> with a total of 28,000 m<sup>3</sup> removed from active transport. The area of excavation is 12,000 m<sup>2</sup> with an average excavation of approximately 2 m and maximum depth of cut of 2.4 m.

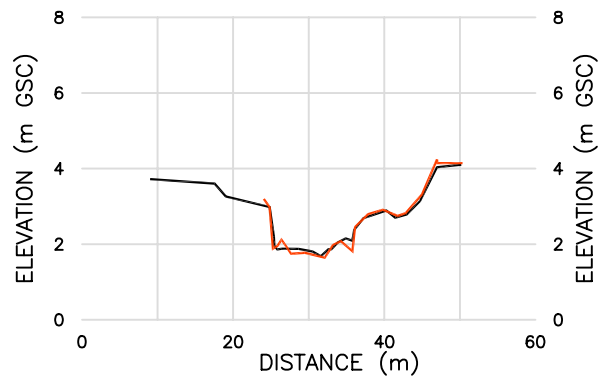
**2 0+050**  
5H:1V

Note: Cross sections 1 and 2 are downstream of the excavation site. Lowering of the bed shown on these sections is from downcutting.

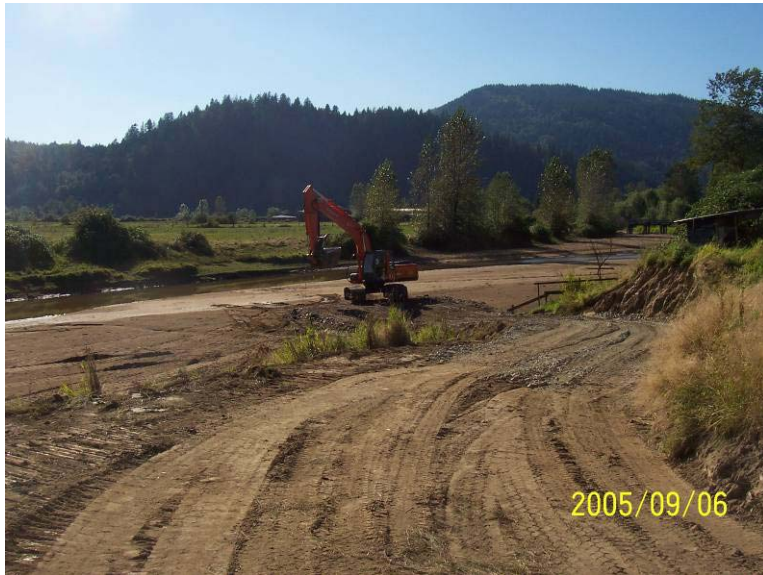
**Photograph 1.** Looking at the upstream sandbar and access along the left bank at commencement of work. In the background, the right bank sand bar can also be seen.

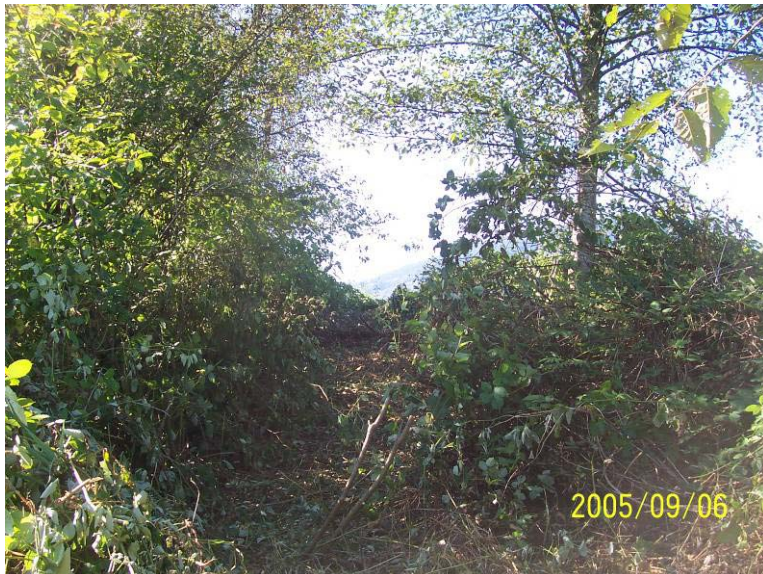
**Photograph 2.** Looking at second access road along the left bank prior to commencement of work. Access consisted of blackberries and detritus.

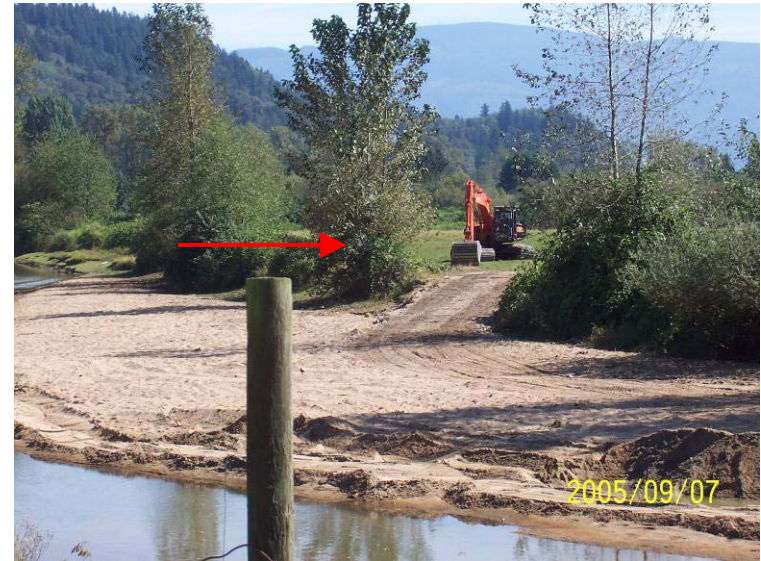
**Photograph 3.** Looking at sandbar along the right bank. A natural opening was used to access the channel. Red arrow indicates cottonwoods that were removed during the excavation.

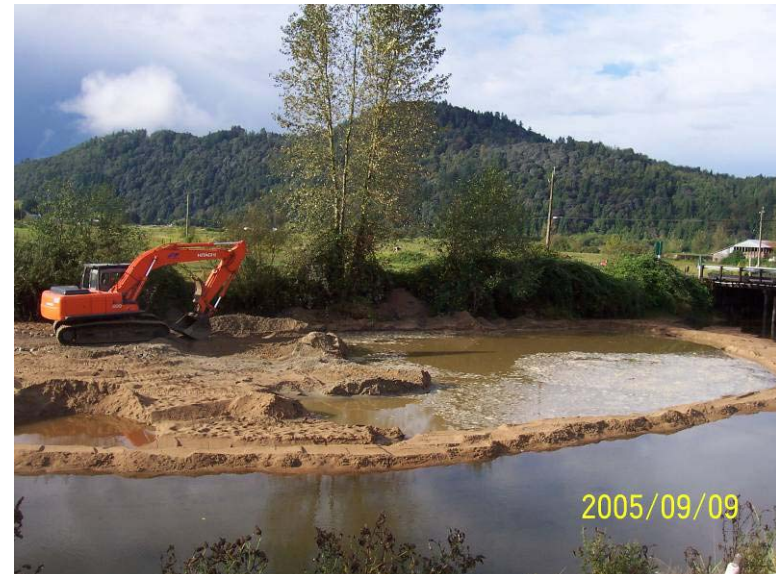
**Photograph 4.** Excavating the sandbar along the right bank in isolation of flow.

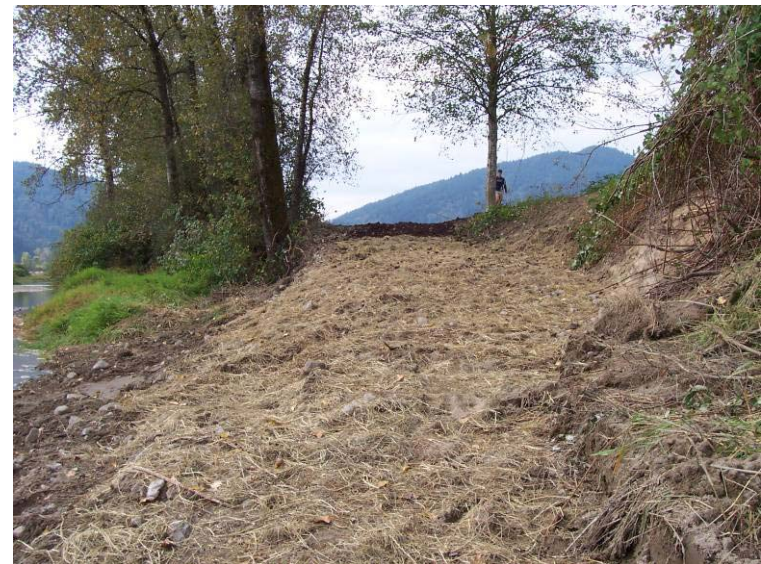
**Photograph 7.** Looking up at the second access road along the left bank of Lower Reach 1 upon completion of work. The access has been seeded and both straw and silage applied. September 13, 2005.

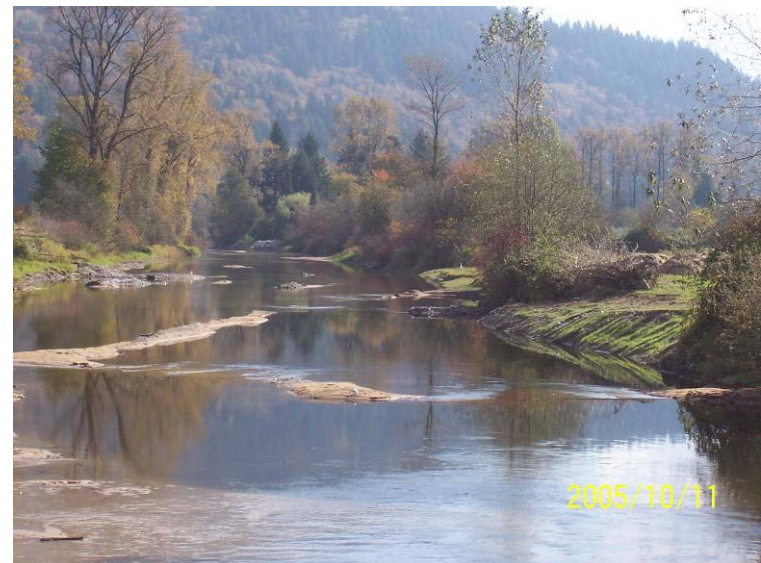
**Photograph 8.** Looking downstream from Farms Road Bridge. At the right bank excavation (Photographs 3 and 4). Berms are breached and grass is growing on the banks.

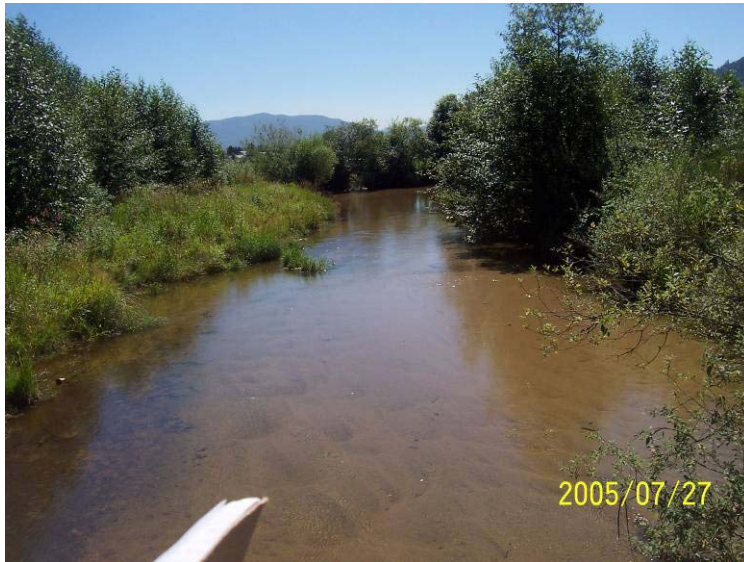
**Photograph 1.** Looking downstream at Reach 1 from Dale Road bridge prior to works.

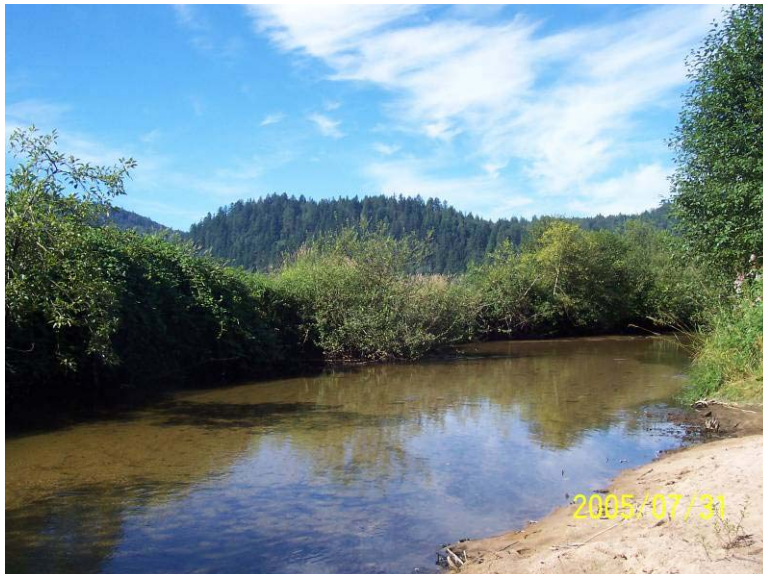
**Photograph 2.** Looking downstream at the opening along the left bank at 60m downstream of Dale Road bridge prior to spoil placement.

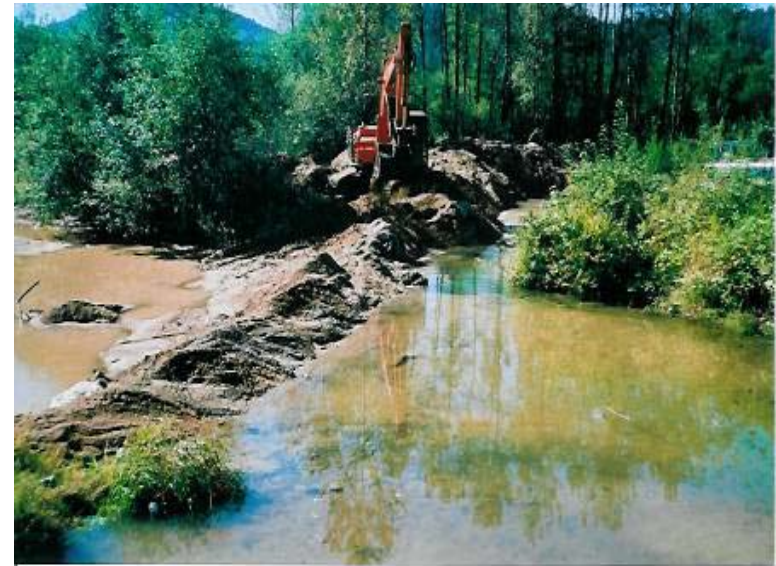
**Photograph 3.** Sandbags wrapped in a poly liner as well as substrate were used to divert water to the excavated right bank diversion channel. September 6, 2005.

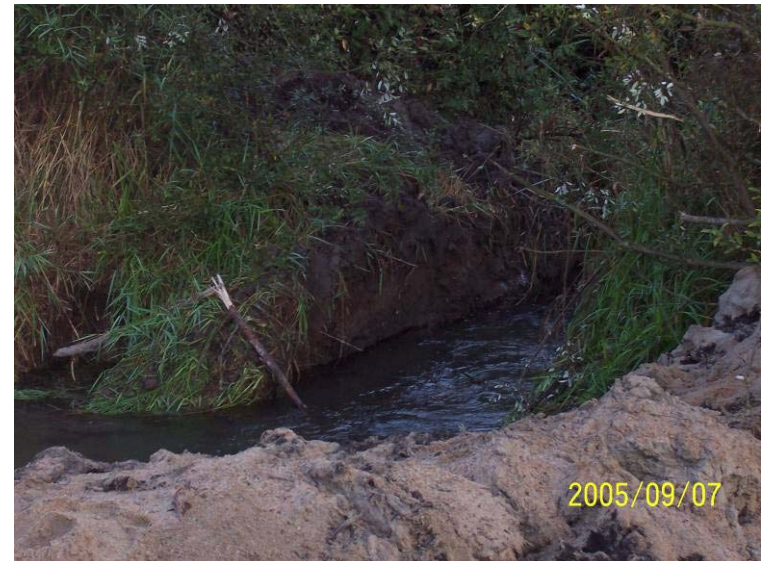
**Photograph 4.** A substrate berm was placed directly upstream of the diversion outlet effectively isolating the 300m excavation area. Pumps were not needed in the isolated excavation area.

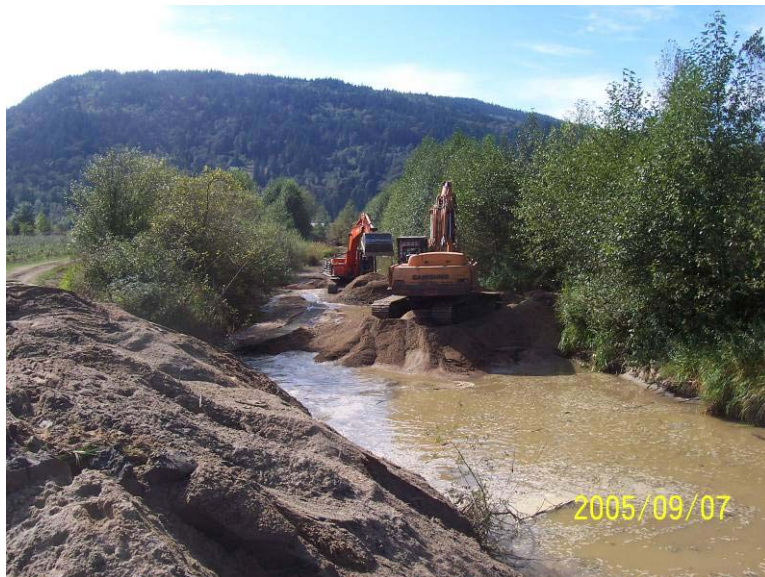
**Photograph 5.** Excavators worked in tandem in isolation of flow to hoe chuck material to openings in the riparian zone (material placed in the foreground is located at the opening in Photograph 2).

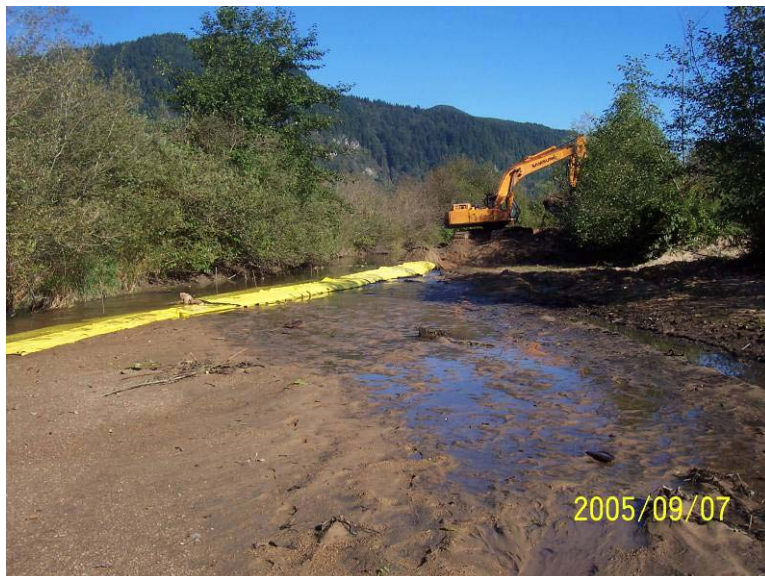
**Photograph 6.** Megasecure was used in two locations in Reach 1 to enable extraction of sandbars on the left bank in isolation of flow.

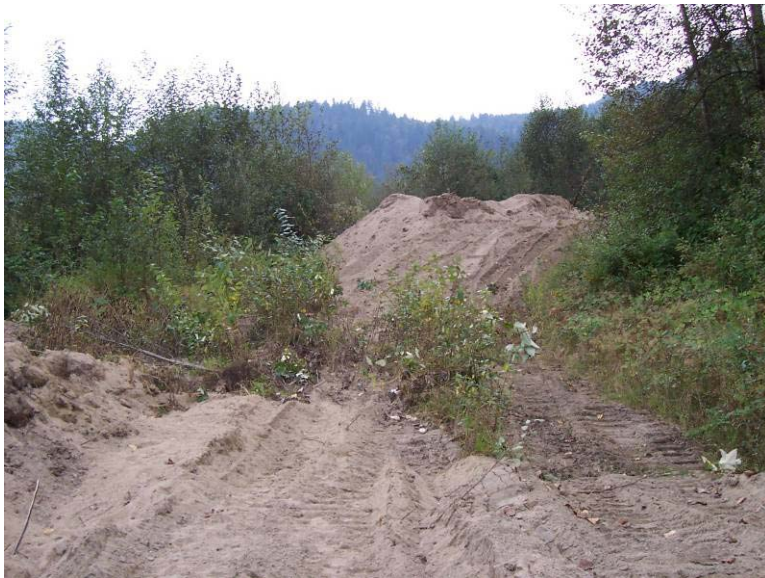
**Photograph 10.** View of temporary spoil pile placed on the access road on the west side of Lagace Creek.

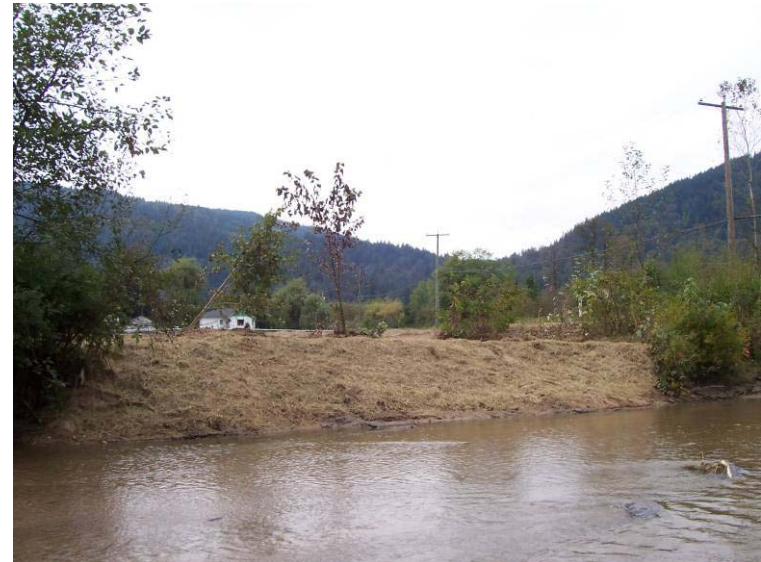
**Photograph 11.** Looking west at the diversion dam location after the site has been seeded, covered with straw and vegetation replaced at the top of the bank.

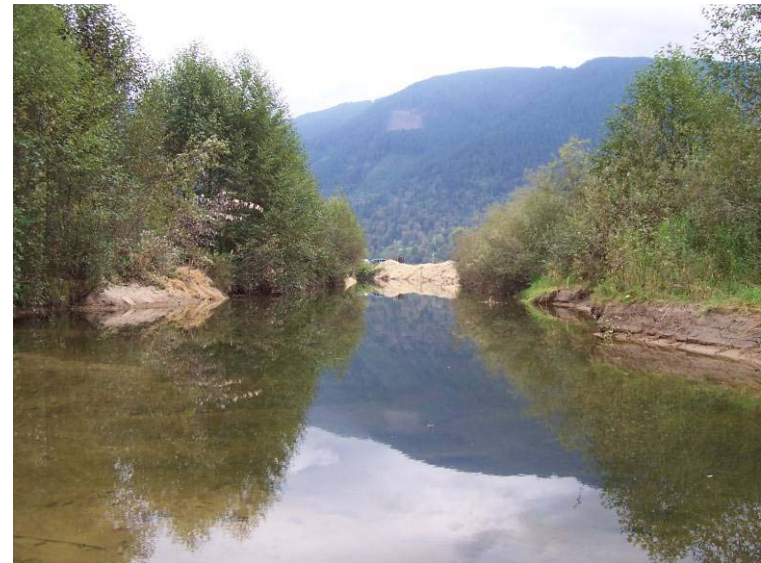
**Photograph 12.** View upstream at Reach 1 at the completion of work. The opening in the background has been seeded and covered with straw. It is the same opening as in Photographs 2 and 5.

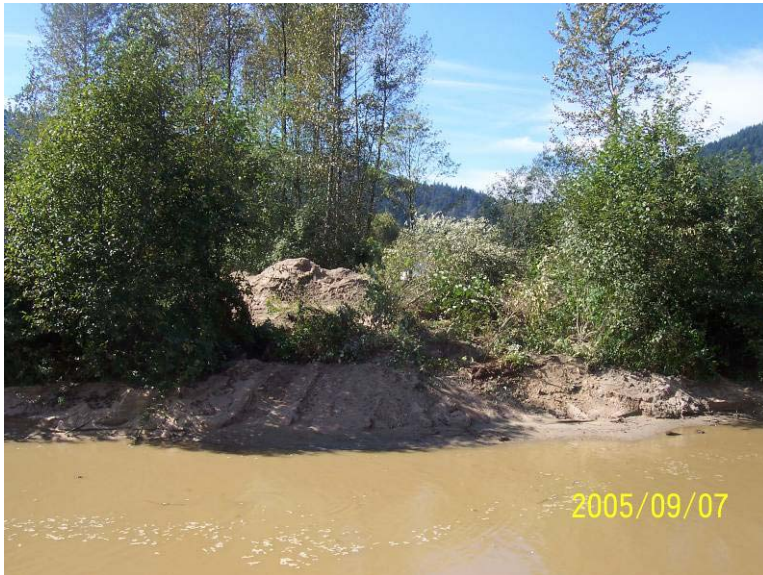
**Photograph 13.** Looking at the right bank at an opening used to spoil material onto the eastern access road. Riparian vegetation was salvaged and replaced.

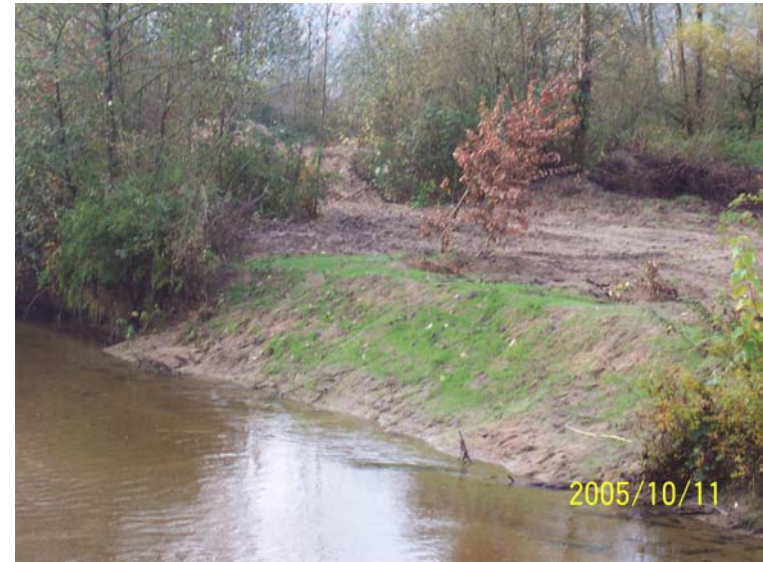
**Photograph 15.** Looking at the diversion location. Grass seed has taken and no erosion was evident. Beavers had cut some of the planted vegetation and one tree did not survive

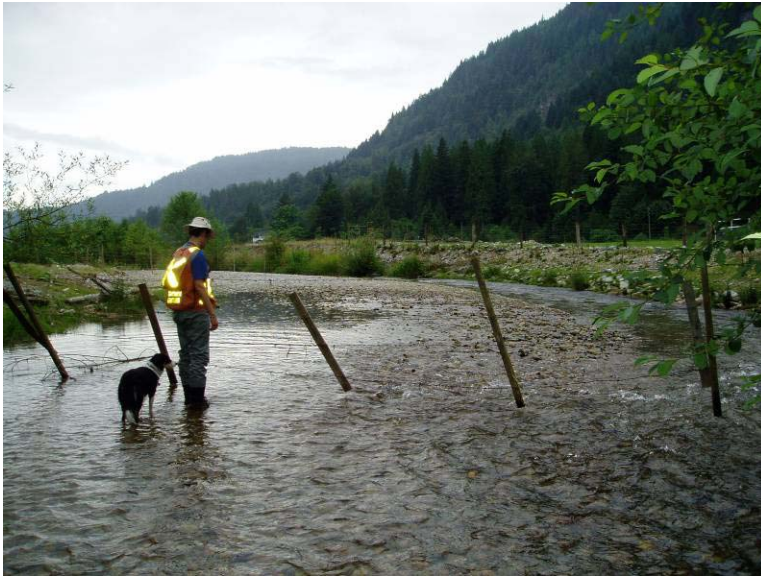
**Photograph 1.** Looking downstream at the elevated left bank sandbar at Schroots corner prior to excavation. July, 2005.

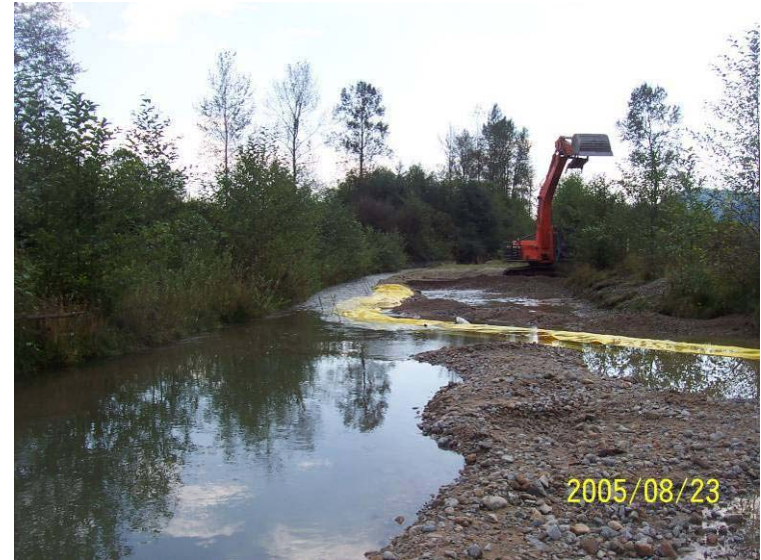
**Photograph 3.** Excavating a right bank sandbar between Schroots corner and the diversion using the Megasecure and berms to divert flow.

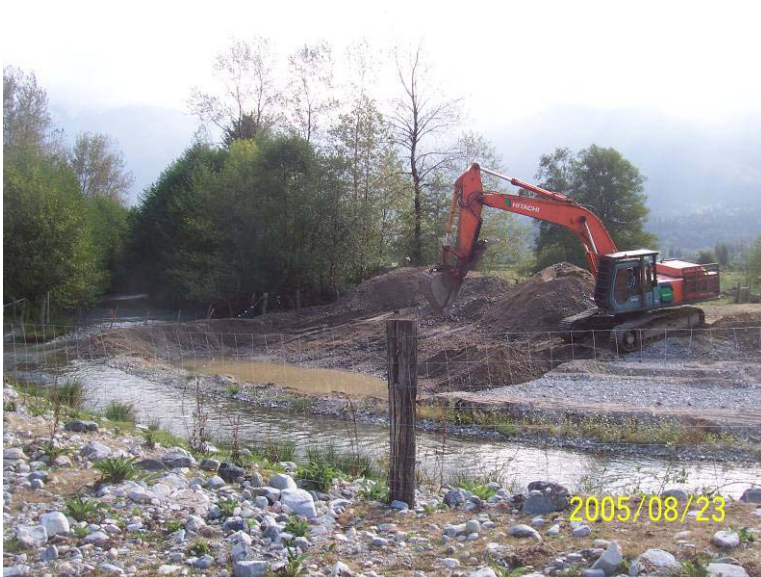
**Photograph 2.** The left bank sandbar at Schroots corner being excavated in isolation of flow.

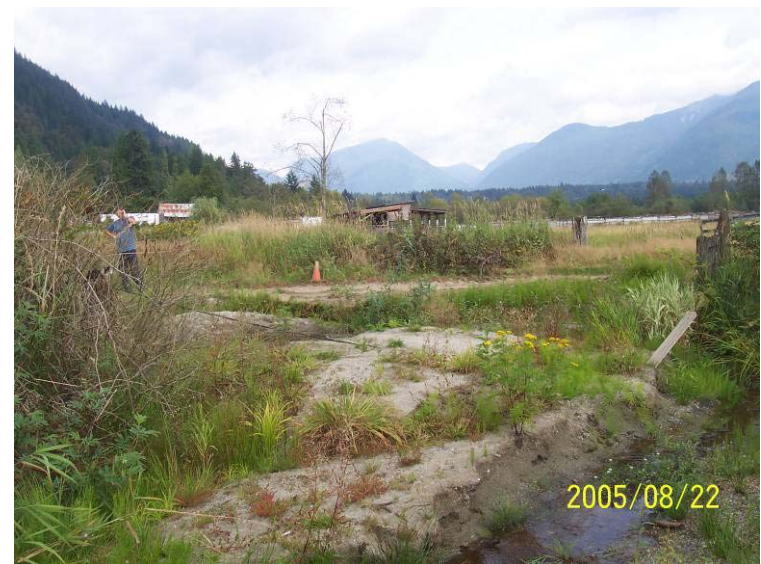
**Photograph 4.** The Bouchier Creek channel required excavating prior to flow diversion from Lagace Creek. The channel had filled in and blocked a culvert due to a debris torrent.

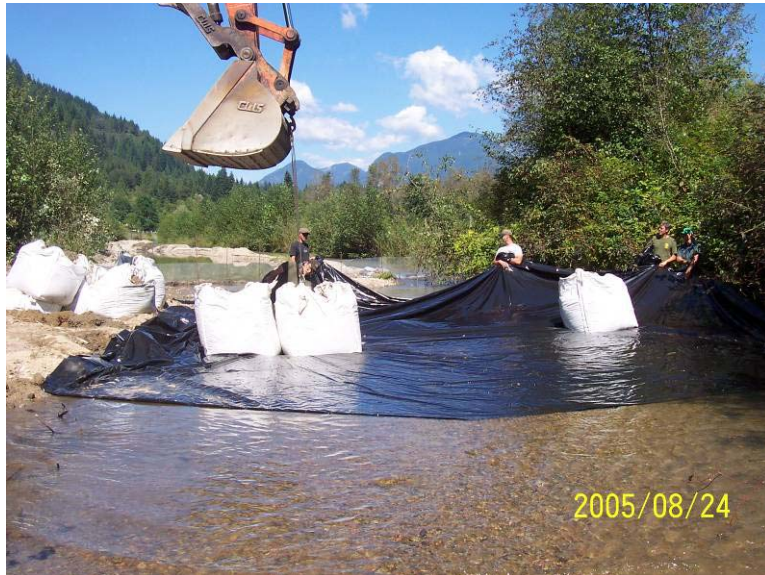
**Photograph 5.** Sandbags wrapped in a poly liner were used to divert water to the excavated right bank diversion channel. Some substrate was also used on the upstream side to ensure a proper seal.

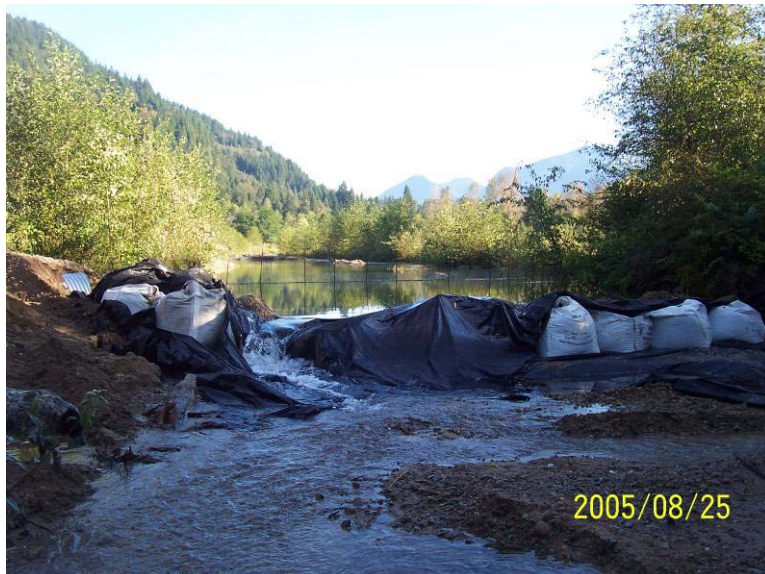
**Photograph 6.** Reduced flow was maintained throughout the excavation, as salvage operations were occurring concurrently directly upstream of the excavation operations.

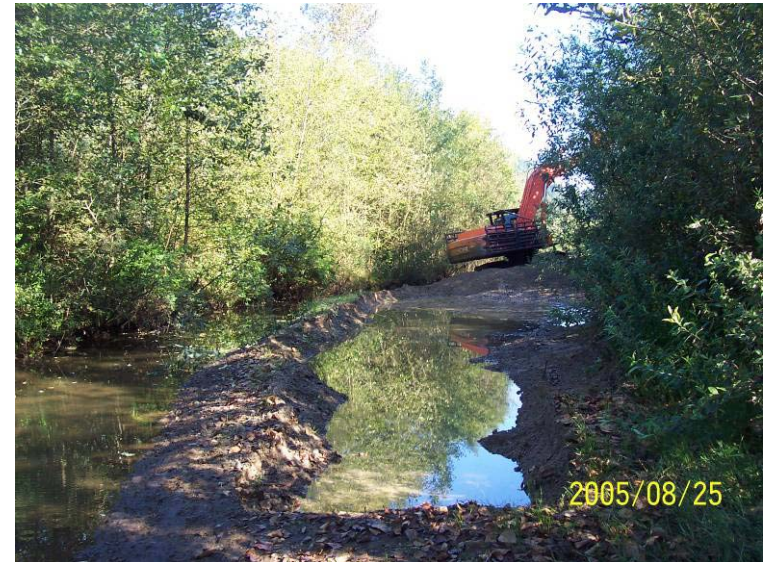
**Photograph 7.** Once isolated, excavation between 302 and 460m from Schroots Corner took place by scalping isolated bars. Bars were only scalped to approximately 0.45m to encourage fall spawning.

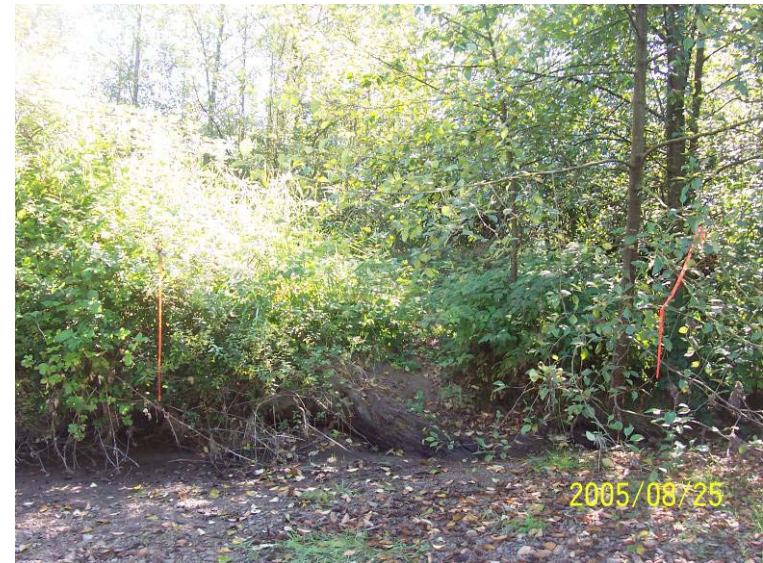
**Photograph 8.** As few open spaces were evident between 302 and 460m, open areas were well marked for spoil placement.

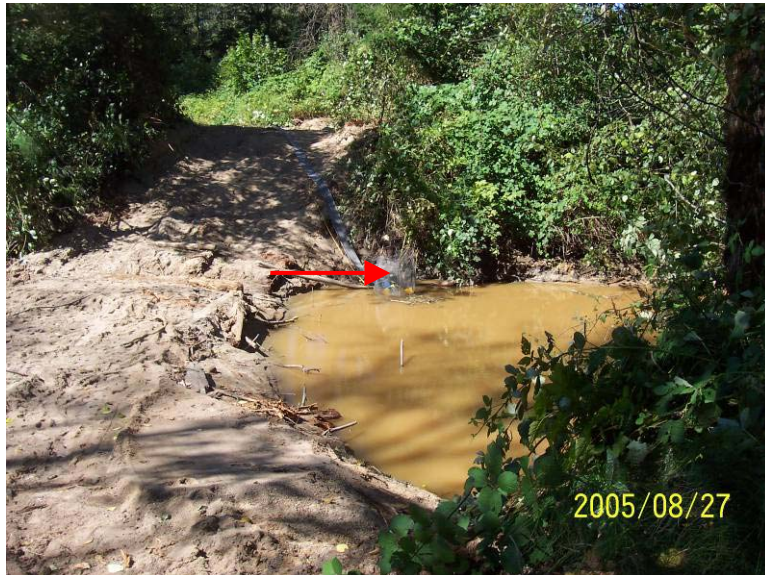
**Photograph 9.** A substrate berm was constructed approximately 300m upstream from the outlet of the diversion. Silt laden water was periodically pumped into the adjacent forest (red arrow).

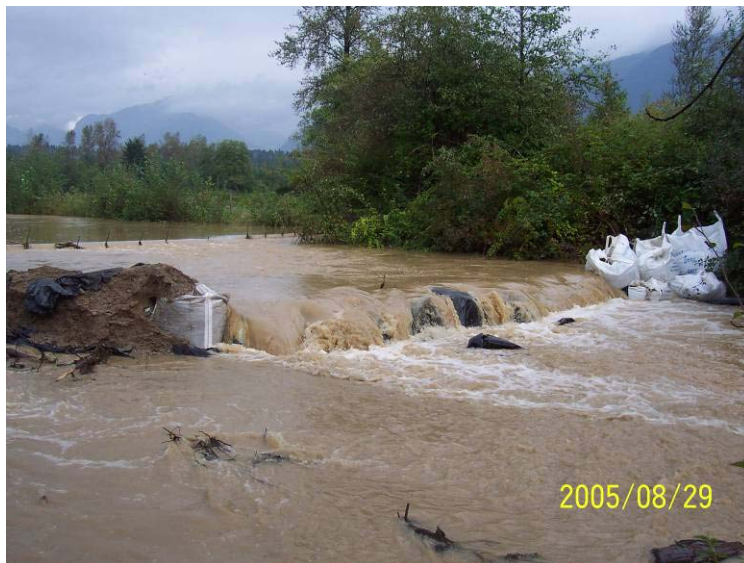
**Photograph 10.** On August 29, a summer rain event overtopped the berm (as was planned to prevent flooding in the diversion channel) and blew out fish fences.

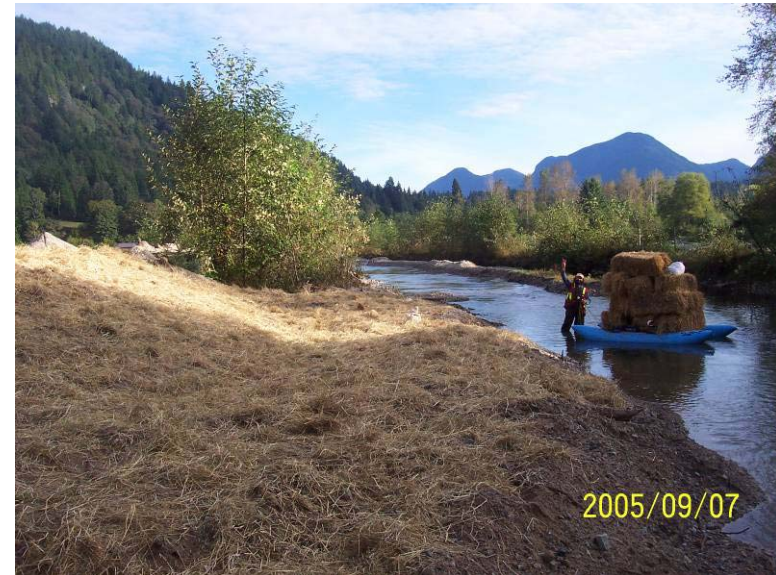
**Photograph 11.** Looking upstream at the diversion area after the berm and culvert have been removed. The site is stable, seeded and covered with straw.

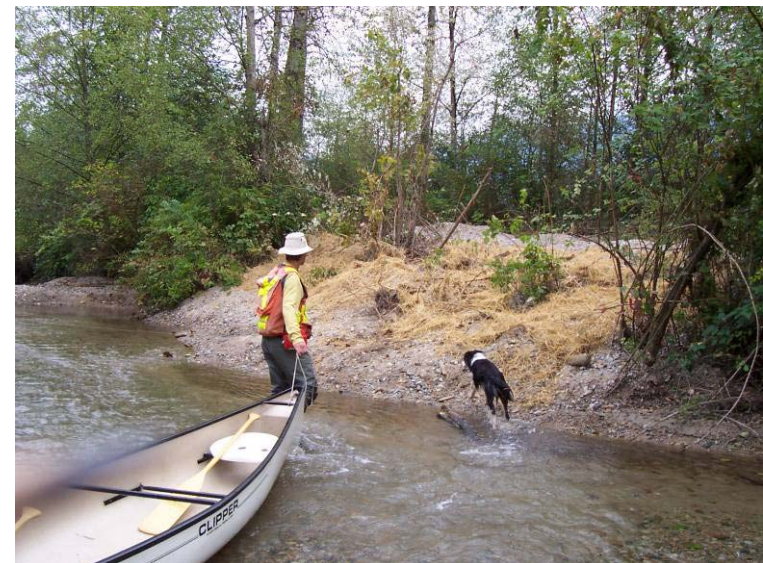
**Photograph 12.** Looking at a properly mitigated spoil site. Banks are shallow, vegetation has been replaced and banks seeded and covered with straw.

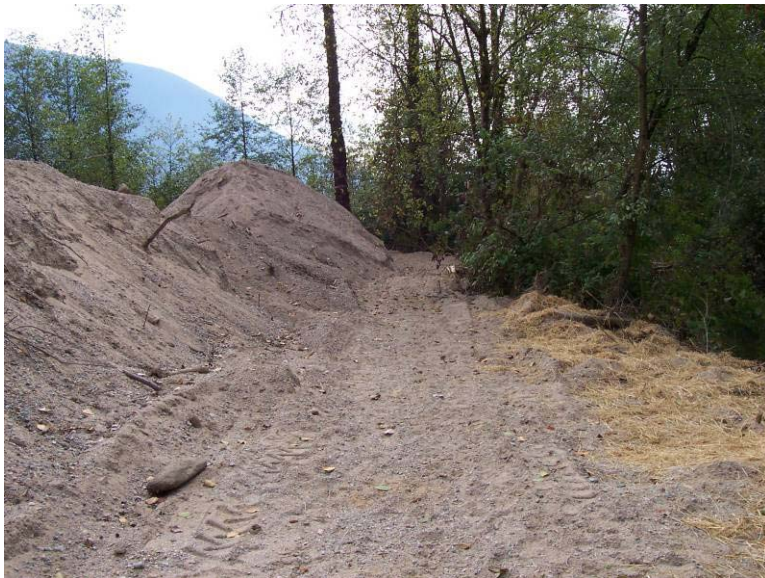
**Photograph 14.** View of temporary spoil piles along the left bank. A bench was created to separate the spoil from the sloped river bank (straw covered area).

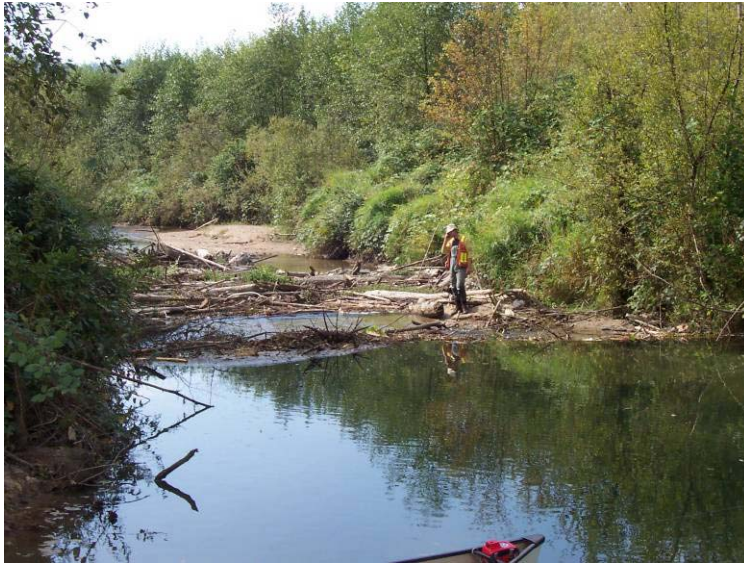
**Photograph 17.** A log jam at 1,500m from Schroots Corner was left in place, as it provided good cover habitat.

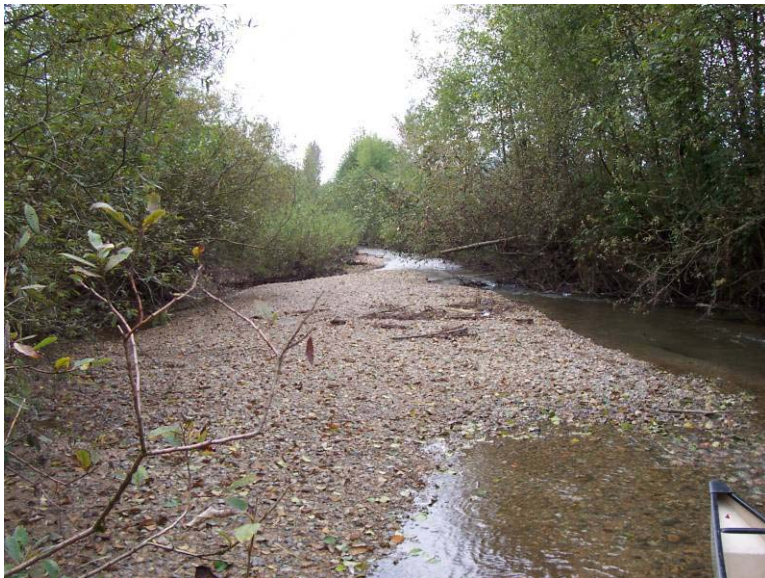
**Photograph 18.** The centre channel gravel bar between 688 and 770m as identified in the habitat mitigation plan was flagged and left undisturbed.

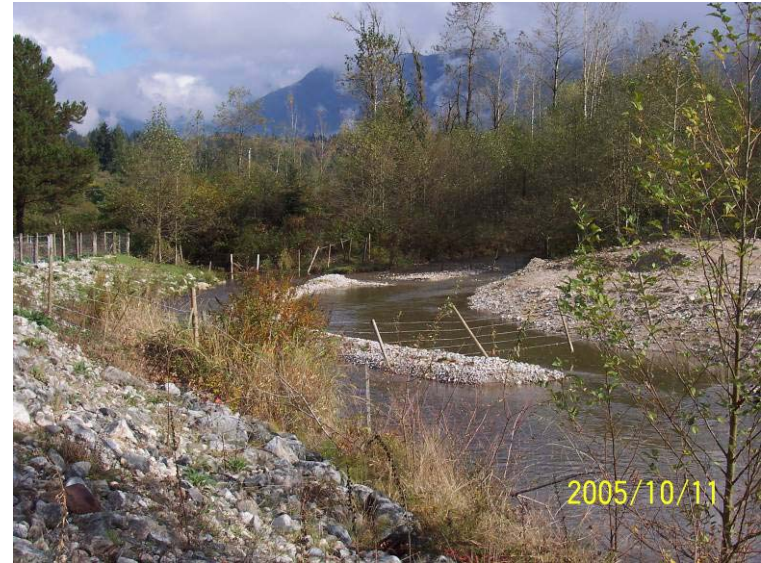
**Photograph 19.** The left bank sandbar at Schroots corner with berms breached at completion of works. Temporary spoil piles have been removed.

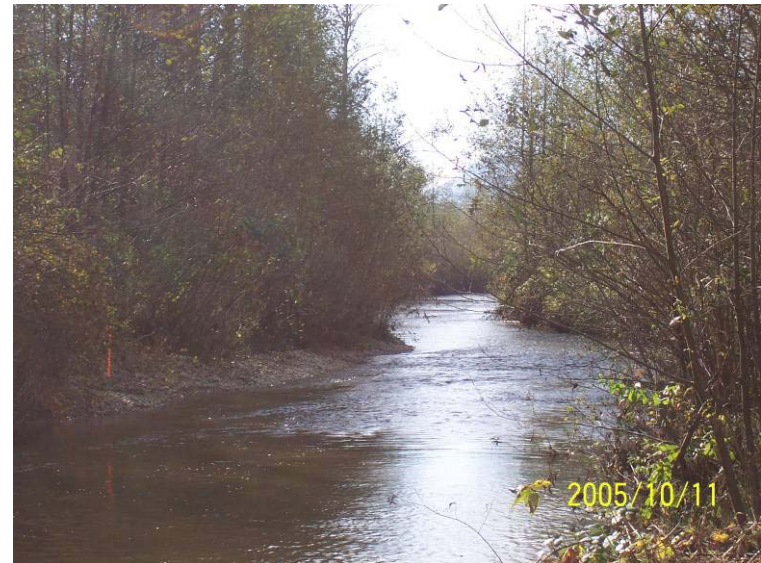
**Photograph 20.** Looking at riffle habitat after excavation (Photograph 7). Chum were observed spawning in scalped bars.

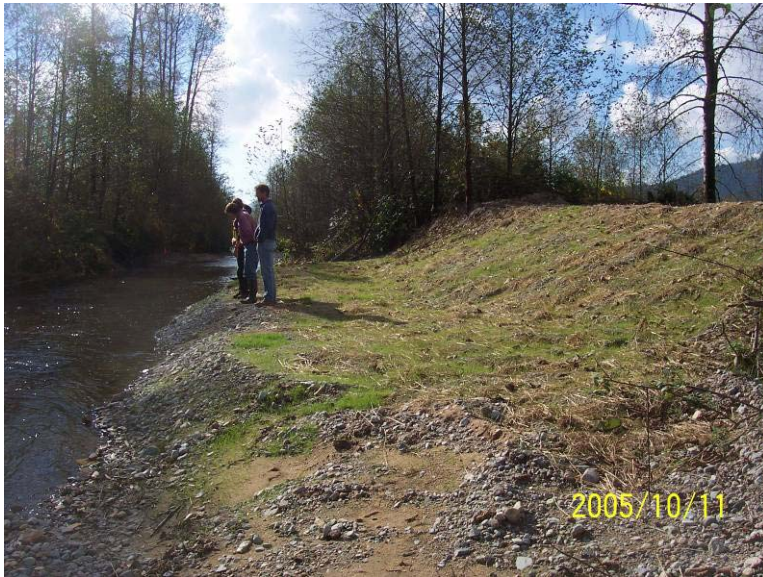
**Photograph 21.** Looking downstream at the diversion area after the berm and culvert have been removed. Grass seed has taken and the banks are stable.

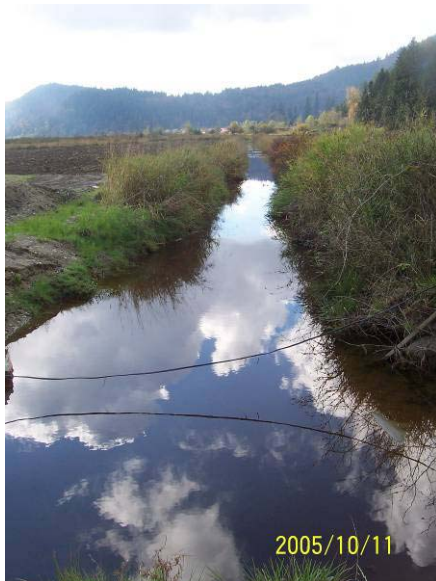
**Photograph 22.** The Bouchier Creek channel after removal of material from the debris torrent.

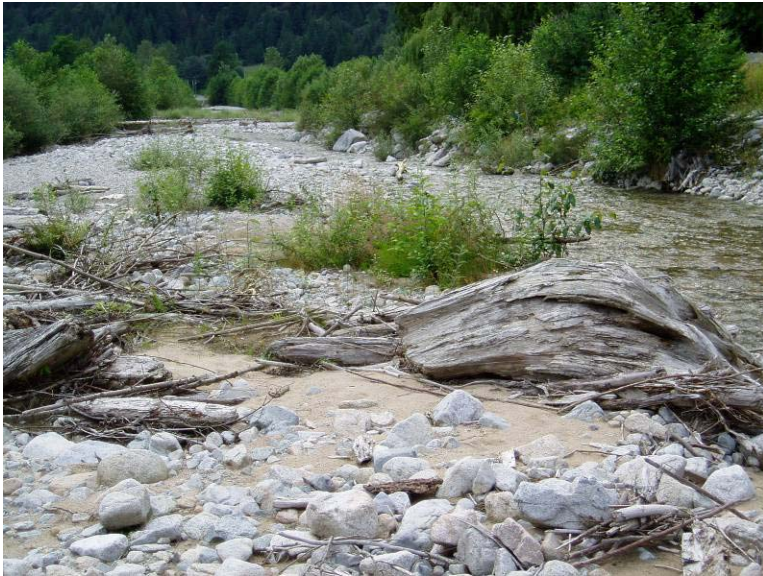
**Photograph 1.** Looking downstream at the Anderson site prior to work. July 2005.

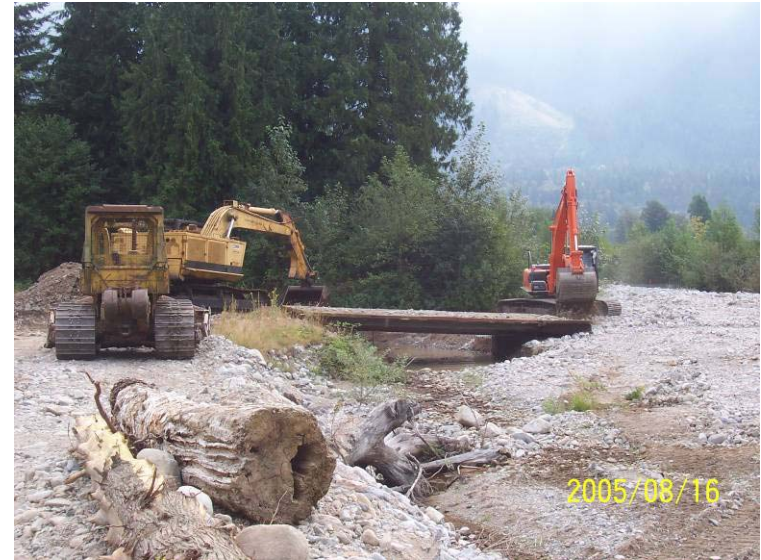
**Photograph 3.** Placement of the bridge at Andersons site to access the bar.

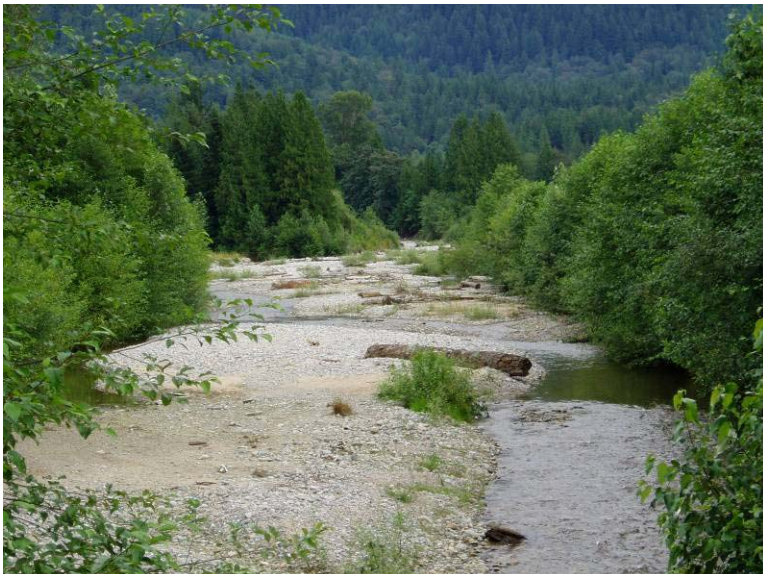
**Photograph 2.** Looking downstream from Seux Road Bridge prior to work. July 2005.

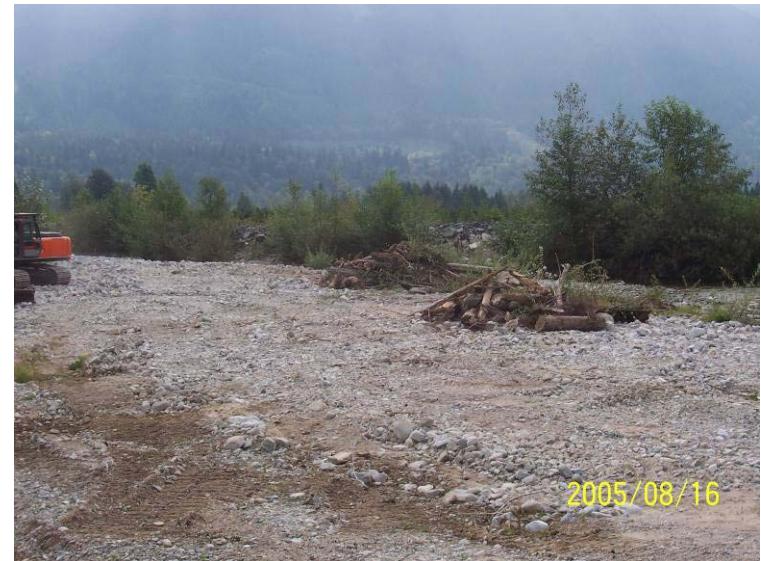
**Photograph 4.** Woody debris was removed from the bar prior to excavation. Unbeknownst to the on site monitors, anchored in large woody debris was also removed.

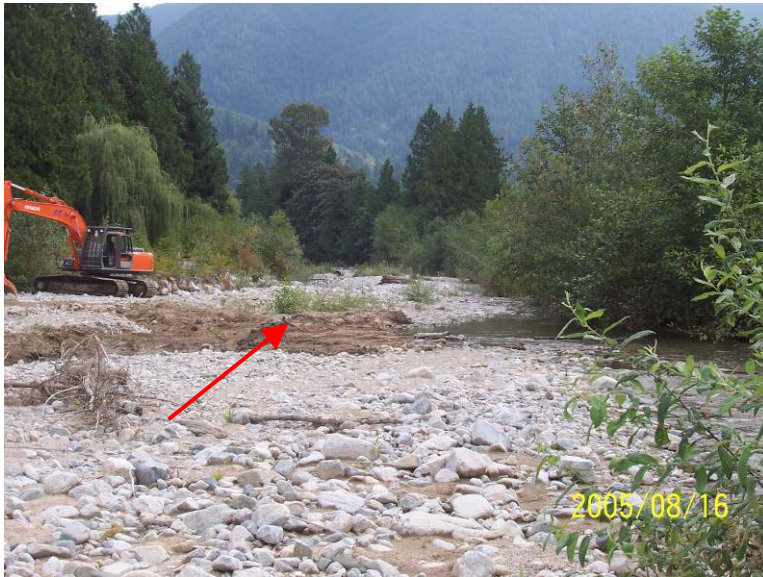
**Photograph 5.** All flow was directed at to the left bank by berming the intake of small seepage channels to the right bank
