**Re: 2005 As-Built Flood Damage Recovery Works, Lagace Creek, Hatzic Valley  
Final Report**

## 2005 AS-BUILT FLOOD DAMAGE RECOVERY WORKS LAGACE CREEK, HATZIC VALLEY FINAL REPORT

OCTOBER 2005

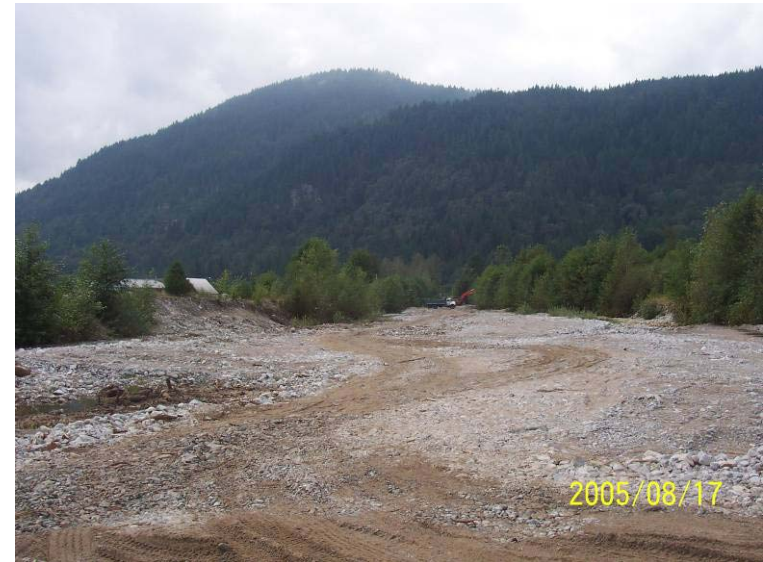
**Photograph 7.** Looking downstream at the Anderson site after all flow has been diverted to the left bank. The braided channels are dry.

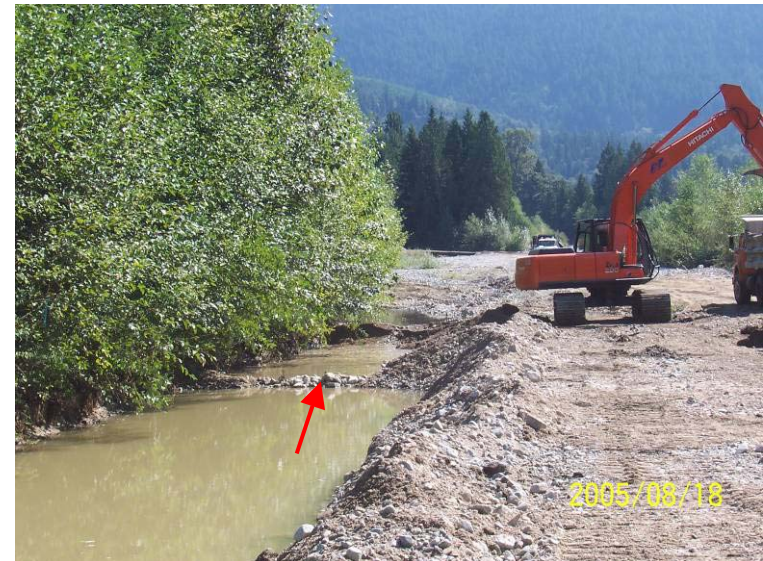
**Photograph 8.** Once water had been diverted to the left bank a deep channel was excavated along the right bank. Rock weirs were placed to settle out sediment laden water.

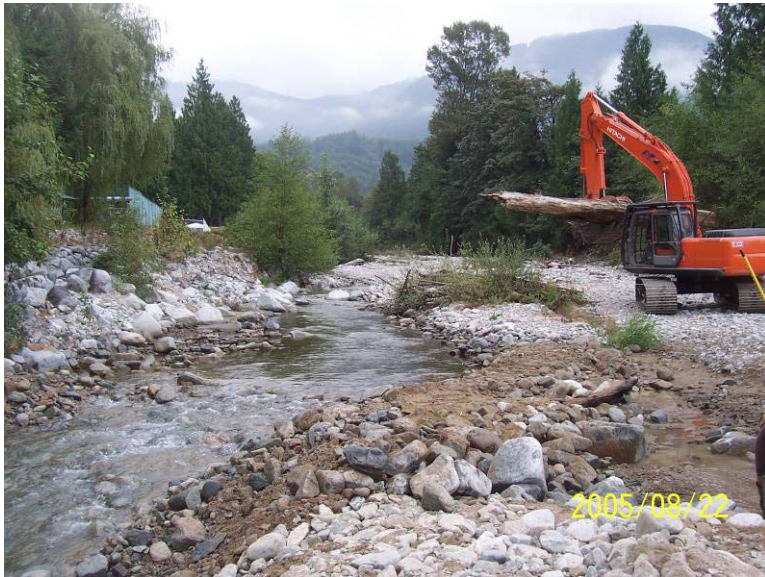
**Photograph 9.** Upstream of the Anderson property, channel diversions successfully isolated the work area.

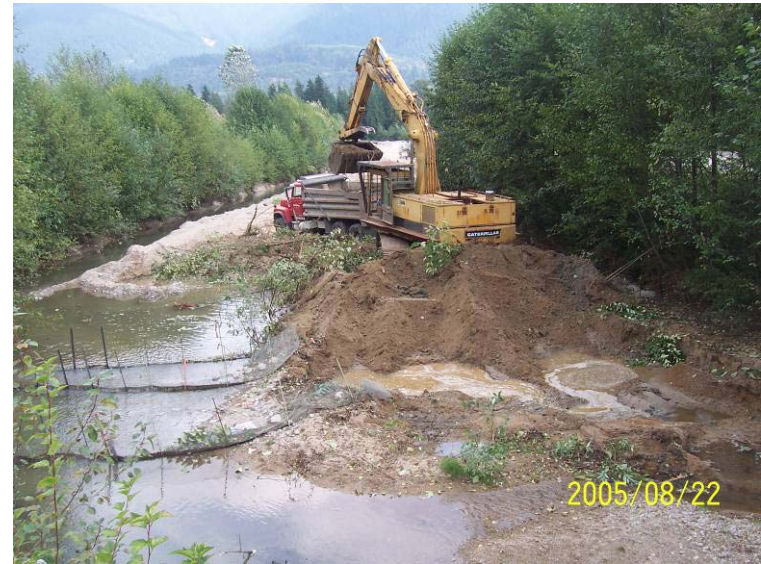
**Photograph 11.** Removal of the vegetated bar in isolation of flow.

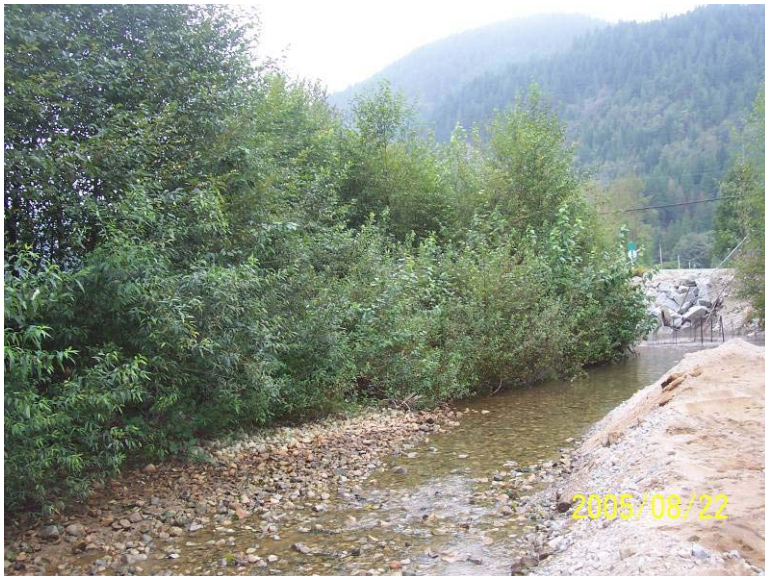
**Photograph 10.** View of 38 by 5m vegetated bar that was removed in order to direct flows away from the eroding right bank near Farms Road bridge

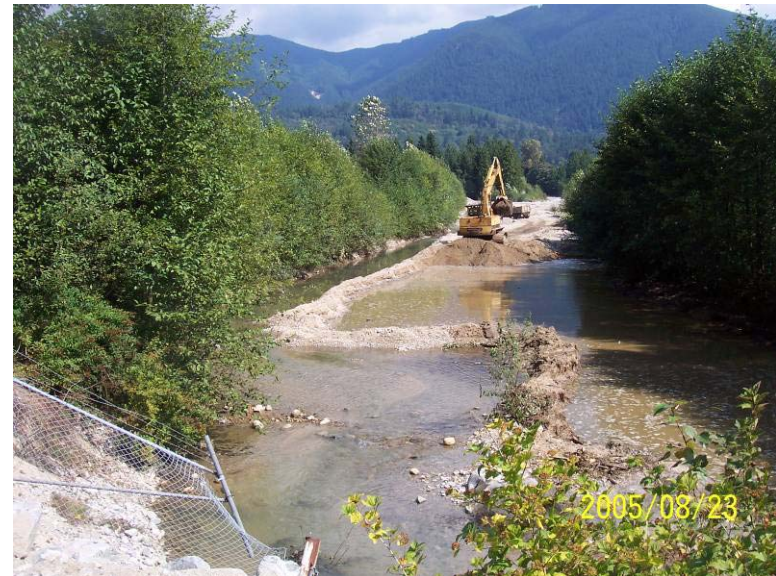
**Photograph 12.** Excavation in isolation of flow.

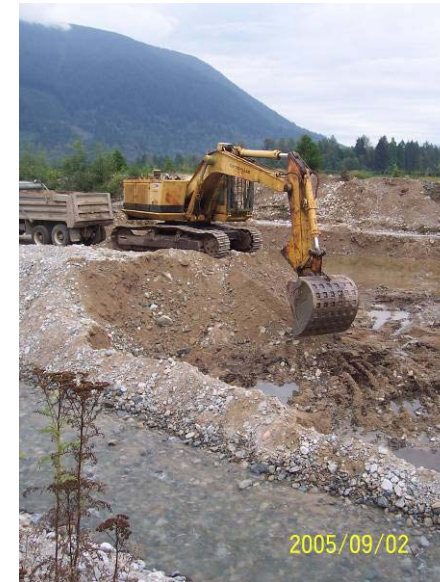
**Photograph 15.** At approximately 2/3 of the way upstream to the temporary bridge crossing, excavation was almost in the “dry” (little flow seeping into the excavation site).

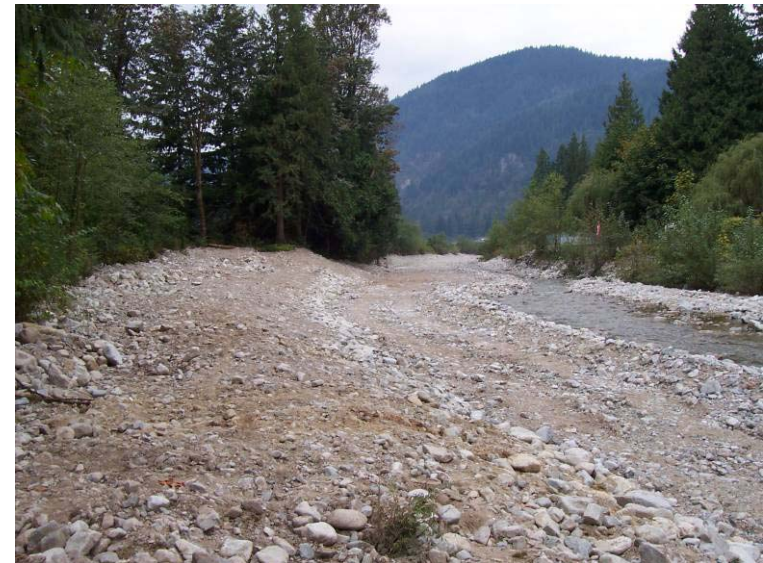
**Photograph 16.** Looking downstream from Seux Road Bridge at completion of the work. September 14, 2005

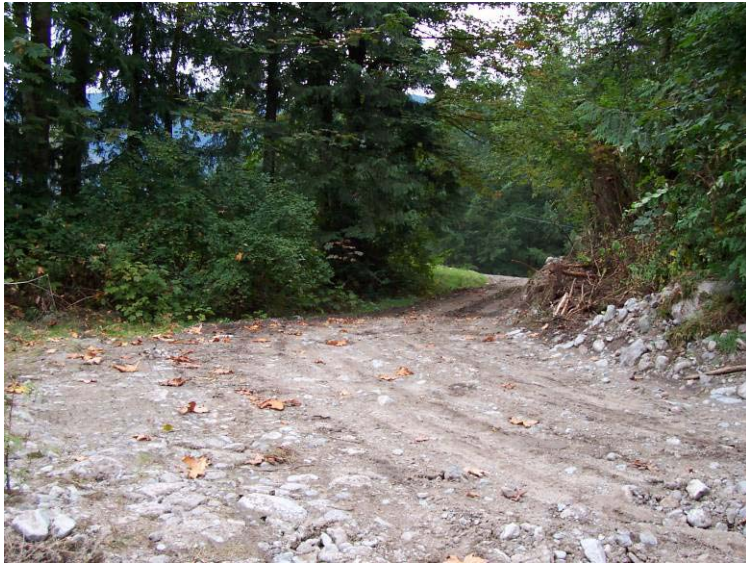
**Photograph 17.** Access road from Seux Road along the left bank. September 14, 2005

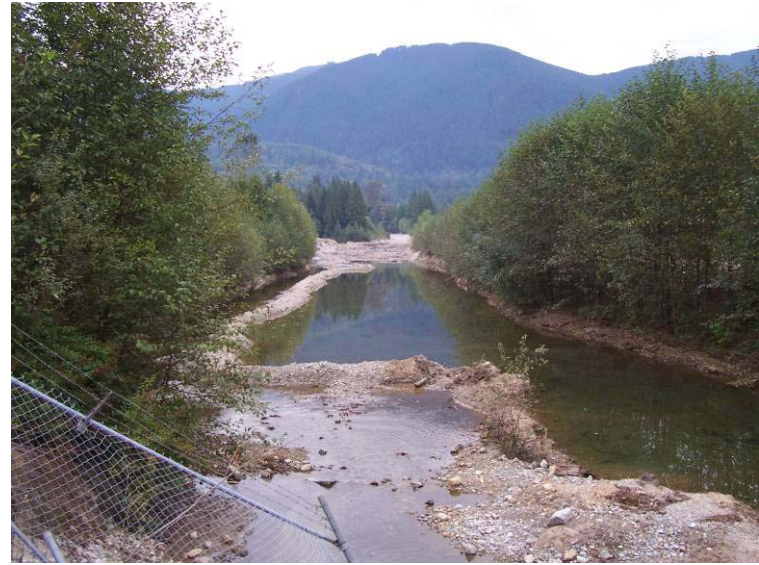
**Photograph 19.** Looking upstream from Farms Road bridge after excavation was complete. September 14, 2005

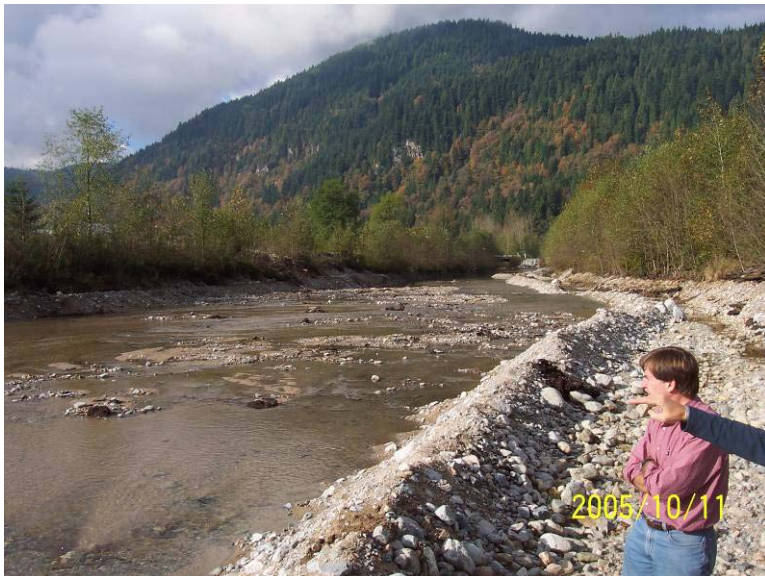
**Photograph 18.** Looking downstream towards Farms Road Bridge from the Anderson site after excavation was complete.

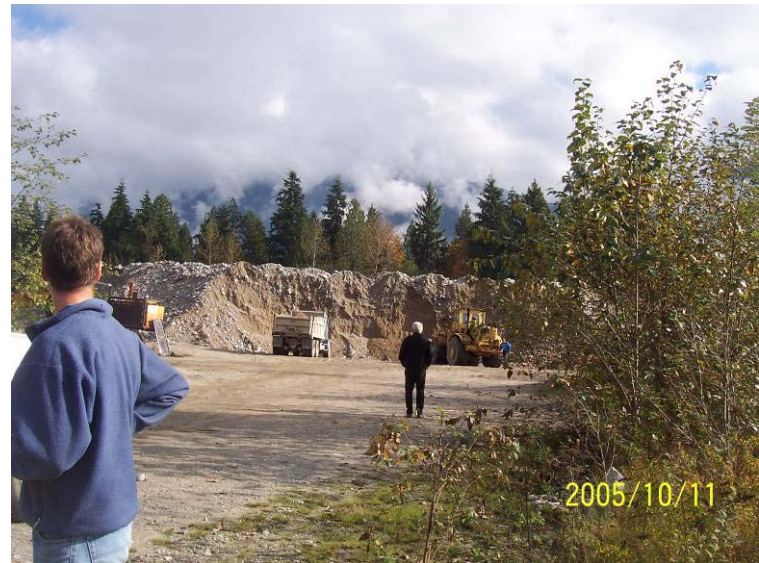
**Photograph 20.** View of excavation spoil pile on Anderson's property.

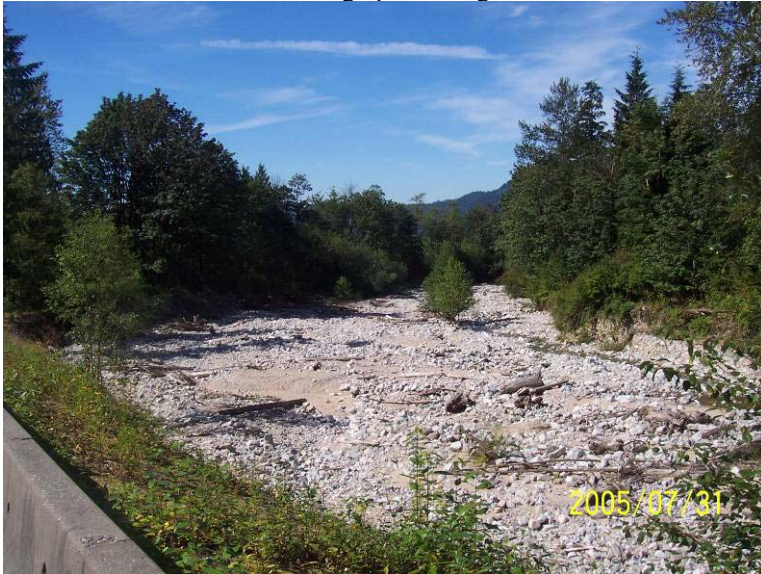
**Photograph 1.** Looking downstream at Reach 5 from Sylvester Road bridge prior to flood protection works.

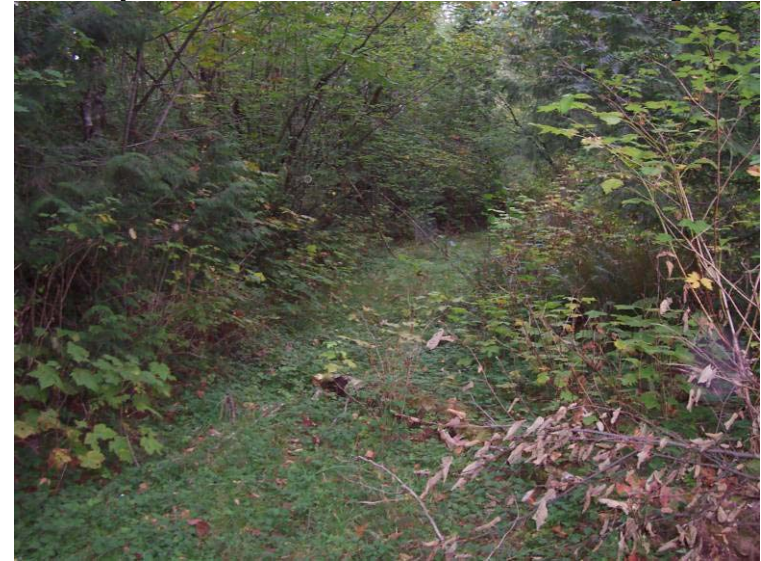
**Photograph 3.** Looking at riparian habitat of the overgrown access road along the right bank used for hauling gravel.

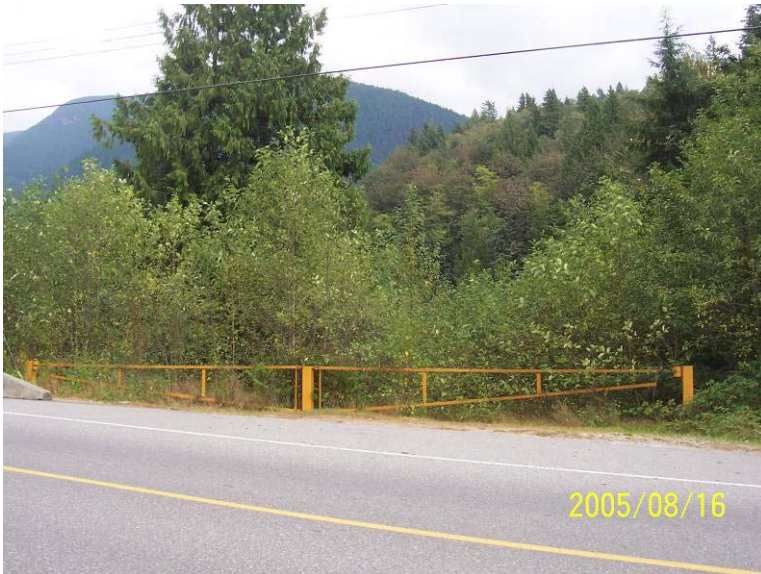
**Photograph 2.** Looking west at young alders prior to removal along the dyke which was used to access to the upper portion of Reach 6 along the left bank.

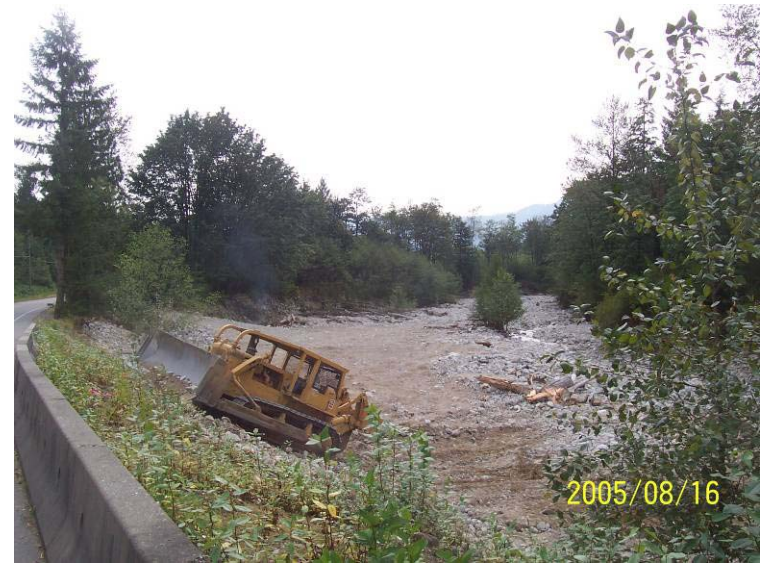
**Photograph 4.** Looking downstream at Reach 5 from Sylvester Road bridge at the inception of recontouring and bank stabilization in isolation of flow.

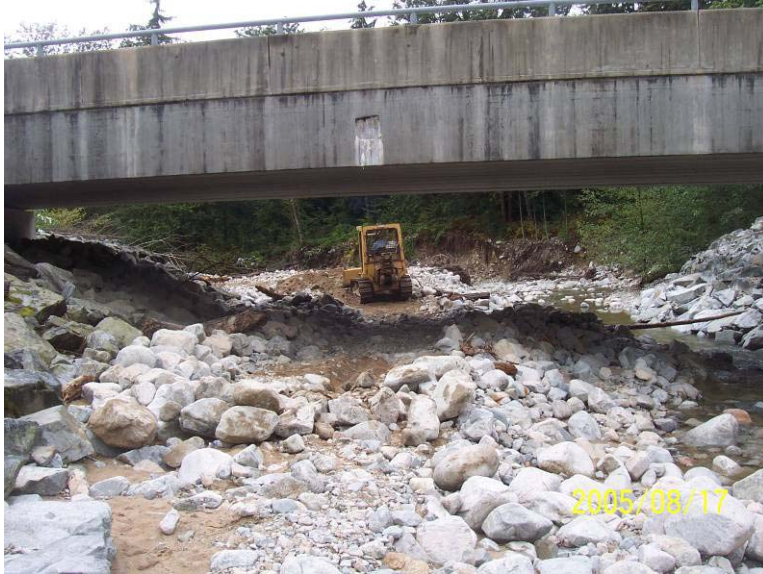
**Photograph 5.** A small bulldozer was used to grade the gravel bar to allow access for a D8. The D8 forded the channel several times to access and prep the upper portion of Reach 6.

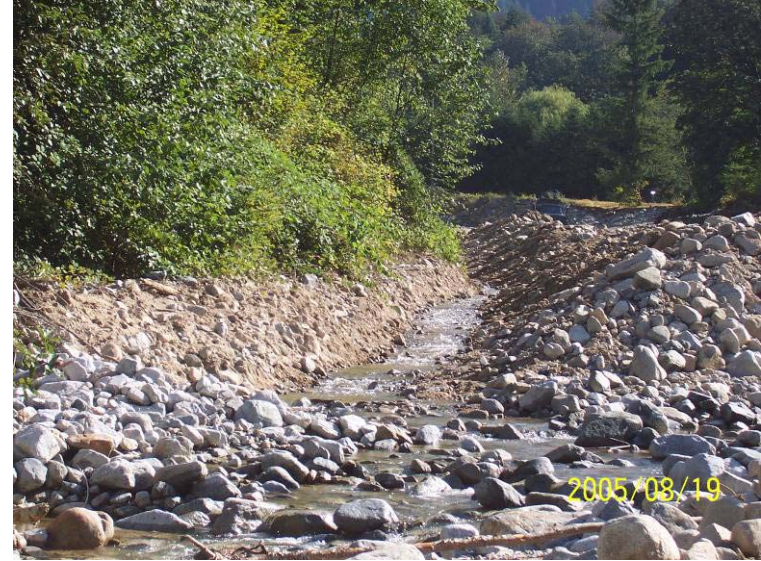
**Photograph 7.** In order to work in the dry, all flow in Reach 5 was diverted to an excavated channel along the right bank. Flow was diverted away from the right bank near the bridge to conduct right bank stabilization work.

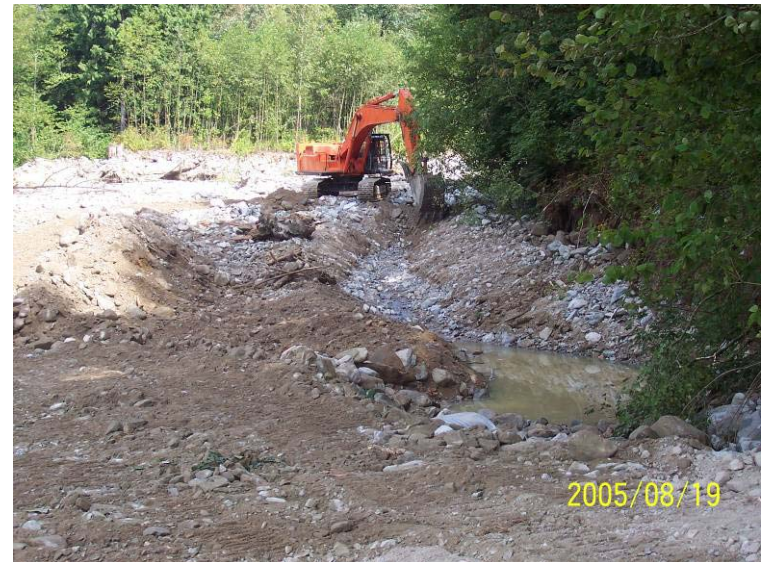
**Photograph 8.** In order to work in the dry, all flow in Reach 6 was diverted to an excavated channel along the left bank.

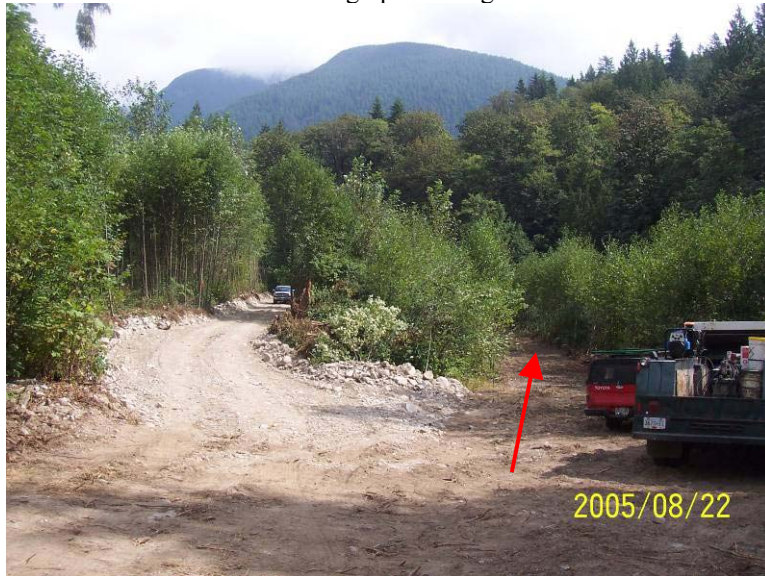
**Photograph 9.** View of the completed haul road. Cleared vegetation to the west (red arrow) was outside the 30m setback and was used to store gravel

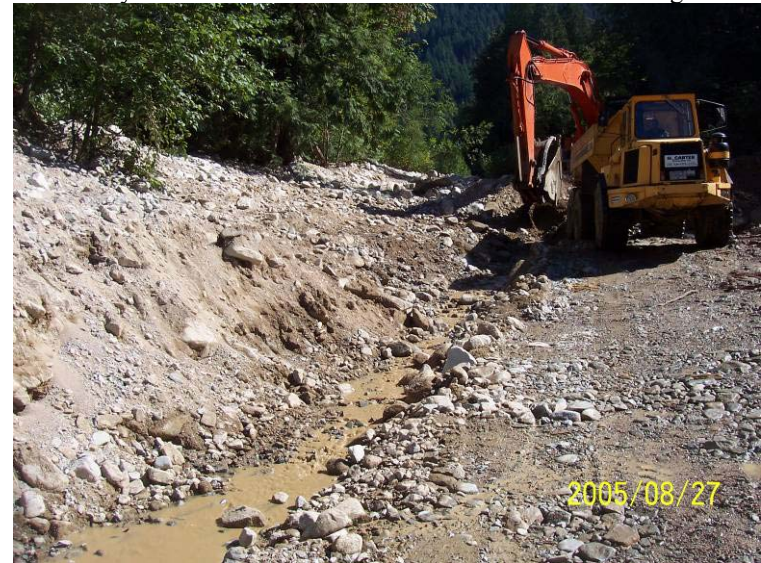
**Photograph 11.** During gravel excavation and recontouring, water seeped into the isolation site. Water was directed into a shallow swale.

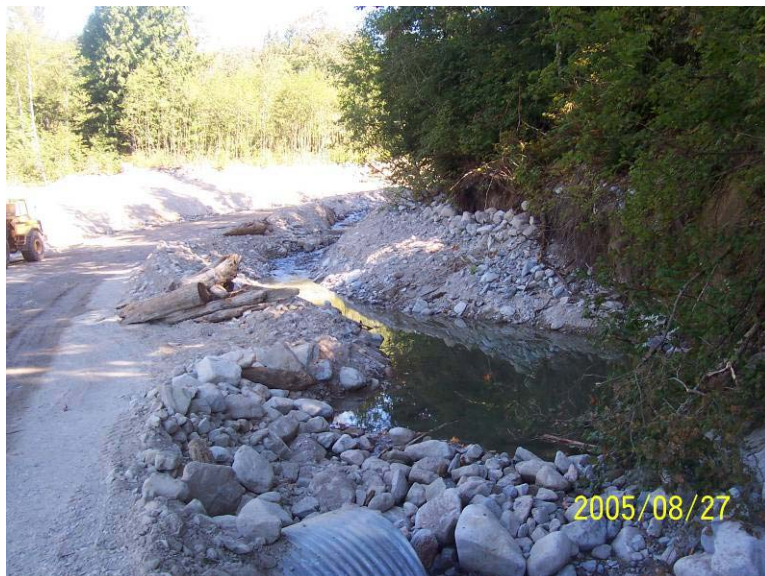
**Photograph 10.** View of completed diversion channel along the left bank of Reach 6.

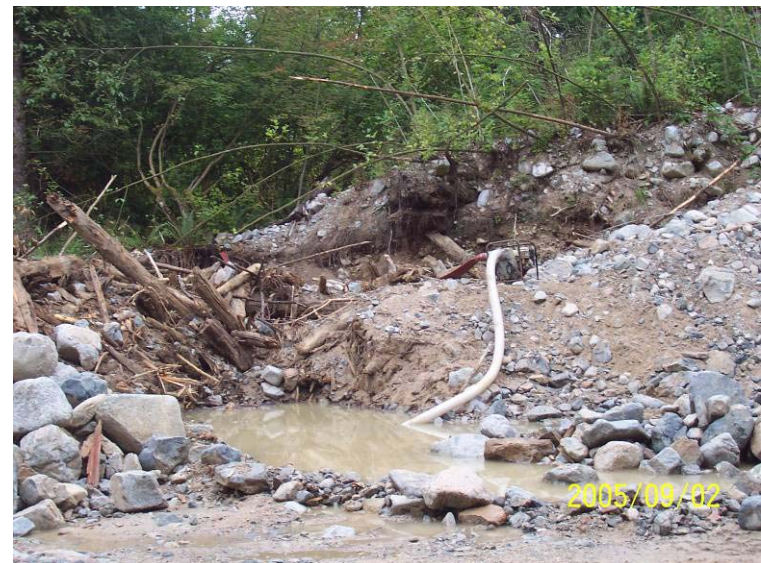
**Photograph 12.** Water from the shallow swale entered a sediment trap and was pumped out using a 3" pump.

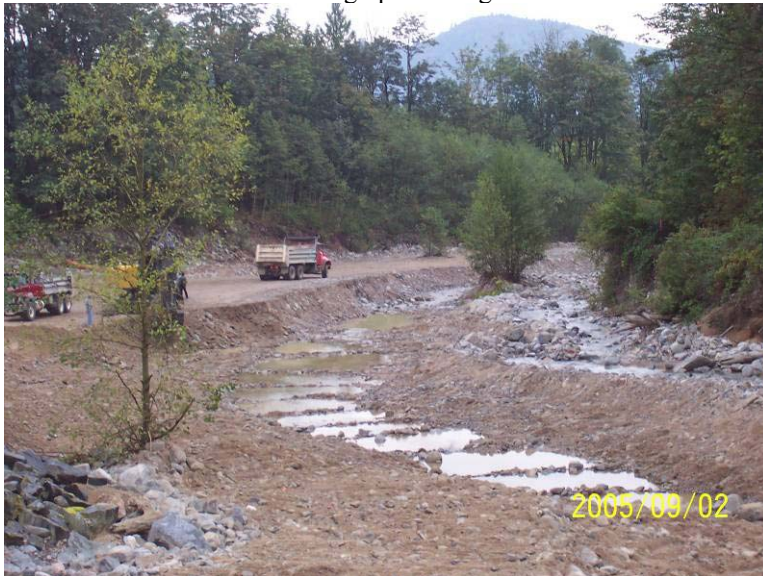
**Photograph 13.** A series of sediment traps were excavated to settle out seepage water in the excavation site within Reach 5.

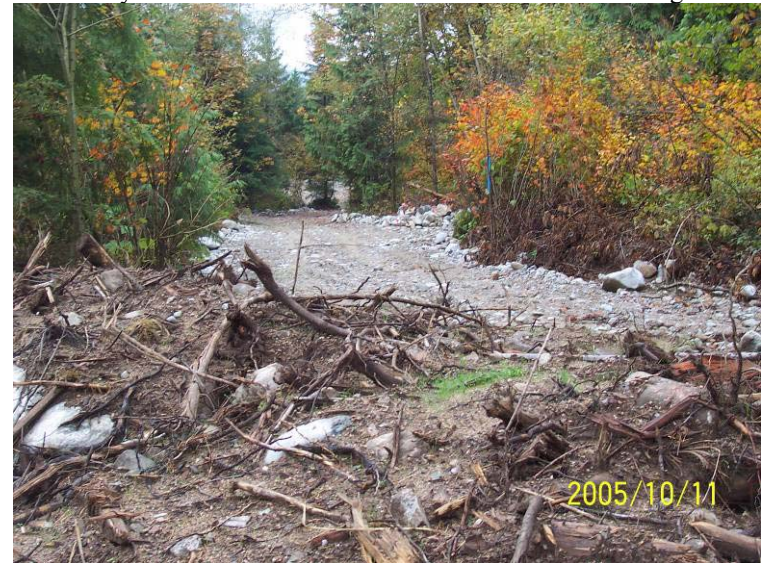
**Photograph 15.** A berm was constructed to separate Pattison Creek from the right bank haul road on Reach 6. The road was roughened up an alder seed mix applied.

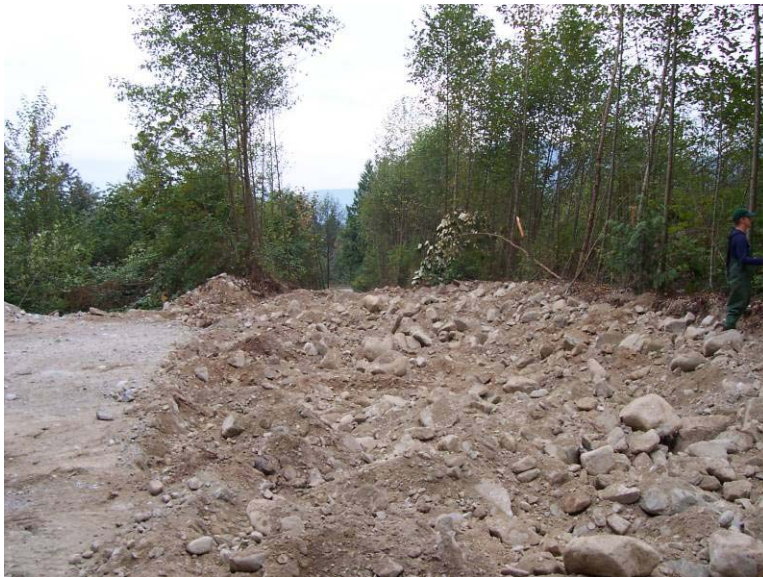
**Photograph 14.** The haul road along the left bank was decompacted and an alder seed mix applied. Compacted gravel to the left of the photograph will be removed by the landowner. September 14, 2005.

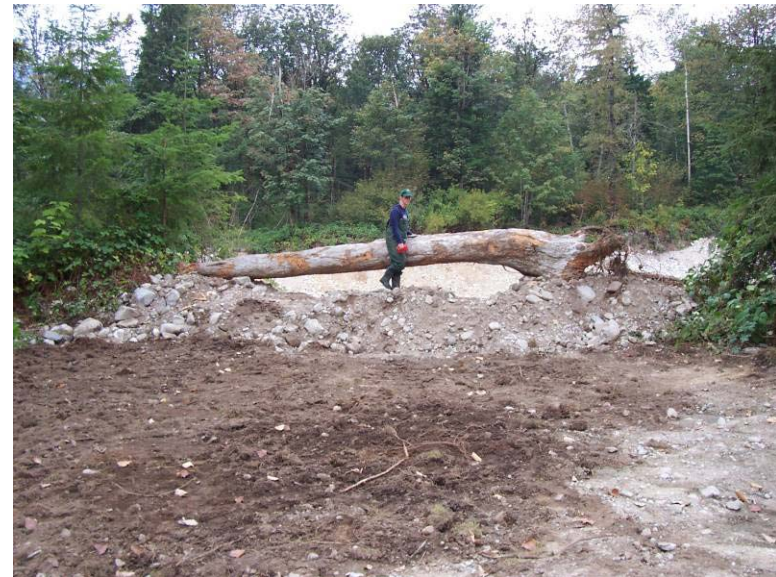
**Photograph 16.** View of Reach 5 access at completion of work. The access has been seeded.

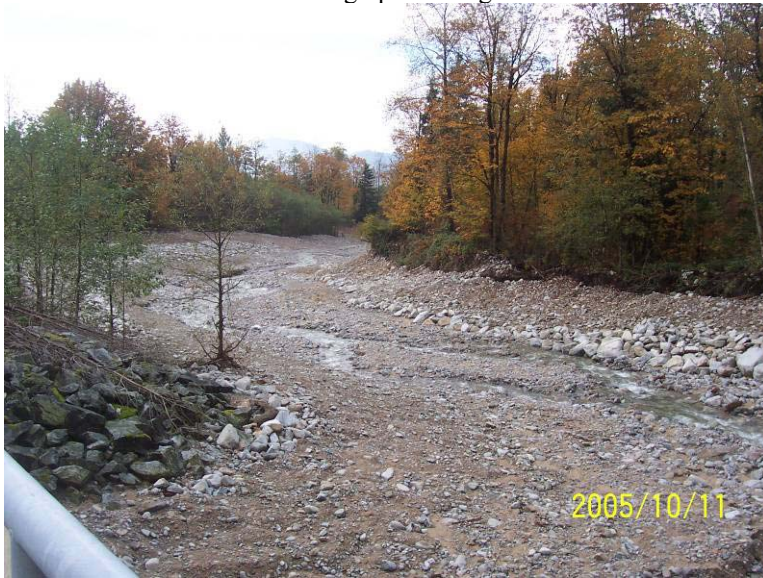
**Photograph 17.** View of Reach 5 from Sylvester Road bridge in October, 2005.

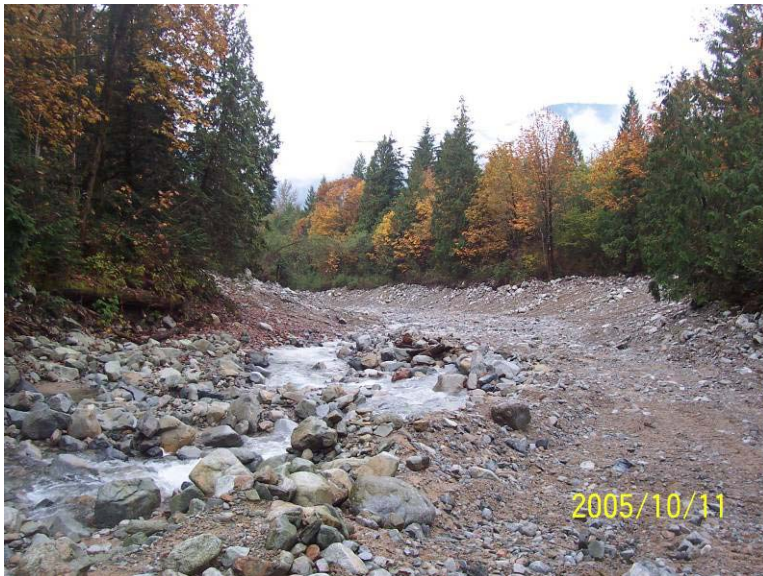
**Photograph 18.** View of Reach 6 in October from the upstream end of the flood protection works.
