# MOUNTAIN BIKE TRAIL & TECHNICAL TRAIL FEATURE INSPECTION

IRON MOUNTAIN, MERRITT, BC

Ministry of Ministry of Forests, Lands and  
Natural Resource Operations

Cascades District – Recreation Sites & Trails  
August 2012

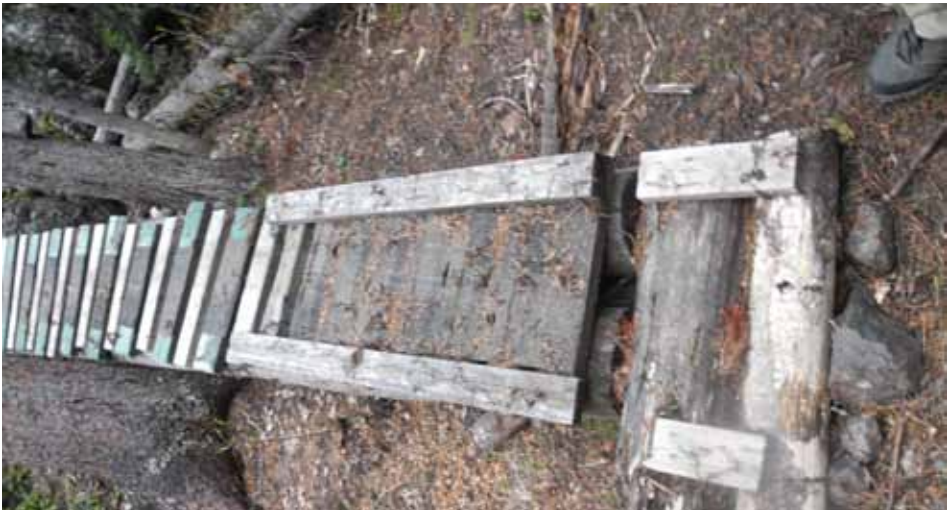
| NO. | TRAIL | ITEM | DIMENSION (MM) | PRESCRIPTION | IMPROVEMNT | FALL_ZONE (1 - POOR, 5 - GOOD) | | | | | IMAGE |
|---|---|---|---|---|---|---|---|---|---|--|---|
| 46 | 99 | elevated bridge roll | 450w x 11000l x 900h | replace | Replace decking as currently ramp is decaying and shakey with foot traffic. Poor fall zone through tight trees | y | 1 | Y | 2 | | DSCN6569.JPG |

| NO. | ITEM | DIMENSION (MM) | PRESCRIPTION | IMPROVEMNT | MEETS STANDARD | LIFE (YEARS) | MANDATORY | FALL_ZONE (1 - POOR, 5 - GOOD) | IMAGE | NORTHING (UTM10) | EASTING (UTM10) | HEIGHT ABOVE MSL (M) |
|---|---|---|---|---|---|---|---|---|---|---|---|---|
| 46 | elevated bridge roll | 450w x 11000l x 900h | replace | Replace decking as currently ramp is decaying and shakey with foot traffic. Poor fall zone through tight trees | y | 1 | Y | 2 | DSCN6569.JPG | 5546502 | 660463 | 1677 |

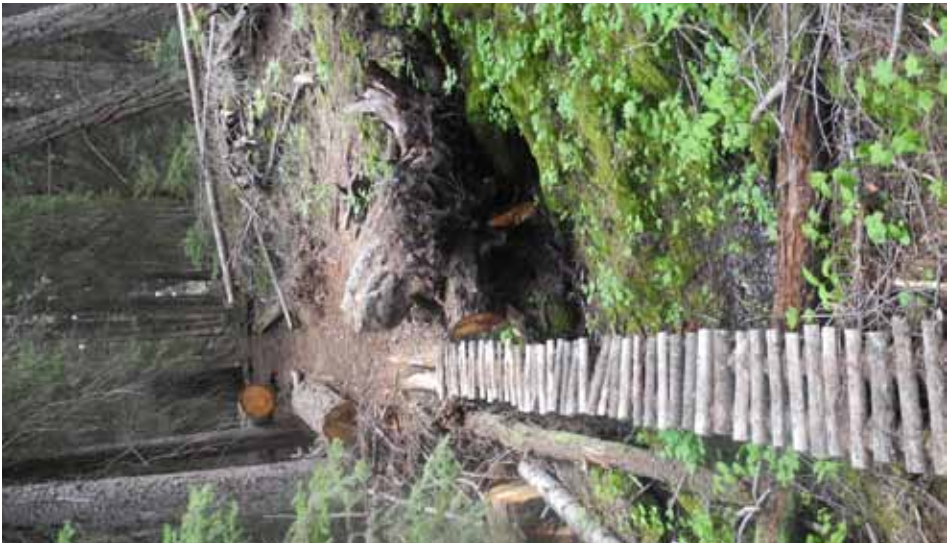
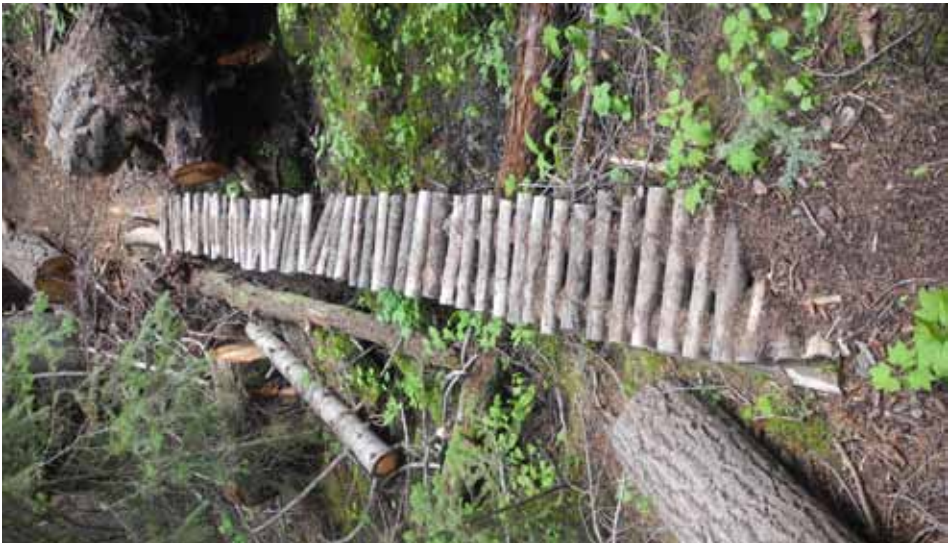
| NO. | TRAIL | ITEM | DIMENSION (MM) | PRESCRIPTION | IMPROVEMNT | FALL_ZONE (1 - POOR, 5 - GOOD) | | | | | IMAGE |
|---|---|---|---|---|---|---|---|---|---|--|---|
| 97 | 99 | elevated bridge roll | 420w x 600h x 6000l | remove | decking and stringers are decaying, recommend removing stunt and using adjacent log, or ground. | n | 1 | y | 1 | | DSCN6937.JPG |

| NO. | ITEM | DIMENSION (MM) | PRESCRIPTION | IMPROVEMNT | MEETS STANDARD | LIFE (YEARS) | MANDATORY | FALL_ZONE (1 - POOR, 5 - GOOD) | IMAGE | NORTHING (UTM10) | EASTING (UTM10) | HEIGHT ABOVE MSL (M) |
|---|---|---|---|---|---|---|---|---|---|---|---|---|
| 97 | elevated bridge roll | 420w x 600h x 6000l | remove | decking and stringers are decaying, recommend removing stunt and using adjacent log, or ground. | n | 1 | y | 1 | DSCN6937.JPG | 5547342 | 660873 | 1445 |

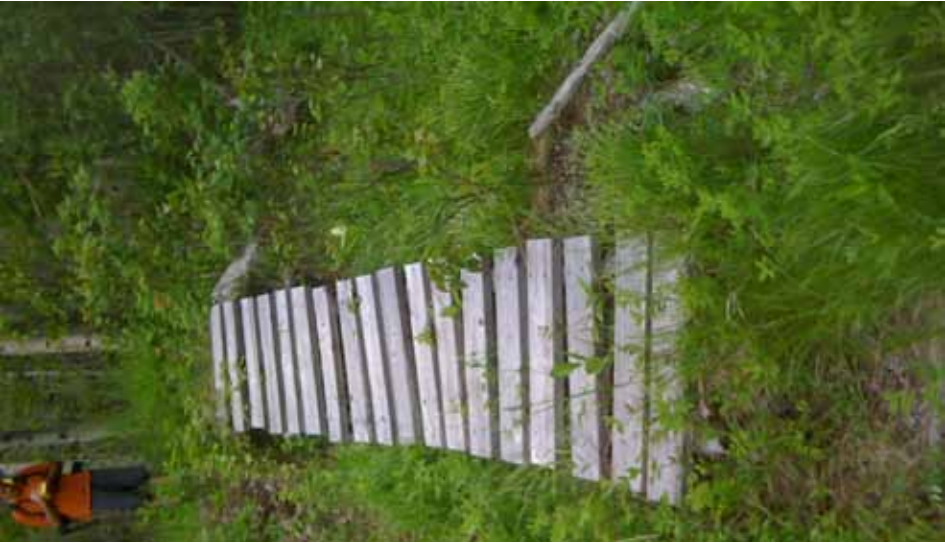
| NO. | TRAIL | ITEM | DIMENSION (MM) | PRESCRIPTION | IMPROVEMNT | FALL_ZONE (1 - POOR, 5 - GOOD) | | | | IMAGE |
|---|---|---|---|---|---|---|---|---|---|---|
| 28 | Bunker Berms | elevated bridge roll | 700w x 4500l x 500h | remove | lots of deflection with foot traffic, and non-mandatory | y | 1 | n | 3 | IMG_0792.JPG |

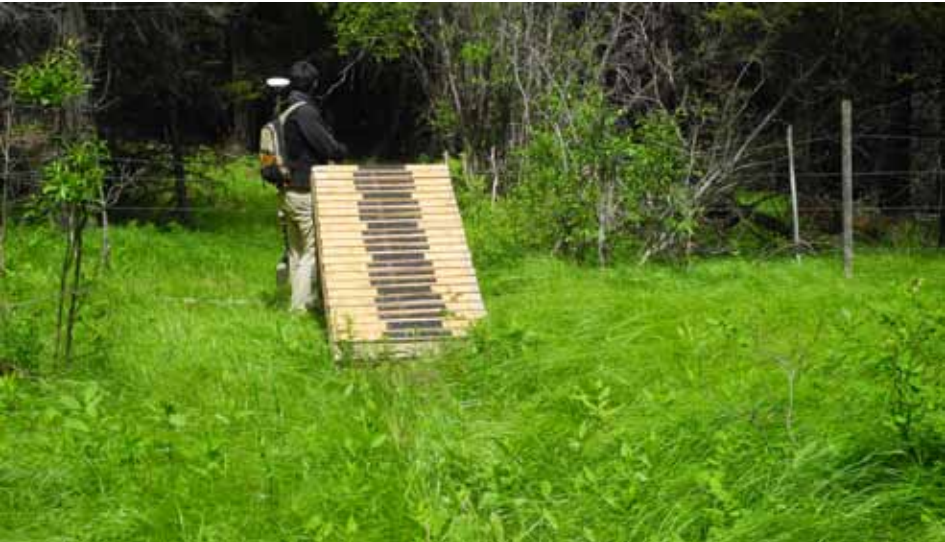
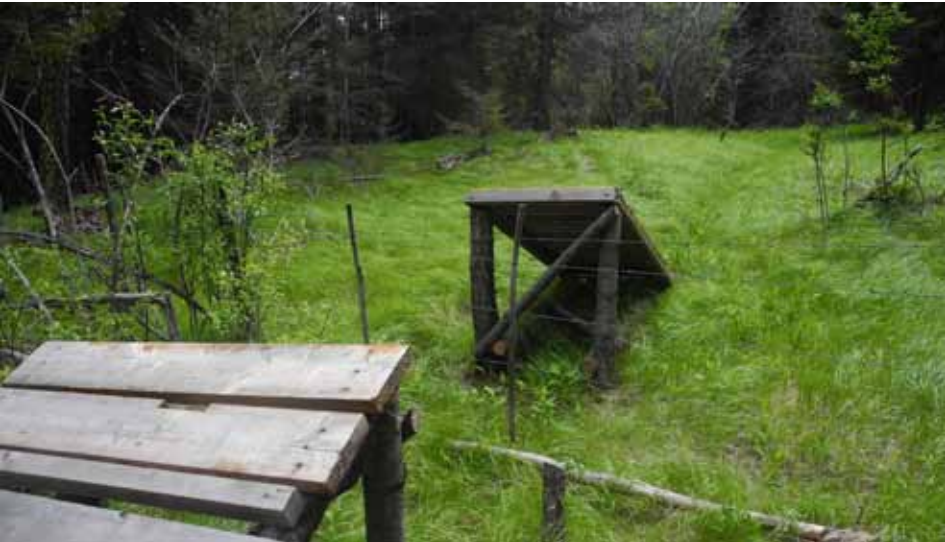
| NO. | TRAIL | ITEM | DIMENSION (MM) | PRESCRIPTION | IMPROVEMNT | FALL_ZONE (1 - POOR, 5 - GOOD) | | | | IMAGE |
|---|---|---|---|---|---|---|---|---|---|---|
| 123 | Glen's Trail | gap jump | 920w x 1000h x 2900gap | improve | gap jump to clear barb-wire fence -- no standard for consequential gap jumps | n | 5 | y | 1 | DSCN7123.JPG |

This trail is under construction but stunt #123 should be replaced with a turnstyle through the fence.

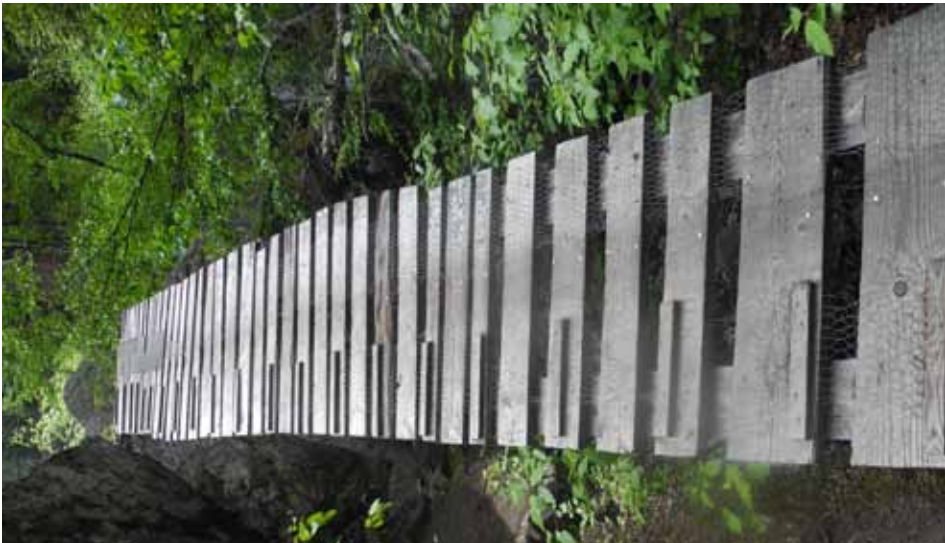
| NO. | TRAIL | ITEM | DIMENSION (MM) | PRESCRIPTION | IMPROVEMNT | MEETS STANDARD | LIFE (YEARS) | MANDATORY | FALL_ZONE (1 - POOR, 5 - GOOD) | IMAGE |
|---|---|---|---|---|---|---|---|---|---|---|
| 65 | Godey Creek | elevated bridge roll | 920w x 12000l x 2000h | replace | stringers deflect under foot traffic, shingles and chicken wire on decking should be replaced with a "cleated" boardwalk, and stringers are broken at base of stunt | y | 2 | y | 1 | DSCN6752.JPG |

| NO. | ITEM | DIMENSION (MM) | PRESCRIPTION | IMPROVEMNT | MEETS STANDARD | LIFE (YEARS) | MANDATORY | FALL_ZONE (1 - POOR, 5 - GOOD) | IMAGE | NORTHING (UTM10) | EASTING (UTM10) | HEIGHT ABOVE MSL (m) |
|---|---|---|---|---|---|---|---|---|---|---|---|---|
| 65 | elevated bridge roll | 920w x 12000l x 2000h | replace | stringers deflect under foot traffic, shingles and chicken wire on decking should be replaced with a "cleated" boardwalk, and stringers are broken at base of stunt | y | 2 | y | 1 | DSCN6752.JPG | 5549374 | 661832 | 862 |

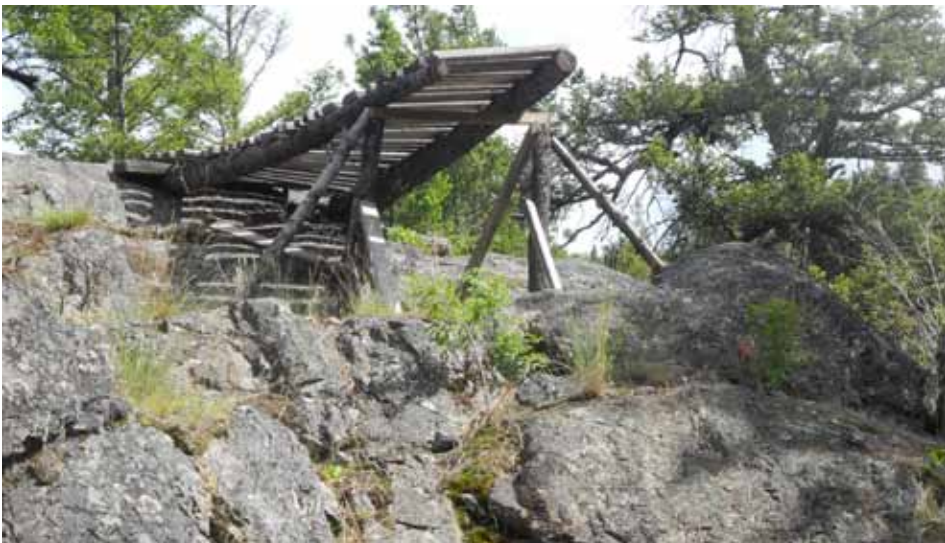
| NO. | TRAIL | ITEM | DIMENSION (MM) | PRESCRIPTION | IMPROVEMNT | MEETS STANDARD | LIFE (YEARS) | MANDATORY | FALL_ZONE (1 - POOR, 5 - GOOD) | IMAGE |
|---|---|---|---|---|---|---|---|---|---|---|
| 6 | Ridge | elevated bridge drop | 700w x 4080l x 1600h | remove | overspanned stringers, poor fall zones, poorly anchored at base of stunt, existing rock down sufficient stunt | n | 2 | y | 1 | DSCN6181.JPG |

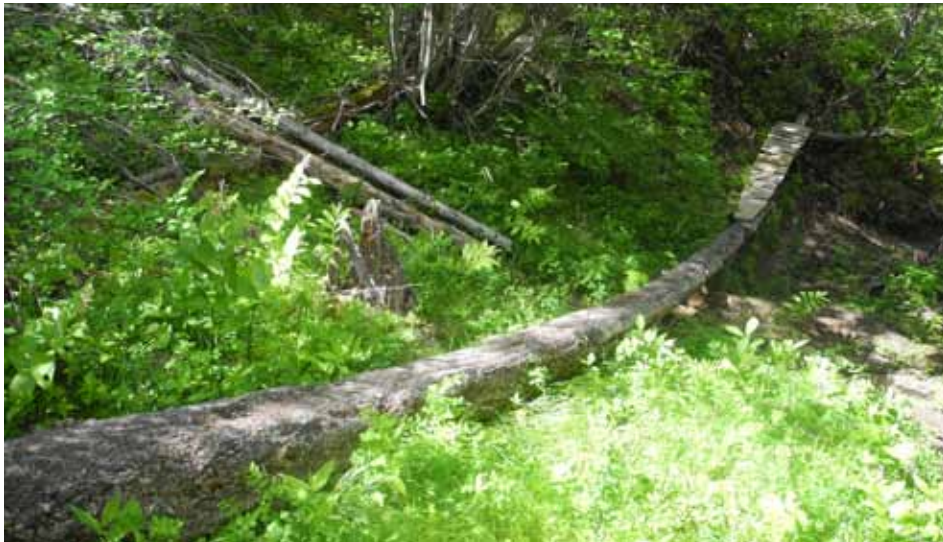
| NO. | TRAIL | ITEM | DIMENSION (MM) | PREScription | IMPROVEMNT | MEETS STANDARD | LIFE (YEARS) | MANDATORY | FALL_ZONE (1 - POOR, 5 - GOOD) | IMAGE |
|---|---|---|---|---|---|---|---|---|---|---|
| 109 | Rotary Wankle | log drop | | replace | complex stunt on fallen log, decking is decaying and stringers deflecting greatly. Recommend replacing or improving dirt trail adjacent to stunt. | n | 2 | n | 2 | DSCN7054.JPG |

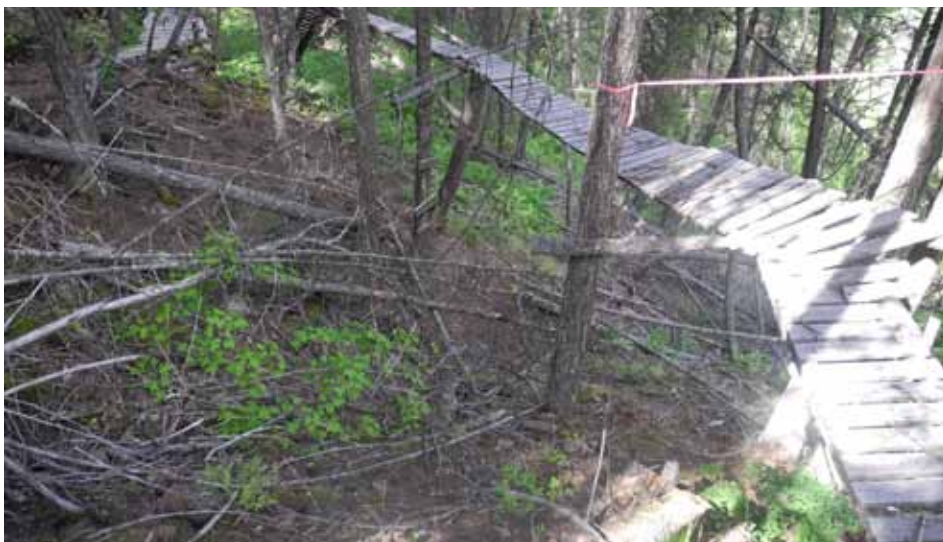
| 111 | Rotary Wankle | elevated bridge roll | | remove | pink tape denotes stunt is closed but stunt should be removed | n | 1 | n | 1 | DSCN7070.JPG |

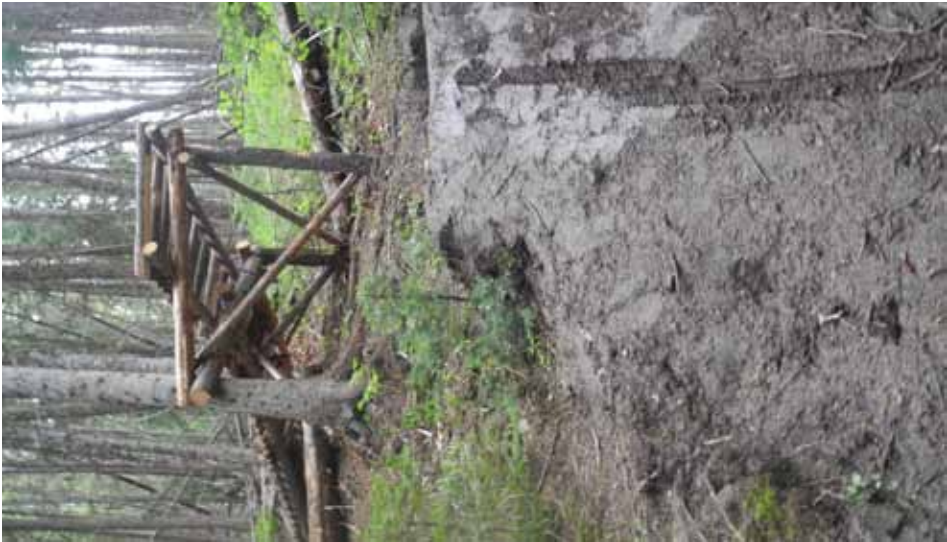
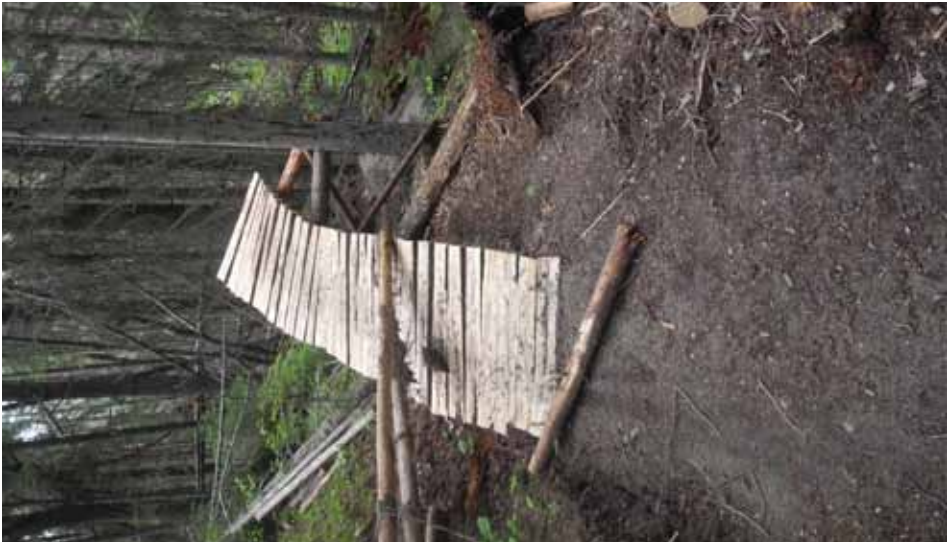
| NO. | TRAIL | ITEM | DIMENSION (MM) | PRESCRIPTION | IMPROVEMNT | MEETS STANDARD | LIFE (YEARS) | MANDATORY | FALL_ZONE (1 - POOR, 5 - GOOD) | IMAGE |
|---|---|---|---|---|---|---|---|---|---|---|
| 94 | The Revival | gap jump | 1040w x 3000h x 300gap | improve | Newly constructed Gap jump onto hip landing in good condition. Improve by reducing the gap, or creating a ridearound | n | 5 | y | 1 | DSCN6915.JPG |

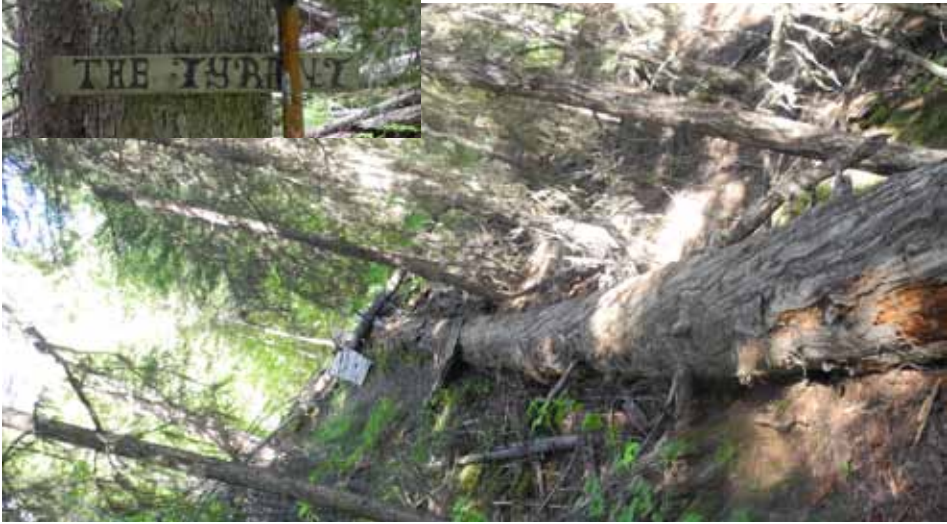
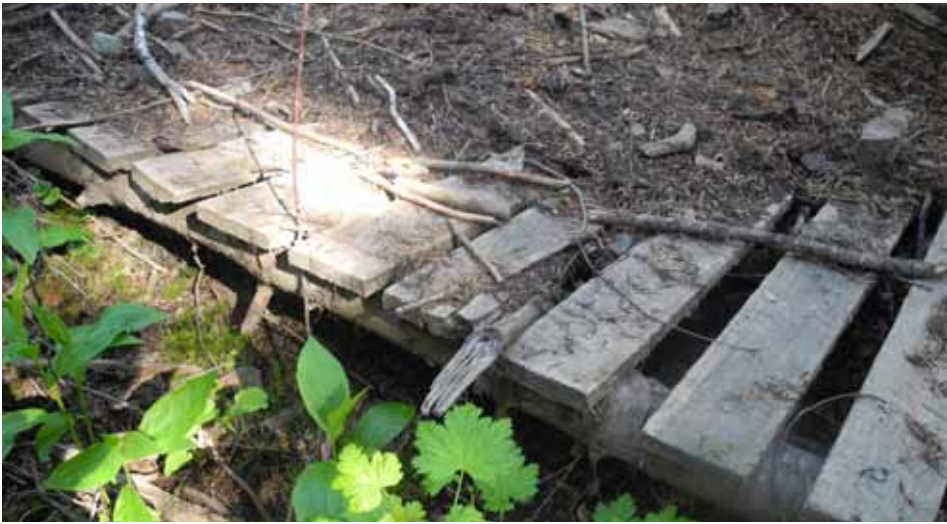
| NO. | TRAIL | ITEM | DIMENSION (MM) | PREScription | IMPROVEMNT | MEETS STANDARD | LIFE (YEARS) | MANDATORY | FALL_ZONE (1 - POOR, 5 - GOOD) | IMAGE |
|---|---|---|---|---|---|---|---|---|---|---|
| 54 | The Tyrant | log ride | 300w x 2000h x 22000l | remove | improve by replacing the rotting on-ramp, increasing the decking dimension from 1x4 decking, level the riding surface and clear the fall zones | N | 1 | Y | 1 | DSCN6674.JPG |

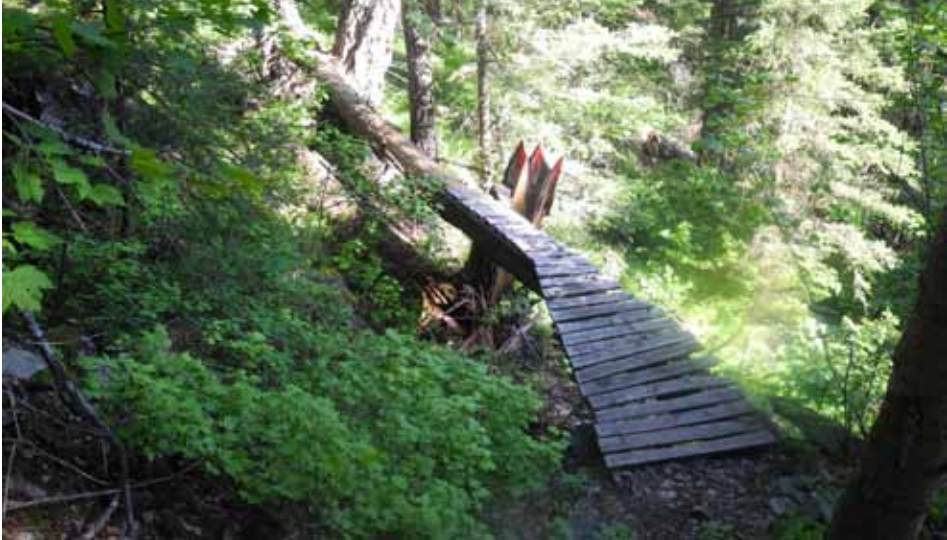
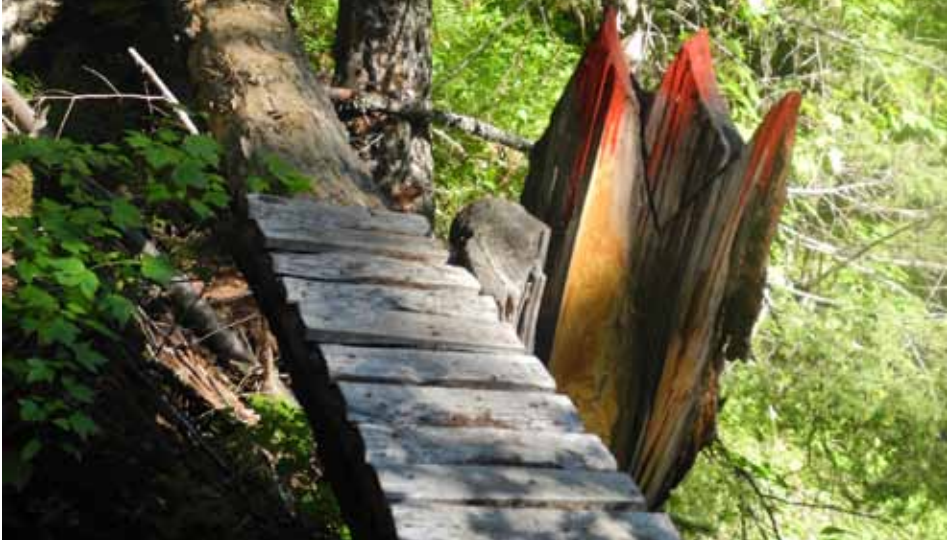
| NO. | TRAIL | ITEM | DIMENSION (MM) | PREScription | IMPROVEMNT | MEETS STANDARD | LIFE (YEARS) | MANDATORY | FALL_ZONE (1 - POOR, 5 - GOOD) | IMAGE |
|---|---|---|---|---|---|---|---|---|---|---|
| 55 | The Tyrant | log ride | 350w x 30000l x 1500h | remove | Remove log as it moves under foot traffic and build a dirt trail | N | 1 | Y | 1 | DSCN6679.JPG |

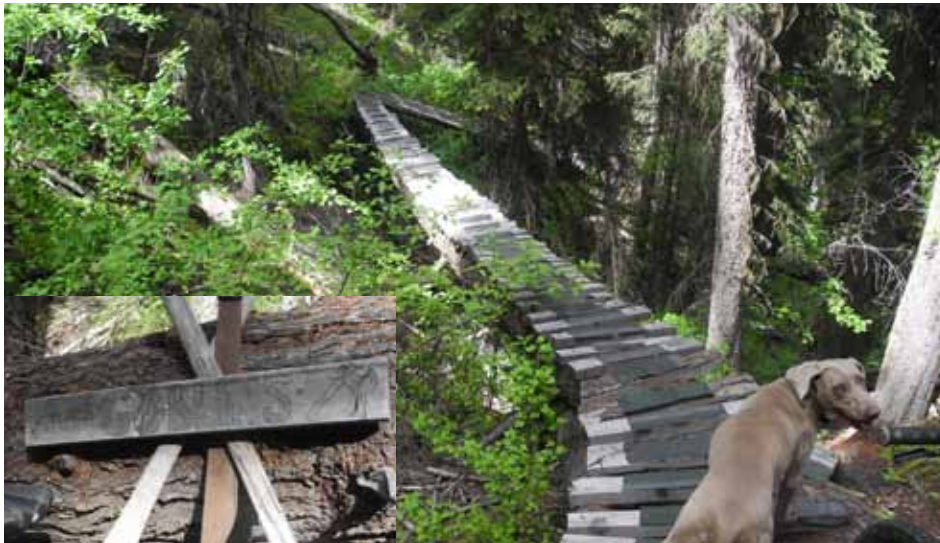
| NO. | TRAIL | ITEM | DIMENSION (MM) | PREScription | IMPROVEMNT | MEETS STANDARD | LIFE (YEARS) | MANDATORY | FALL_ZONE (1 - POOR, 5 - GOOD) | IMAGE |
|---|---|---|---|---|---|---|---|---|---|---|
| 100 | The Tyrant | elevated bridge roll / log ride | 690w x 4200h | remove | complex stunt, recommend replacing decaying deck boards, cleating the boardwalk, and improving fall zones. | n | 1 | y | 1 | DSCN7020.JPG |

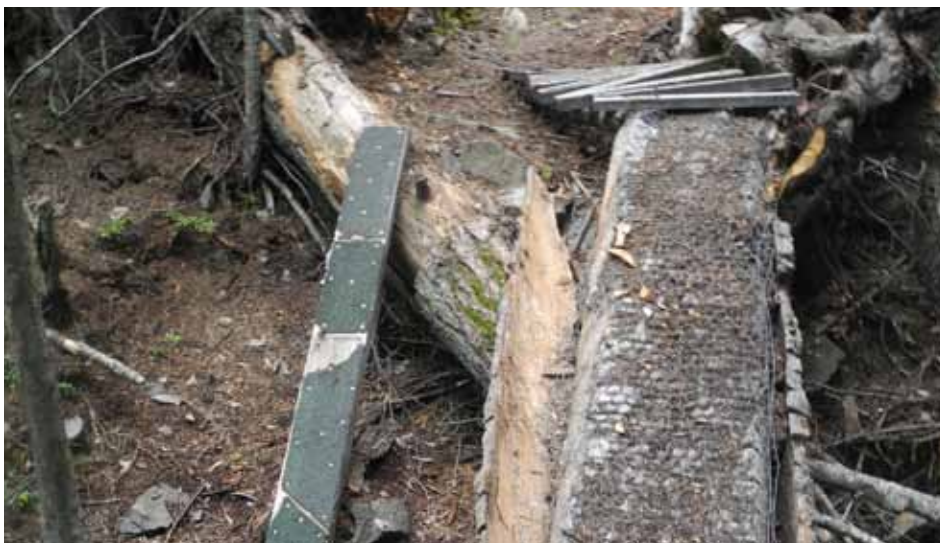
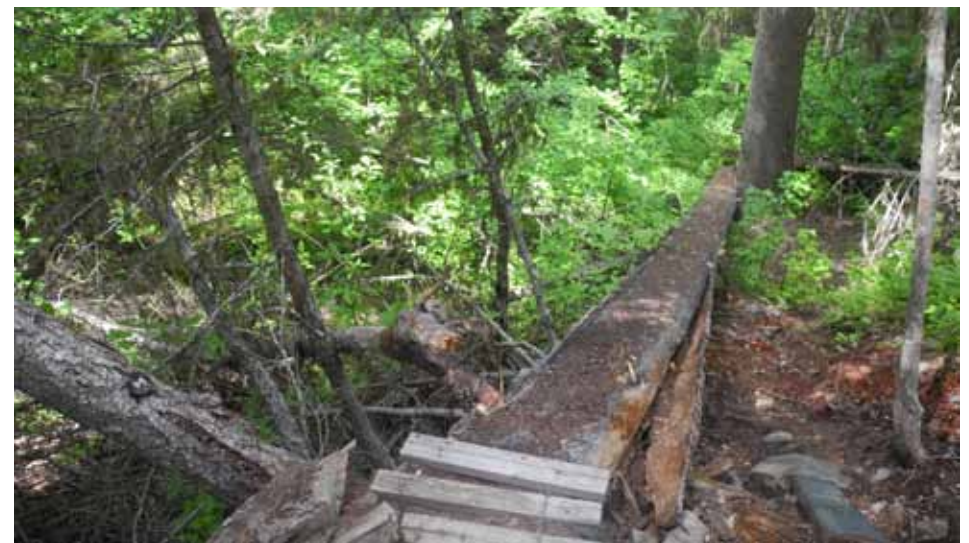
| 103 | The Tyrant | log ride | 300w x 1330h x 13000l | improve | improve stunt by cleating the tread and creating a safe exit from the stunt. | n | 3 | y | 1 | DSCN7034.JPG |

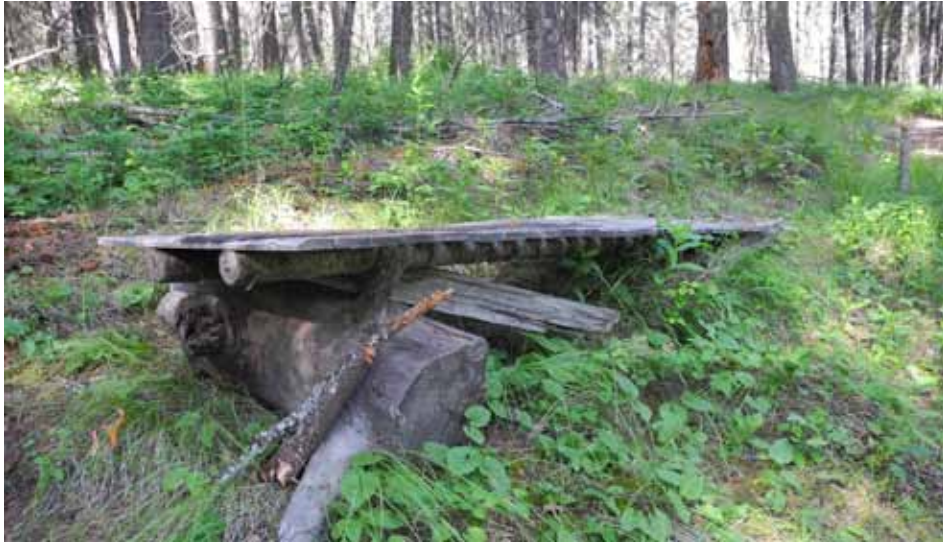
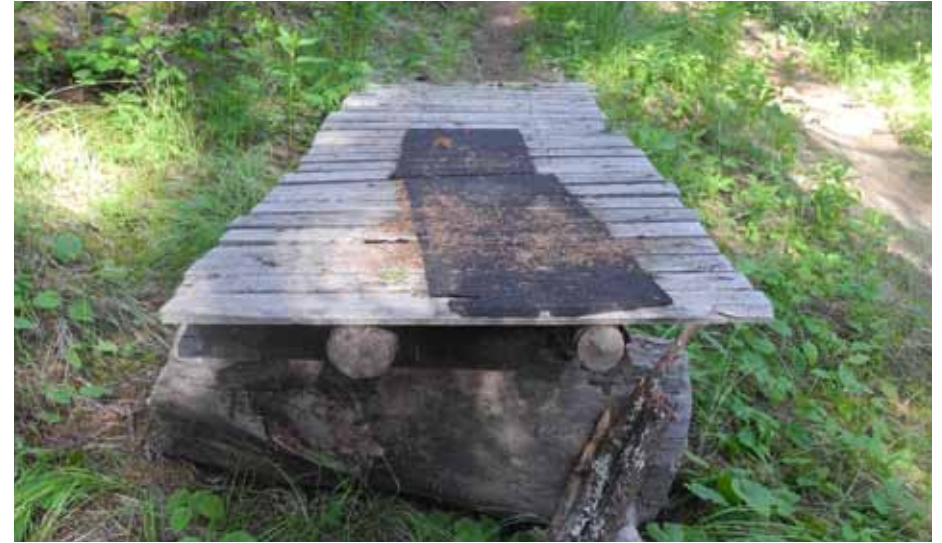
| NO. | TRAIL | ITEM | DIMENSION (MM) | PRESCRIPTION | IMPROVEMNT | MEETS STANDARD | LIFE (YEARS) | MANDATORY | FALL_ZONE (1 - POOR, 5 - GOOD) | IMAGE |
|---|---|---|---|---|---|---|---|---|---|---|
| 36 | Too Much info | elevated bridge drop | 870w x 2790l x 600h | remove | stunt is deflecting too much with foot traffic, remove and build dirt jump | n | 1 | n | 3 | DSCN6306.JPG |

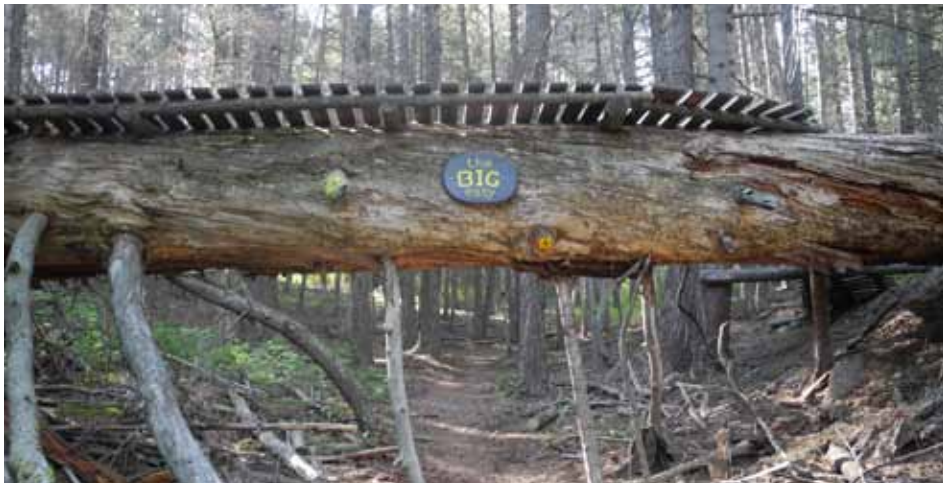
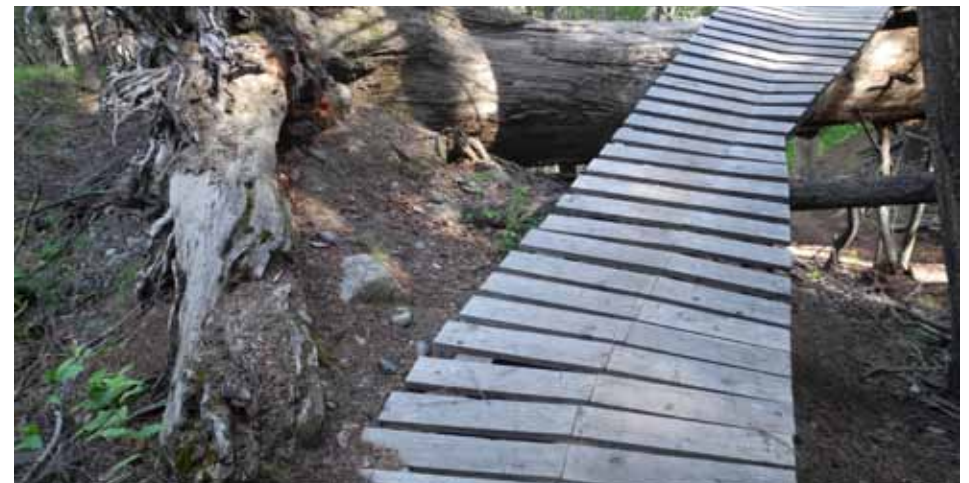
stringers on approach ramps are overspanned, decking is split in middle and it's unclear of how purlins are fastened. Recommend replacing decking with one-piece 2"x4" and increase diameter of stringers on the approach ramp

| 37 | Too Much info | elevated bridge | 1220w x 1880l x 3100h | improve | | n | 1 | n | 1 | DSCN6322.JPG |

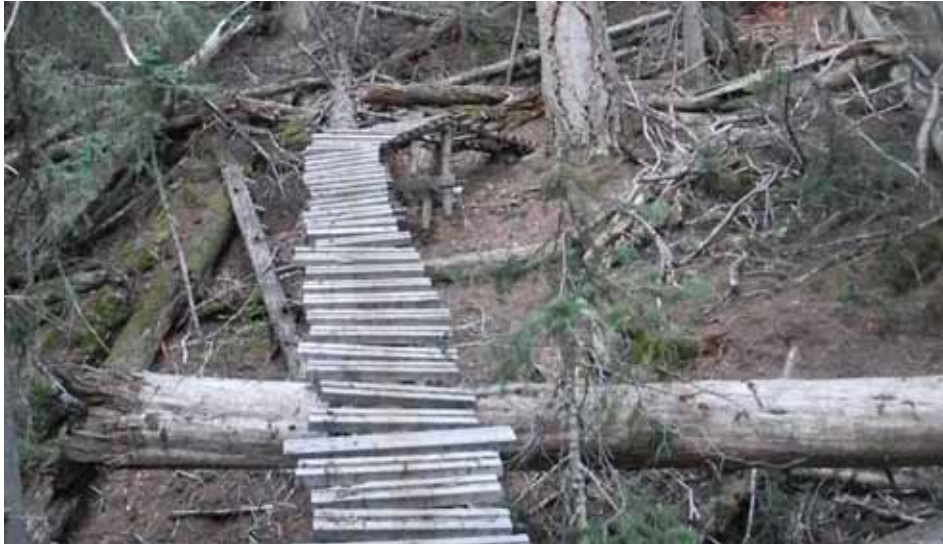
| NO. | TRAIL | ITEM | DIMENSION (MM) | PRESCRIPTION | IMPROVEMNT | MEETS STANDARD | LIFE (YEARS) | MANDATORY | FALL_ZONE (1 - POOR, 5 - GOOD) | IMAGE |
|---|---|---|---|---|---|---|---|---|---|---|
| 49 | Treats | elevated bridge drop | 200w x 2000h x 15000l | remove | major deflection in stringers, uneven riding surface, 1x4 and 2x4 decking failing, recommend removal of stunt | n | 1 | y | 1 | DSCN6609.JPG |

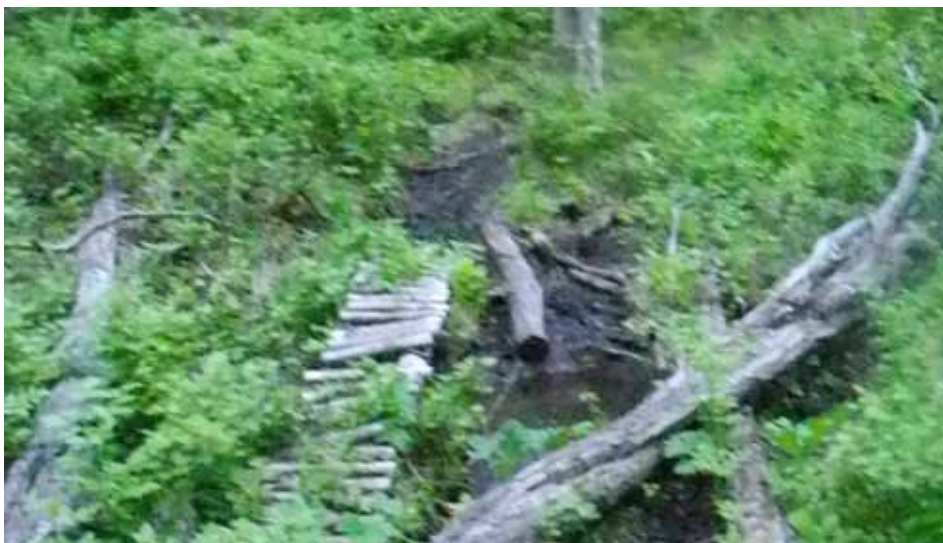
| 50 | Treats | bridge | 500w x 750h x 10000l | remove | delapitated old bridge should be replaced or removed | y | 1 | n | 2 | DSCN6631.JPG |

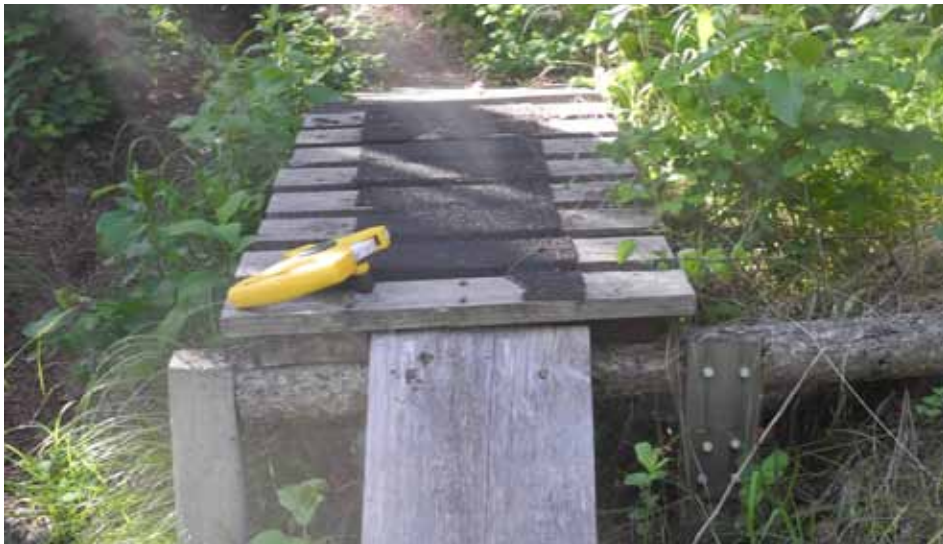
| NO. | TRAIL | ITEM | DIMENSION (MM) | PRESCRIPTION | IMPROVEMNT | MEETS STANDARD | LIFE (YEARS) | MANDATORY | FALL_ZONE (1 - POOR, 5 - GOOD) | IMAGE |
|---|---|---|---|---|---|---|---|---|---|---|
| 34 | Ursa Major | elevated bridge roll | 610w x 3060l x 700h | remove | shakey structure because posts are rotting where touching the ground, shingles are loose - remove or rebuild | y | 2 | n | 2 | DSCN6287.JPG |

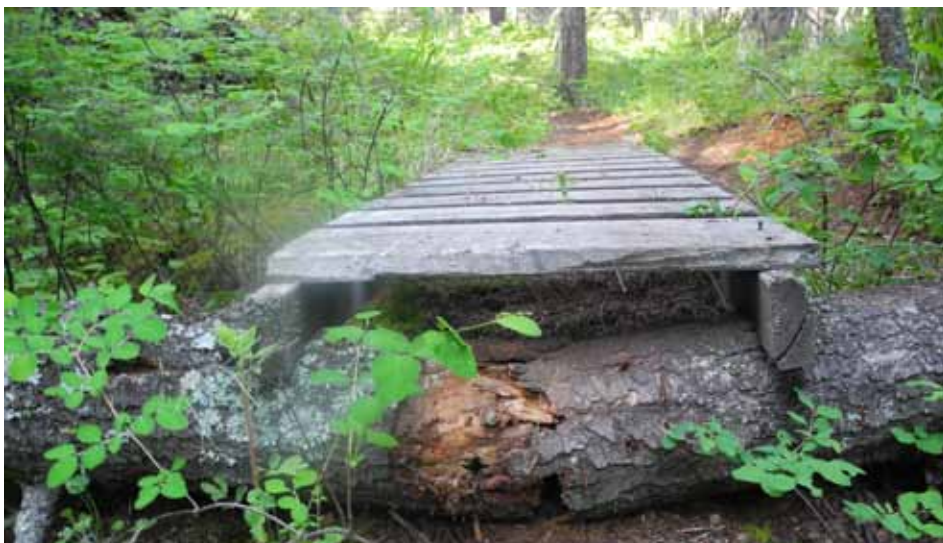
| 35 | Ursa Major | elevated bridge drop | 650w x 2430l x 350h | improve | log on which stunt is situated is broken, recommend removing log and stunt | n | 1 | y | 2 | DSCN6295.JPG |

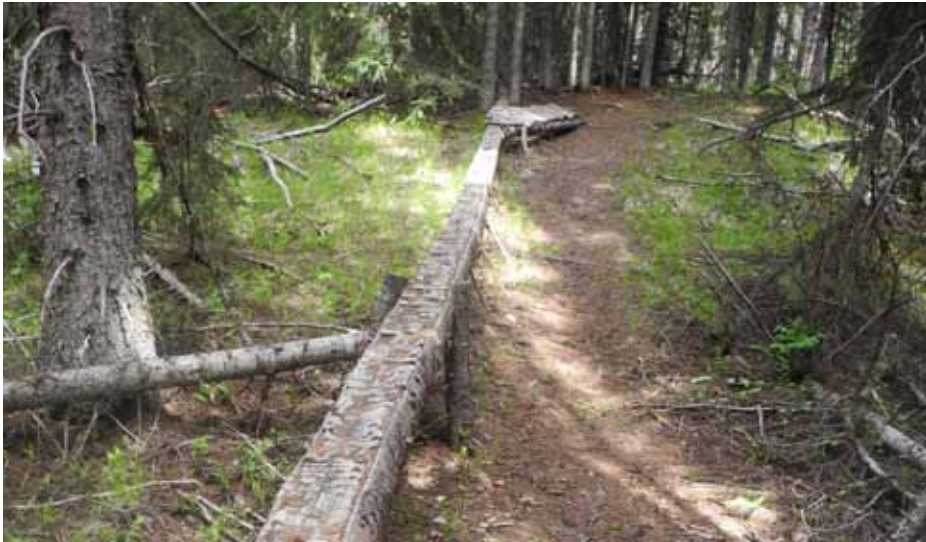
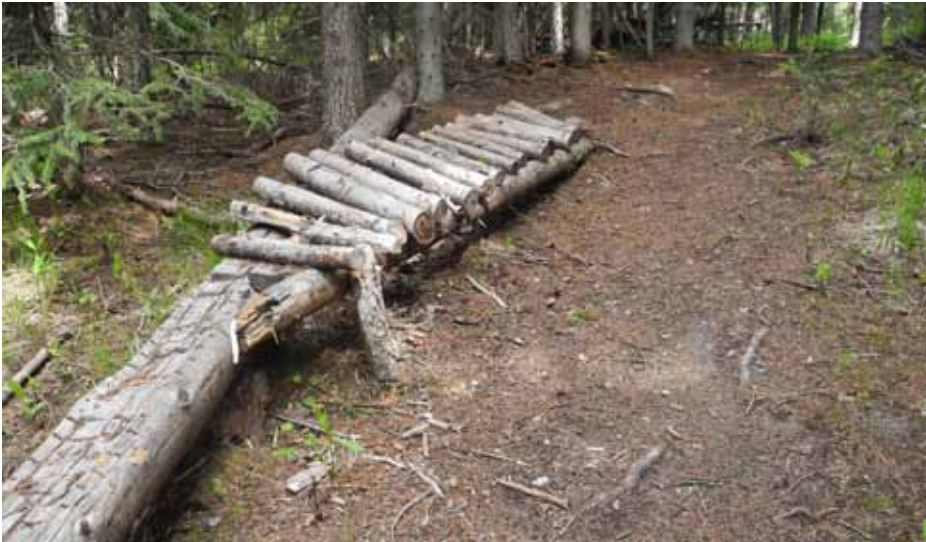
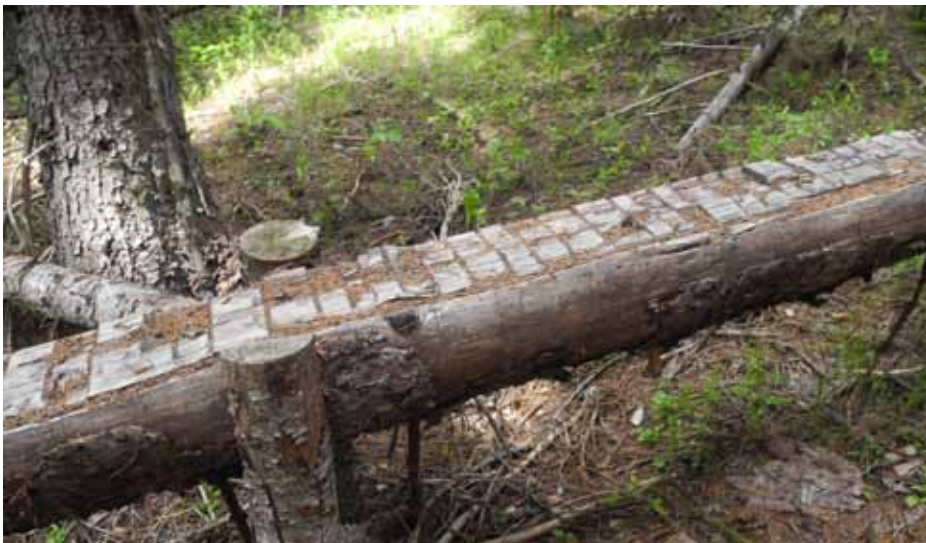
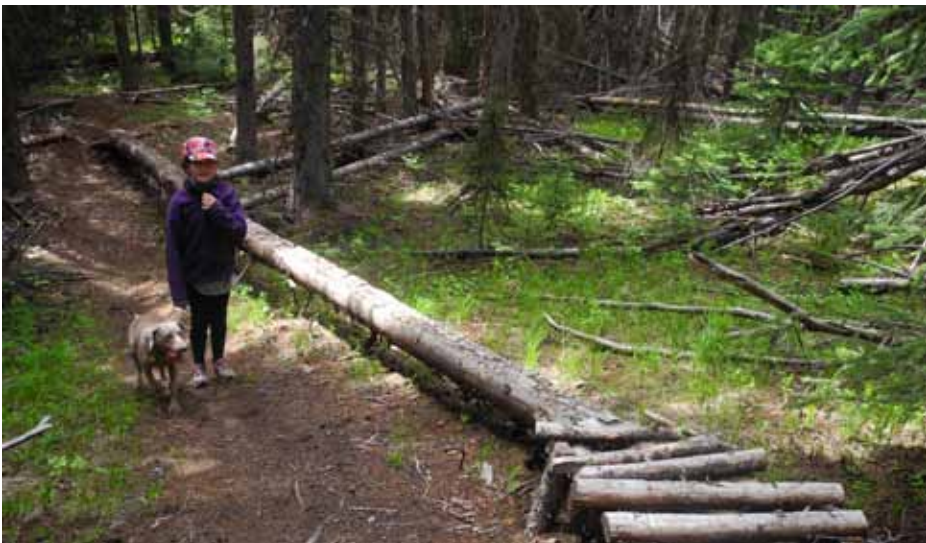
| No | Item | Dimension (mm) | Prescription | Description | Meets Standard | Life Expect (years) | Mandatory | Fall Zone<br>1 - poor<br>5 - good |
|---|---|---|---|---|---|---|---|---|
| 115 | log drop | 200w x 600h | improve | old log ride needs new entry ramp, or just decomission and use ridearound | y | 1 | n | 3 |

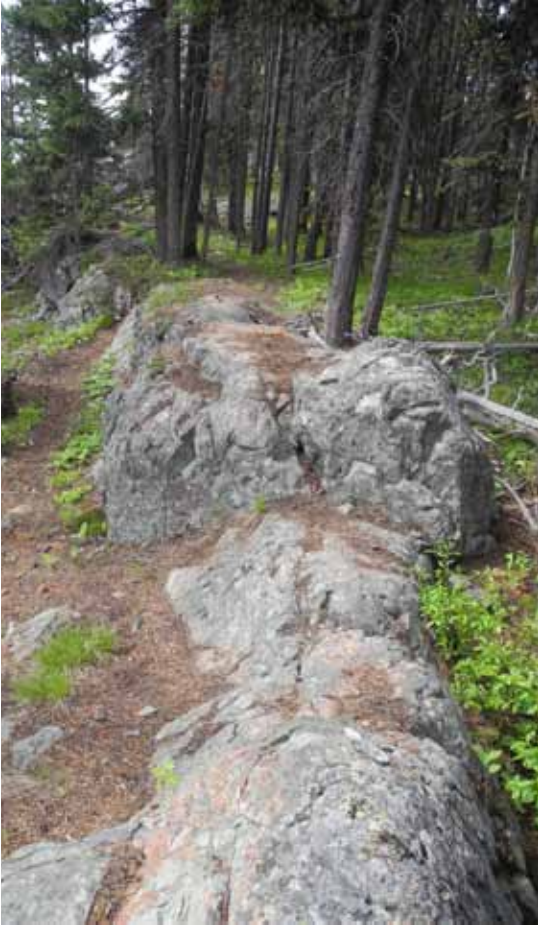
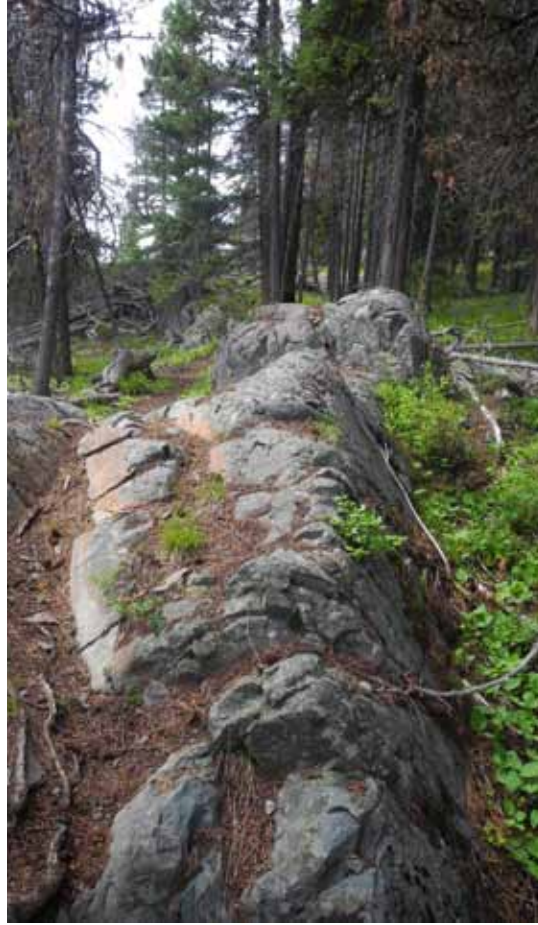
116 rock roll < 1000h monitor good natural feature

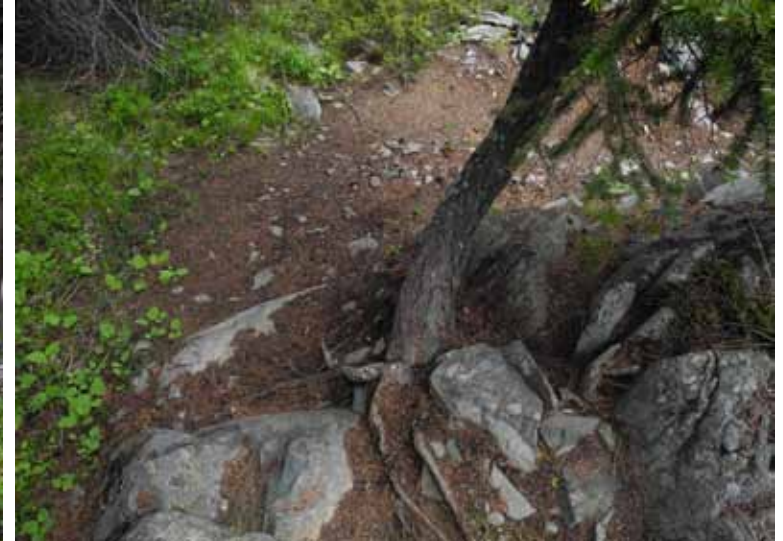
117 rock roll monitor improve ride around

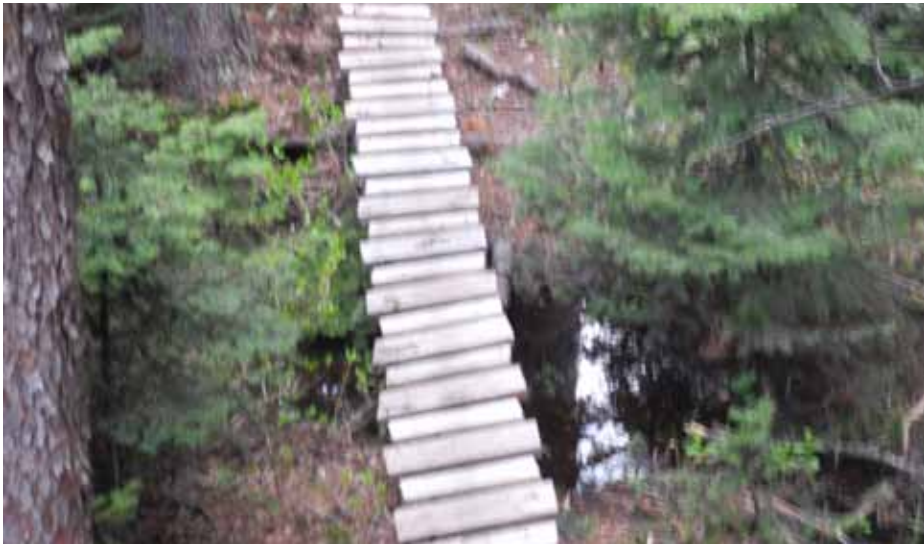
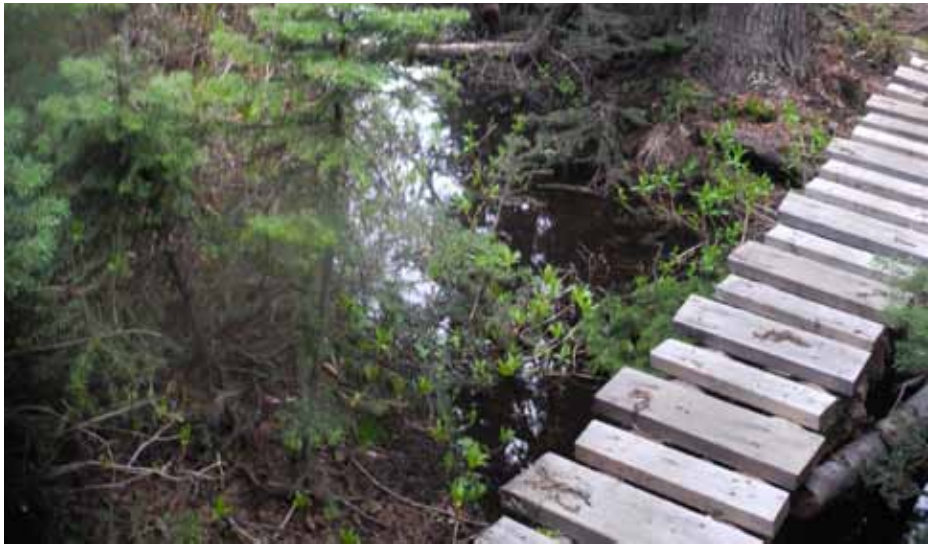
| No. | ITEM | DIMENSION (MM) | PRESCRIPTION | IMPROVEMNT | MEETS<br>STANDARD | LIFE (YEARS) | MANDATORY | FALL_ZONE<br>(1 - POOR, 5 -<br>GOOD) | IMAGE | NORTHING<br>(UTM10) | EASTING<br>(UTM10) | HEIGHT<br>ABOVE<br>MSL (M) |
|---|---|---|---|---|---|---|---|---|---|---|---|---|
| 45 | bridge | 250w x 6000l x<br>250w | improve | improve by creating level riding surface | y | 2 | y | 2 | DSCN6558.JPG | 5546458 | 660530 | 1687 |

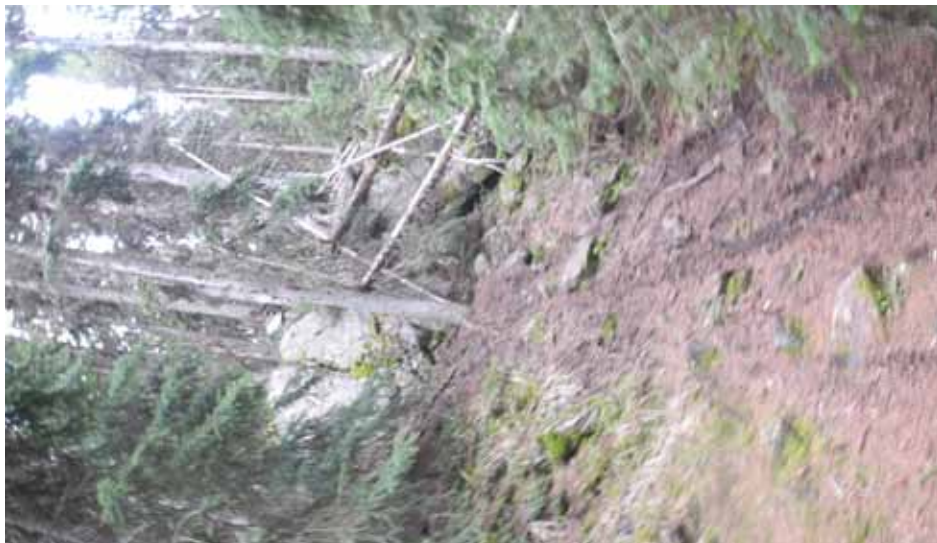
| 47 | rock drop | | monitor | mandatory rock drop, clear fall zones of debris, armour the landing zone to minimize erosion | Y | 5 | Y | 1 | DSCN6577.JPG | 5546571 | 660394 | 1650 |

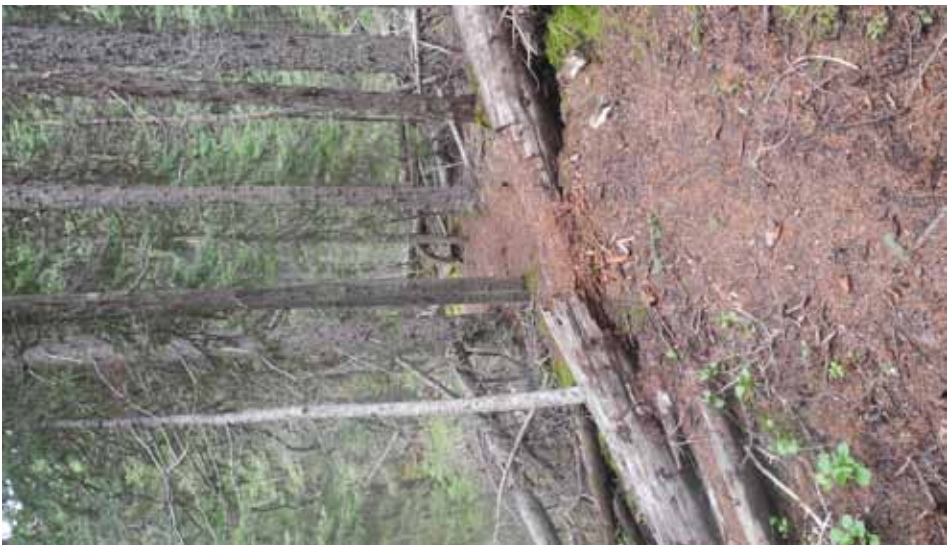
| NO. | ITEM | DIMENSION (MM) | PRESCRIPTION | IMPROVEMNT | MEETS STANDARD | LIFE (YEARS) | MANDATORY | FALL_ZONE (1 - POOR, 5 - GOOD) | IMAGE | NORTHING (UTM10) | EASTING (UTM10) | HEIGHT ABOVE MSL (M) |
|---|---|---|---|---|---|---|---|---|---|---|---|---|
| 138 | log drop | 500 high - mandatory | monitor | natural feature decaying but it okay | y | 5 | y | 1 | DSCN6805.JPG | 5546727 | 660387 | 1620 |

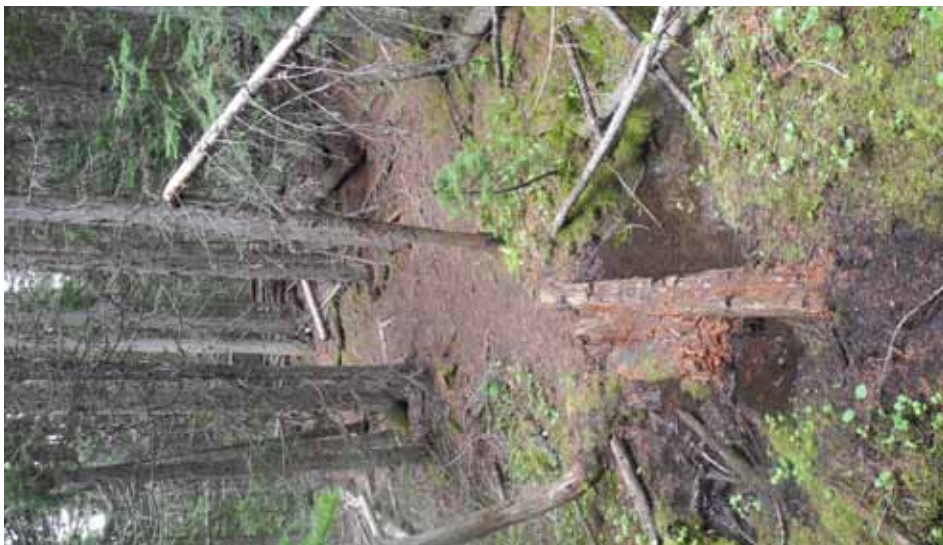
| NO. | ITEM | DIMENSION (MM) | PRESCRIPTION | IMPROVEMNT | MEETS STANDARD | LIFE (YEARS) | MANDATORY | FALL_ZONE (1 - POOR, 5 - GOOD) | IMAGE | NORTHING (UTM10) | EASTING (UTM10) | HEIGHT ABOVE MSL (M) |
|---|---|---|---|---|---|---|---|---|---|---|---|---|
| 139 | log ride | 3000mm crossing | replace | old log crossing should be removed or replaced | n | 1 | n | 1 | DSCN6804.JPG | 5546749 | 660405 | 1613 |
