# MOUNTAIN BIKE TRAIL & TECHNICAL TRAIL FEATURE INSPECTION

IRON MOUNTAIN, MERRITT, BC

Ministry of Ministry of Forests, Lands and  
Natural Resource Operations

Cascades District – Recreation Sites & Trails  
August 2012

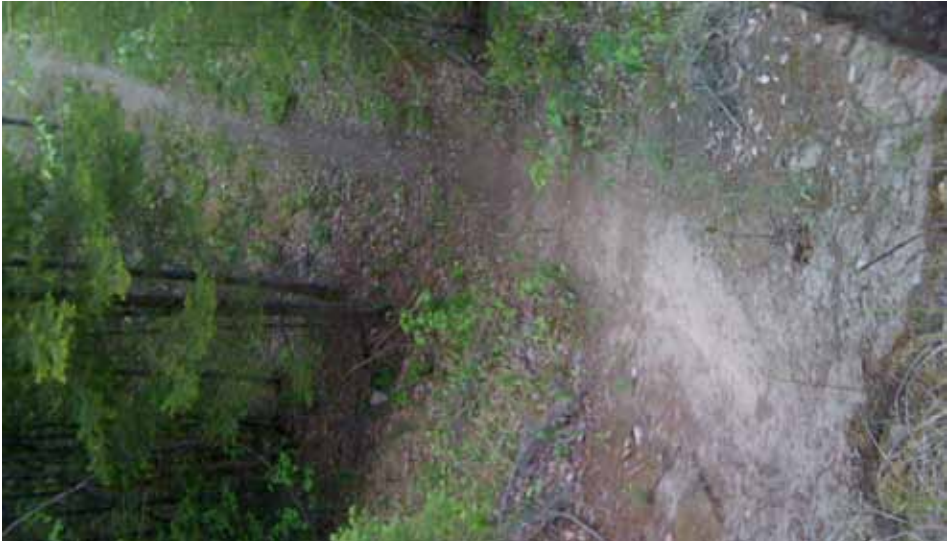
| NO. | ITEM | DIMENSION (MM) | DESCRIPTION | IMPROVEMNT | MEETS STANDARD | LIFE (YEARS) | MANDATORY | FALL_ZONE (1 - POOR, 5 - GOOD) | IMAGE | NORTHING (UTM10) | EASTING (UTM10) | HEIGHT ABOVE MSL (m) |
|---|---|---|---|---|---|---|---|---|---|---|---|---|
| 15 | rock drop | 65% & 7000h | improve | Trail descends steeply and the rider must turn abruptly in order to avoid this drop. A sign should be installed to warn riders that trail to left is the easier route | y | 5 | n | 1 | IMG_0732.JPG | 5548684 | 662698 | 1047 |

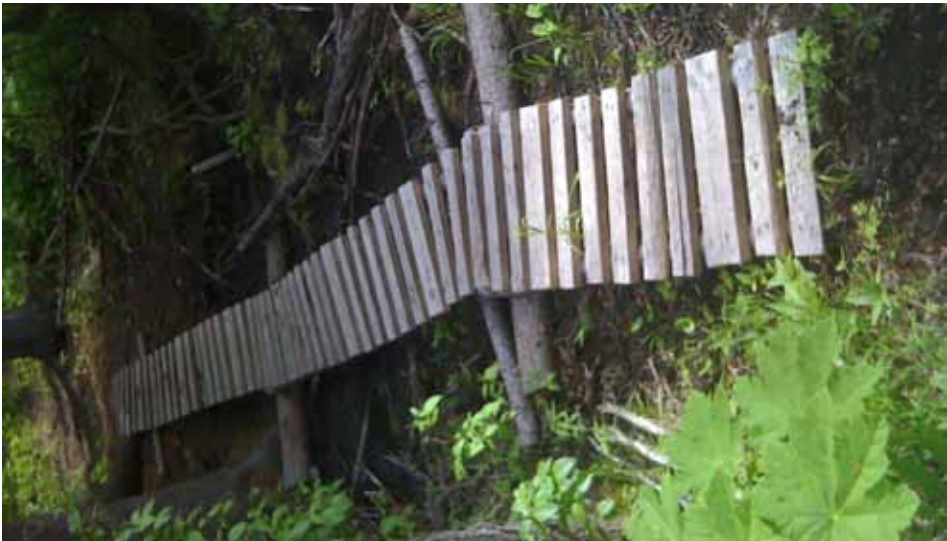
| 16 | bridge | 650w x 9000l x 350h | improve | improve by levelling the bridge decking | y | 2 | y | 2 | IMG_0735.JPG | 5548452 | 662533 | 1096 |

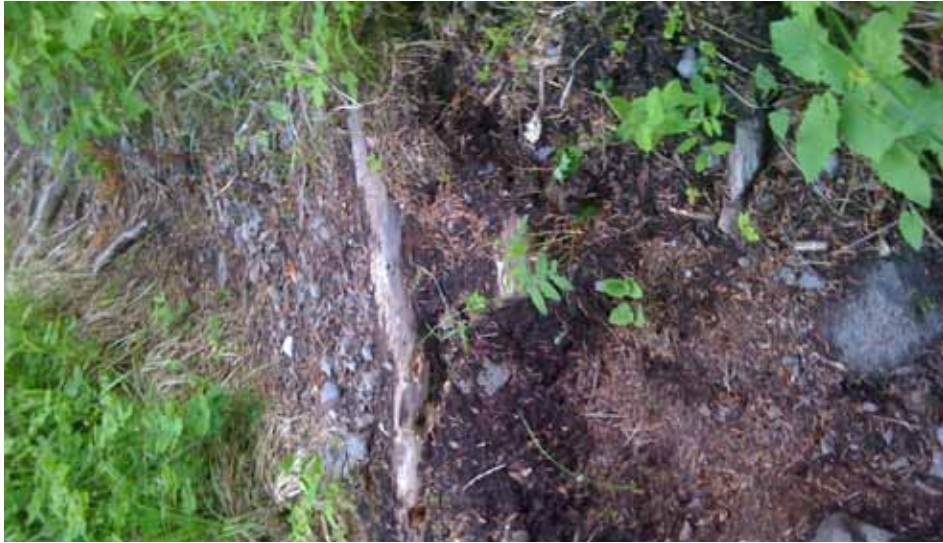
| 17 | log drop | 109w x 200l x 400h | monitor | good natural feature but wood in contact with ground is rotting | y | 2 | y | 3 | IMG_0739.JPG | 5548378 | 662531 | 1107 |

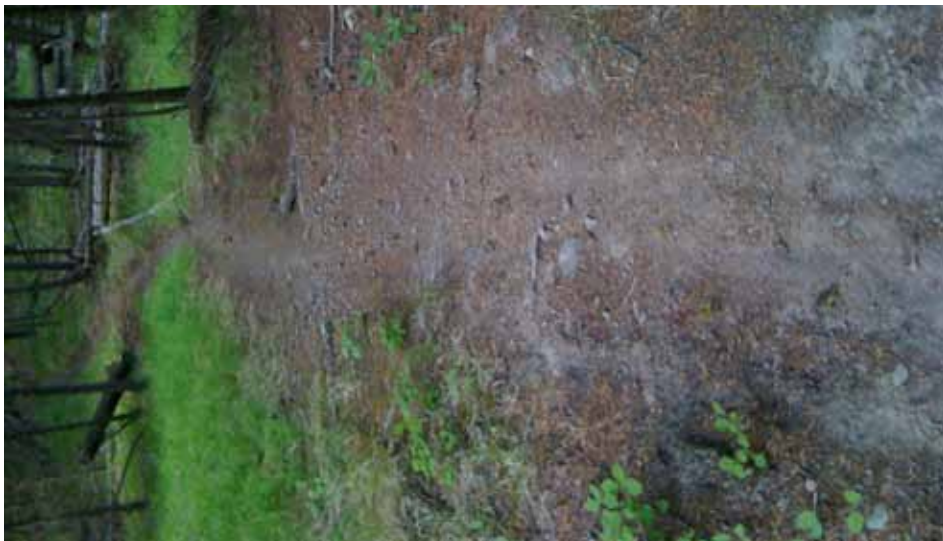
| 18 | log drop | 500h | monitor | good natural feature but wood in contact with ground is rotting | y | 3 | y | 3 | IMG_0742.JPG | 5548325 | 662536 | 1123 |

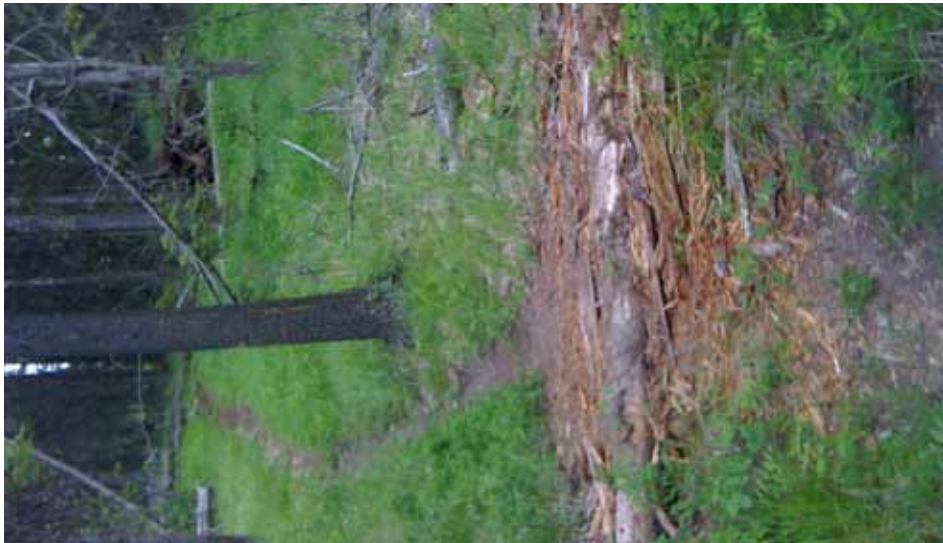
| NO. | ITEM | DIMENSION (MM) | PRESCRIPTION | IMPROVEMNT | MEETS STANDARD | LIFE (YEARS) | MANDATORY | FALL_ZONE (1 - POOR, 5 - GOOD) | IMAGE | NORTHING (UTM10) | EASTING (UTM10) | HEIGHT ABOVE MSL (m) |
|---|---|---|---|---|---|---|---|---|---|---|---|---|
| 19 | log drop | 500h | monitor | good natural feature but wood in contact with ground is rotting | y | 3 | y | 3 | IMG_0745.JPG | 5548314 | 662544 | 1124 |

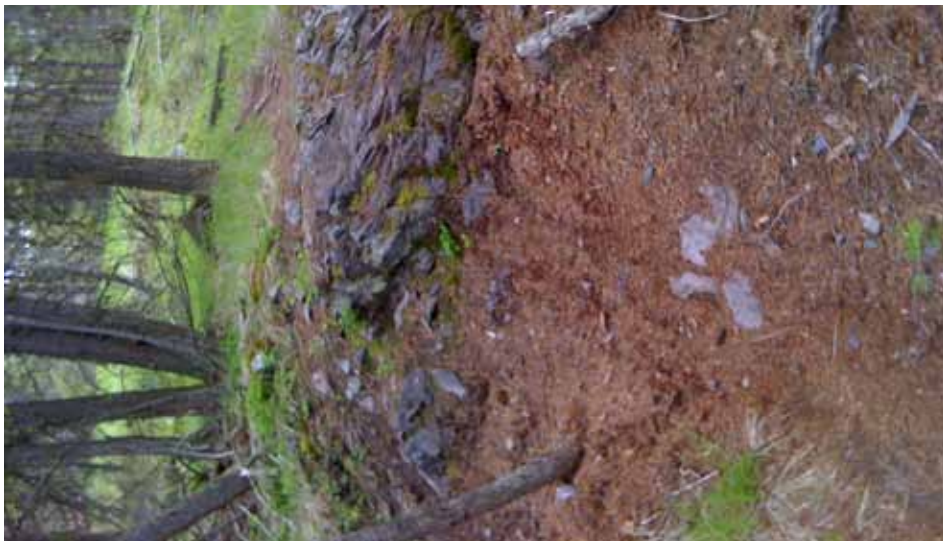
| 20 | rock drop | 1050h | monitor | great natural feature | y | 5 | n | 3 | IMG_0746.JPG | 5548300 | 662559 | 1132 |

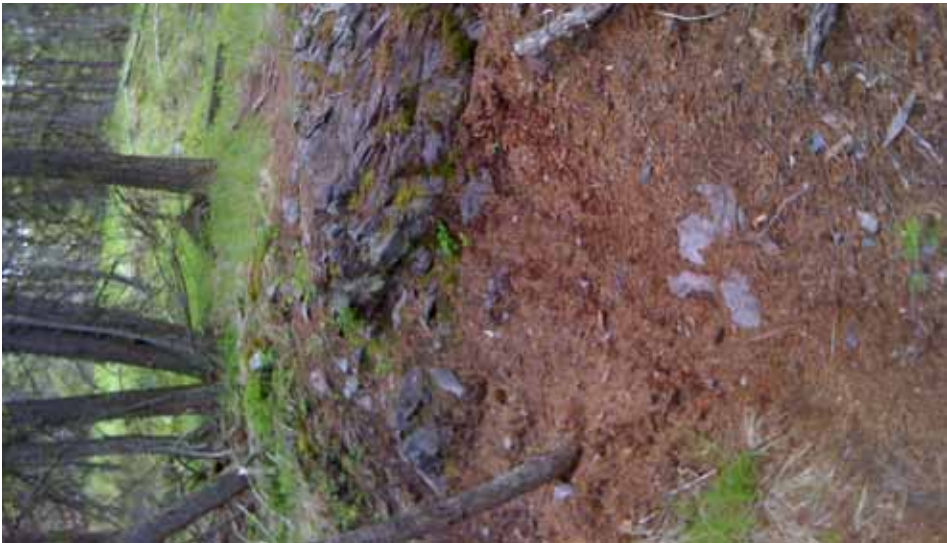
| 21 | rock roll | 2000h | improve | improve the stunt by improving the fall zones | y | 5 | y | 2 | IMG_0746.JPG | 5548175 | 662504 | 1153 |

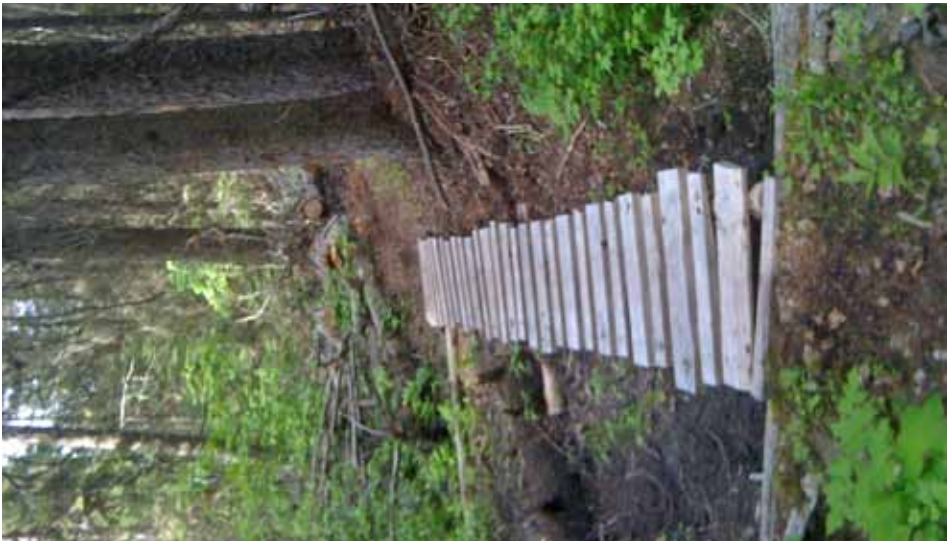
| 22 | bridge | 740w x 600l x 390h | improve | improve by replacing non galvanized nails | n | 2 | y | 2 | IMG_0755.JPG | 5548110 | 662457 | 1151 |

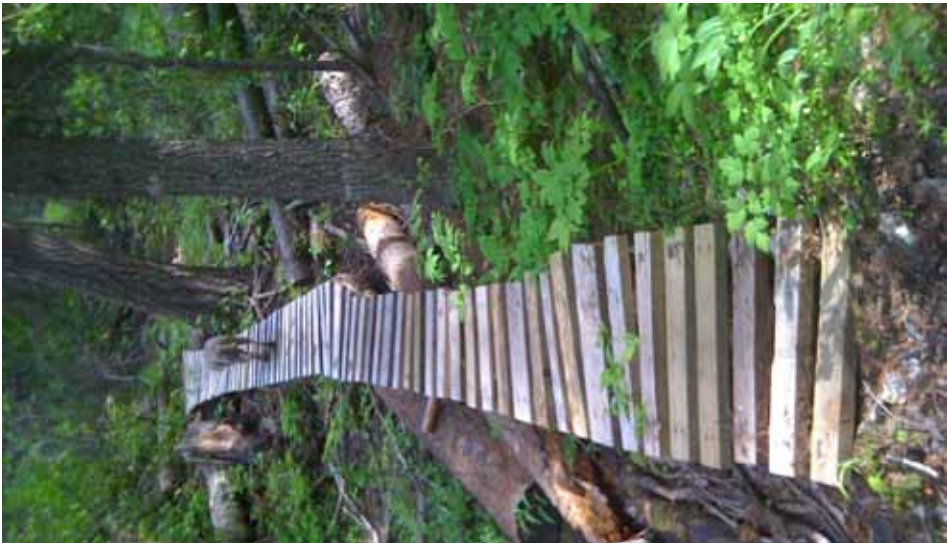
| 23 | bridge | 620w x 75000l<br>x 570h | improve | improve by replacing non galvanized nails and levelling the decking | y | 3 | y | 2 | IMG_0758.JPG | 5548094 | 662458 | 1158 |

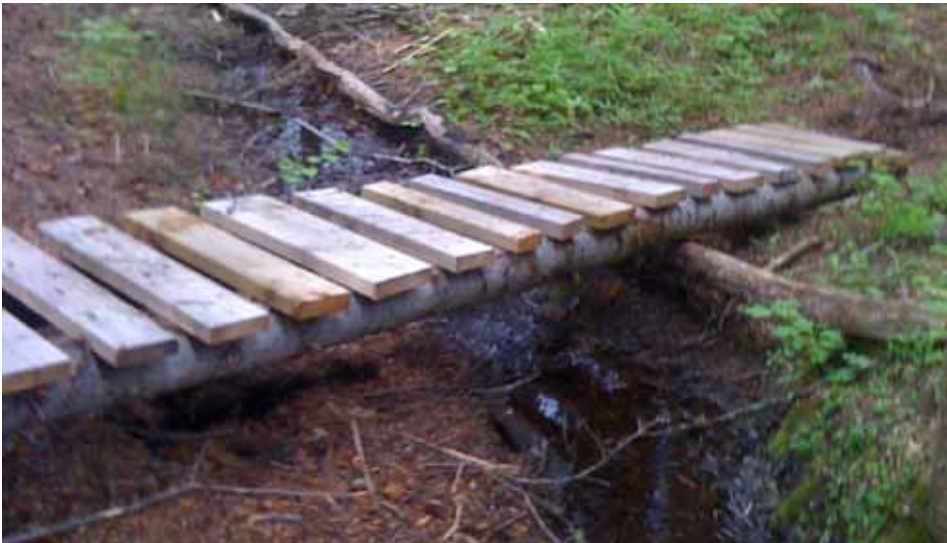
| 24 | bridge | 570w x 5360l x<br>520h | improve | improve by replacing non galvanized nails | y | 3 | y | 2 | IMG_0773.JPG | 5548070 | 662457 | 1158 |

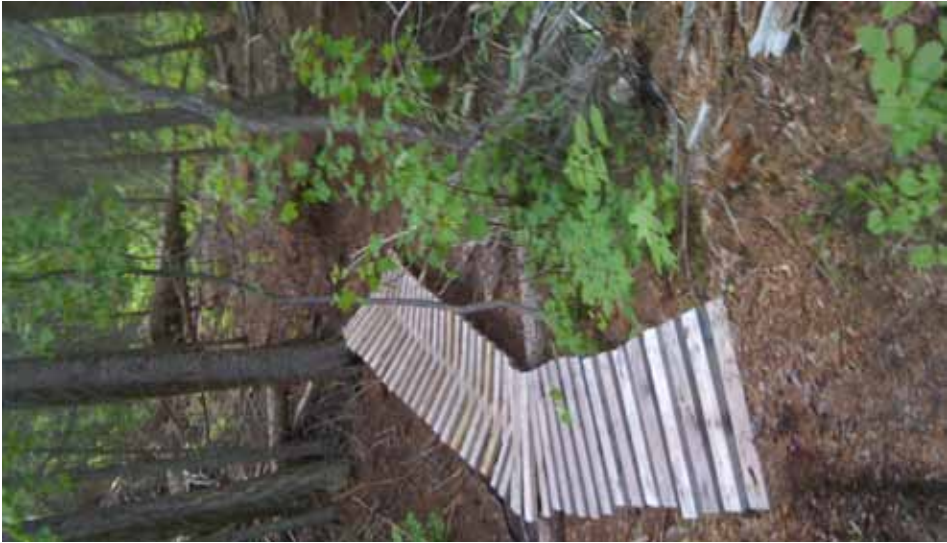
| 25 | bridge | 600w x 7030l x 350h | improve | improve by replacing non galvanized nails | y | 3 | y | 2 | IMG_0780.JPG | 5548066 | 662454 | 1160 |

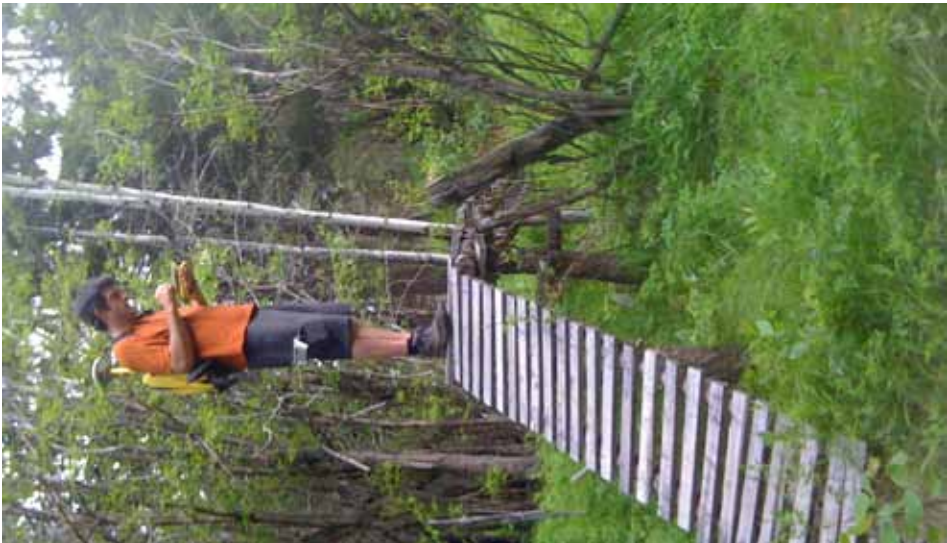
| 27 | bridge | 610w x 9850l x 1010h | improve | create ride around and build turnstyle through fence in order to improve the fall zones over barbed wire fence | y | 2 | y | 2 | IMG_0783.JPG | 5548021 | 662478 | 1172 |

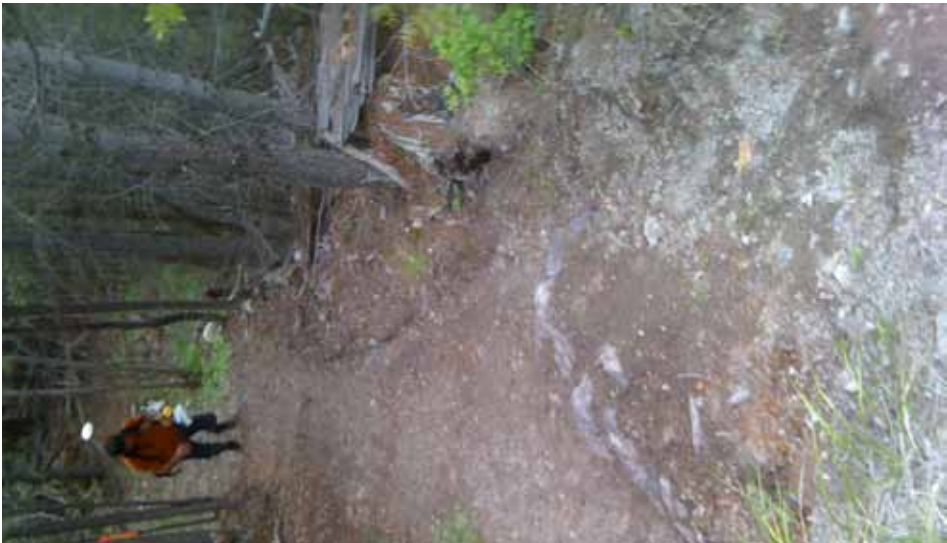
| 30 | dirt roll | 15000 x 35% | monitor | steep drop could be improved with better ride around | y | 5 | y | 2 | IMG_0803.JPG | 5547497 | 662242 | 1284 |

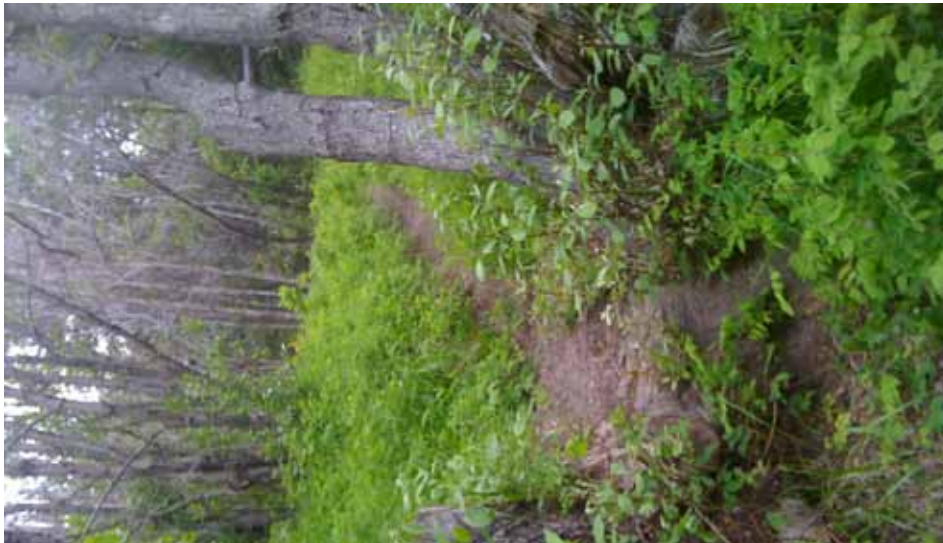
| NO. | ITEM | DIMENSION (MM) | PREScription | IMPROVEMNT | MEETS STANDARD | LIFE (YEARS) | MANDATORY | FALL_ZONE (1 - POOR, 5 - GOOD) | IMAGE | NORTHING (UTM10) | EASTING (UTM10) | HEIGHT ABOVE MSL (m) |
|---|---|---|---|---|---|---|---|---|---|---|---|---|
| 225 | log drop | 500h | monitor | good natural feature but will rot over time | y | 3 | y | 2 | IMG_0791.JPG | 5547751 | 662325 | 1218 |

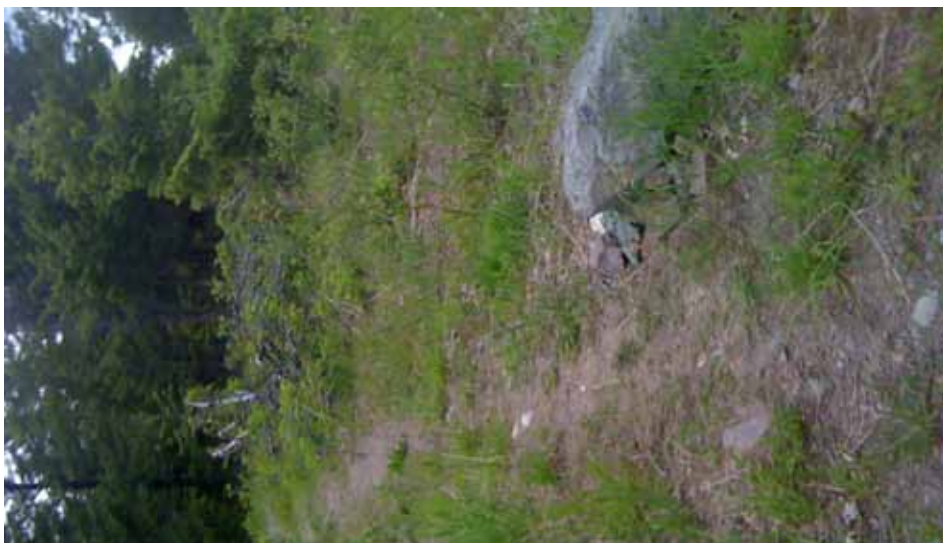
| 226 | rock roll | | monitor | good natural feature as gateway off road | y | 5 | y | 2 | IMG_0788.JPG | 5547944 | 662464 | 1177 |

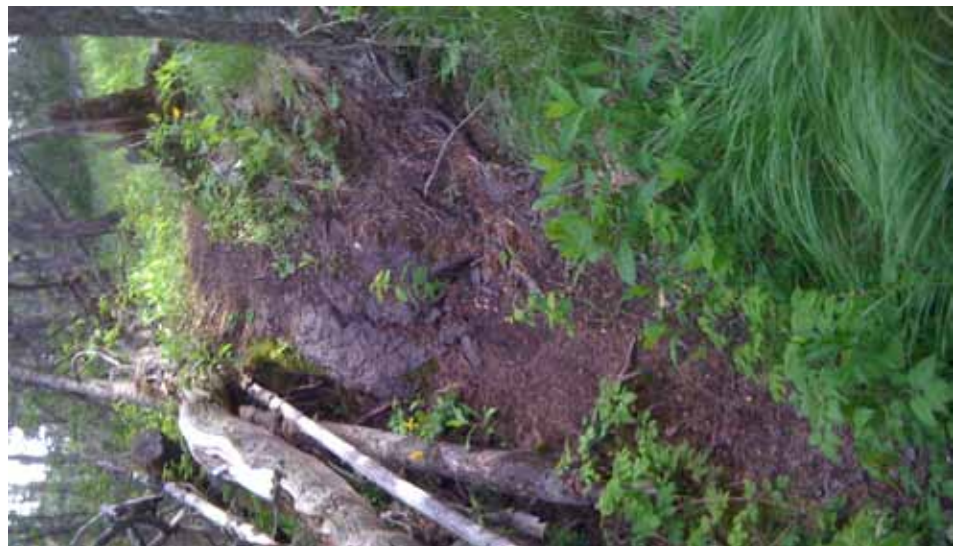
| 227 | rock roll | | monitor | good natural feature | y | 5 | y | 2 | IMG_0750.JPG | 5548206 | 662505 | 1147 |

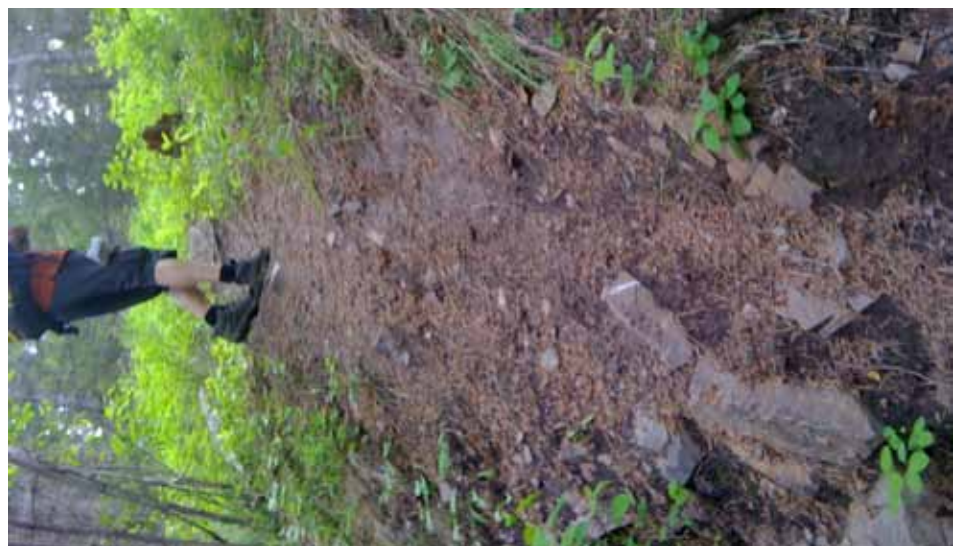
| 228 | dirt drop | | monitor | good natural feature | y | 5 | y | 2 | IMG_0733.JPG | 5548630 | 662627 | 1071 |

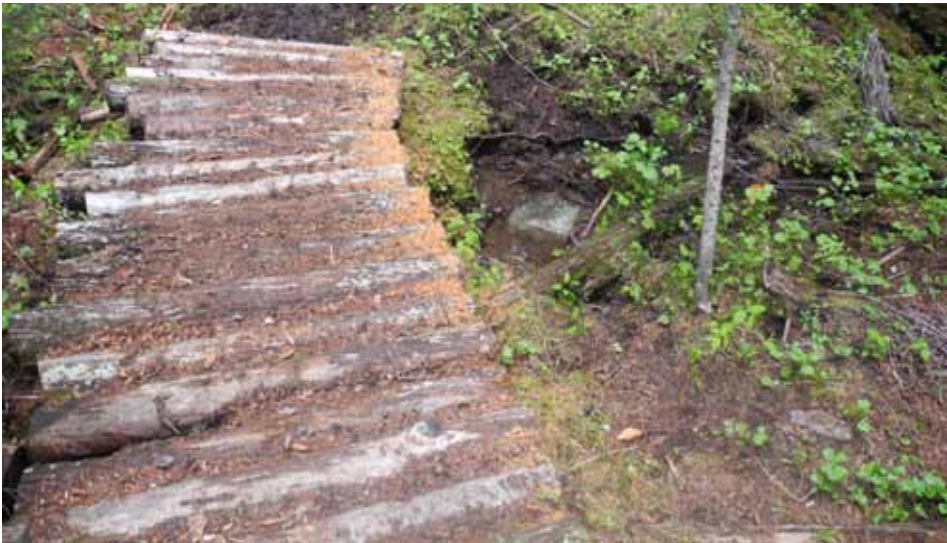
| NO. | ITEM | DIMENSION (MM) | PRESCRIPTION | IMPROVEMNT | MEETS STANDARD | LIFE (YEARS) | MANDATORY | FALL_ZONE (1 - POOR, 5 - GOOD) | IMAGE | NORTHING (UTM10) | EASTING (UTM10) | HEIGHT ABOVE MSL (m) |
|---|---|---|---|---|---|---|---|---|---|---|---|---|
| 81 | puncheon | | replace | mushy logs crossing creek, recommend replacing with bridge or removing altogether | y | 3 | y | 2 | DSCN6843.JPG | 5546929 | 660725 | 1600 |

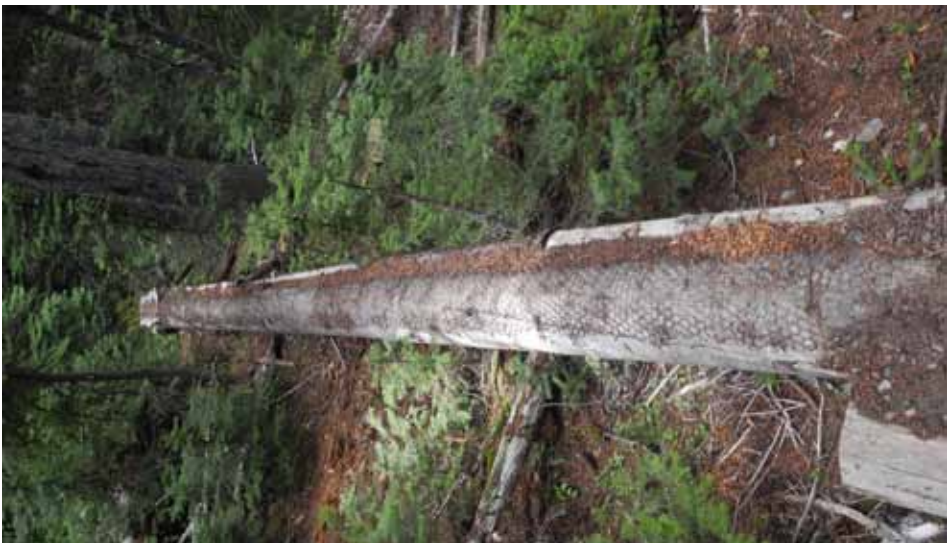
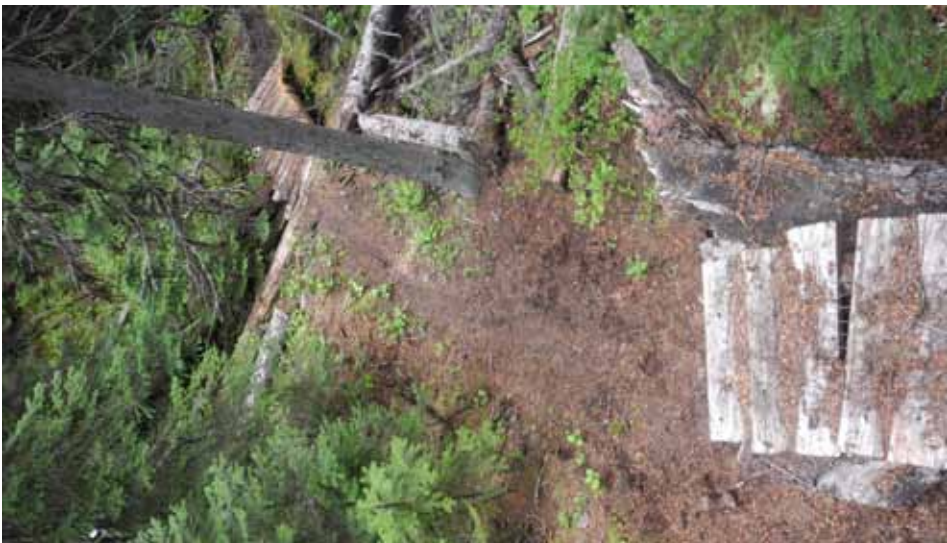
| NO. | ITEM | DIMENSION (MM) | PRESCRIPTION | IMPROVEMNT | MEETS STANDARD | LIFE (YEARS) | MANDATORY | FALL_ZONE (1 - POOR, 5 - GOOD) | IMAGE | NORTHING (UTM10) | EASTING (UTM10) | HEIGHT ABOVE MSL (m) |
|---|---|---|---|---|---|---|---|---|---|---|---|---|
| 82 | log ride | 500w x 500h x 6000l | monitor | ground level stunt, non-mandatory, but recommend creating a riding surface free of chicken-wire. | y | 5 | n | 4 | DSCN6845.JPG | 5546916 | 660733 | 1558 |

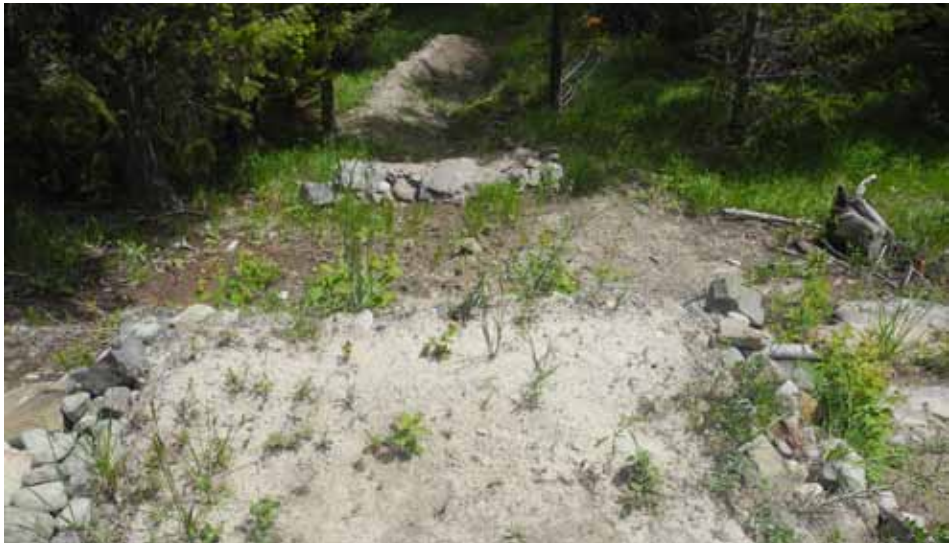
| NO. | ITEM | DIMENSION (MM) | DESCRIPTION | IMPROVEMNT | MEETS STANDARD | LIFE (YEARS) | MANDATORY | FALL_ZONE (1 - POOR, 5 - GOOD) | IMAGE | NORTHING (UTM10) | EASTING (UTM10) | HEIGHT ABOVE MSL (M) |
|---|---|---|---|---|---|---|---|---|---|---|---|---|
| 124 | gap jump | 110h x 4000gap | monitor | good sight lines, good fall zones, consequential gap jump | n | 5 | y | 2 | DSCN7131.JPG | 5547430 | 662256 | 1294 |

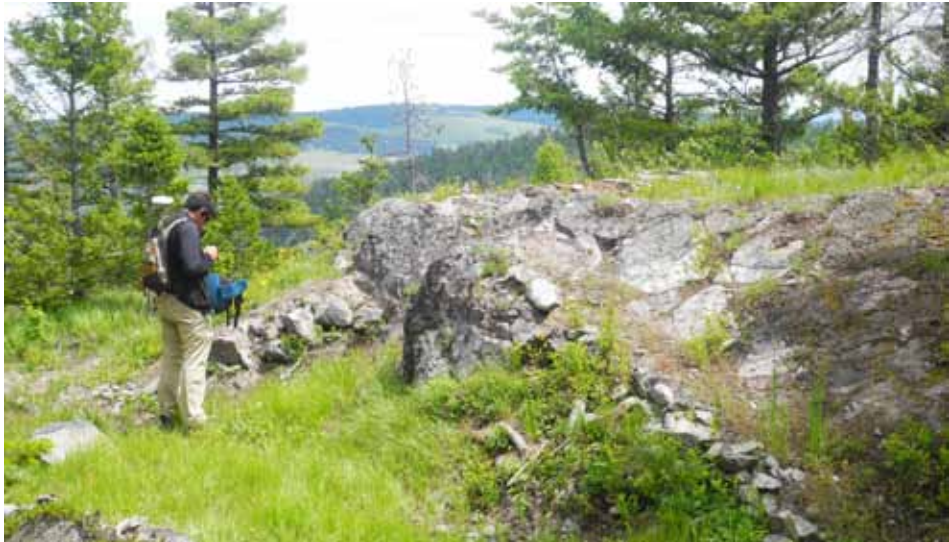
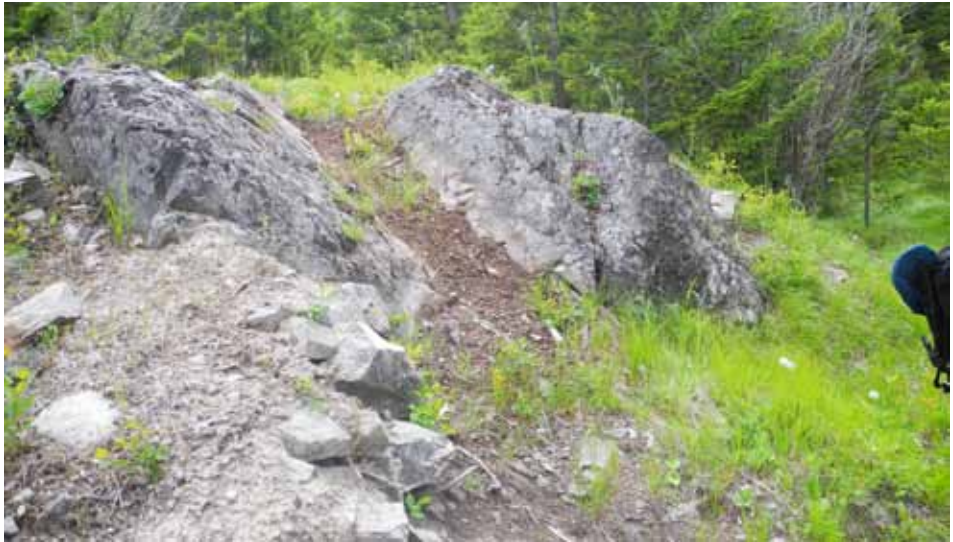
| NO. | ITEM | DIMENSION (MM) | DESCRIPTION | IMPROVEMNT | MEETS STANDARD | LIFE (YEARS) | MANDATORY | FALL_ZONE (1 - POOR, 5 - GOOD) | IMAGE | NORTHING (UTM10) | EASTING (UTM10) | HEIGHT ABOVE MSL (M) |
|---|---|---|---|---|---|---|---|---|---|---|---|---|
| 125 | gap jump | 1300h x 2300gap | monitor | good sight lines, consequential gap jump, ride around exists | n | 5 | n | 2 | DSCN7136.JPG | 5547389 | 662358 | 1275 |

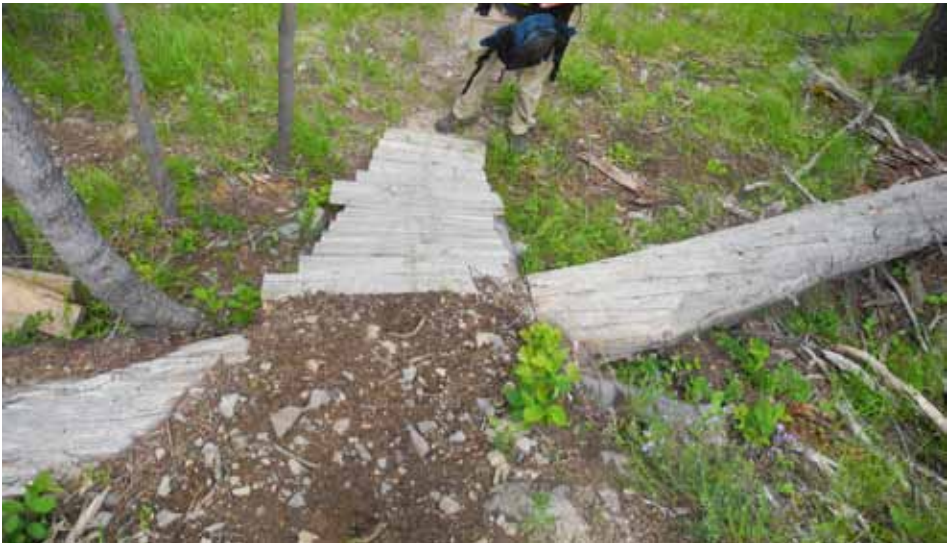
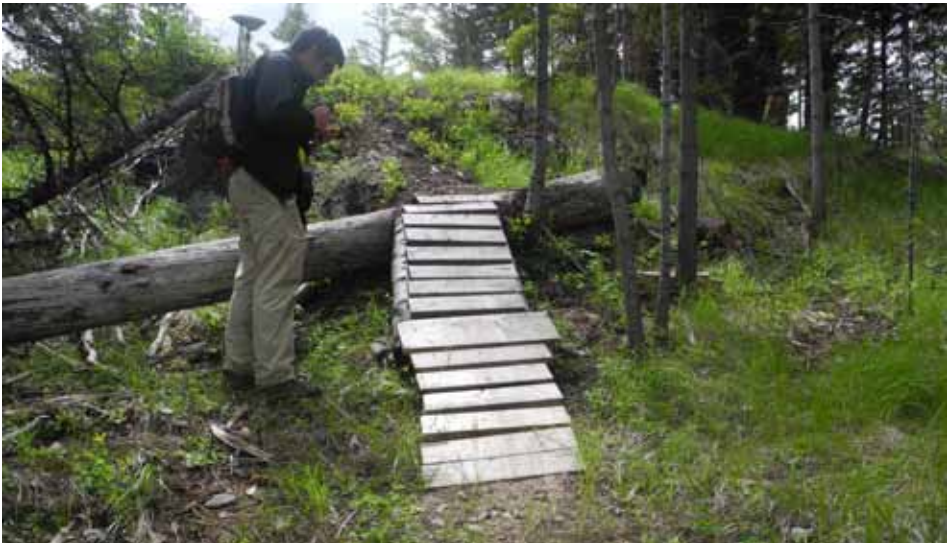
| NO. | ITEM | DIMENSION (MM) | PRESCRIPTION | IMPROVEMNT | MEETS STANDARD | LIFE (YEARS) | MANDATORY | FALL_ZONE (1 - POOR, 5 - GOOD) | IMAGE | NORTHING (UTM10) | EASTING (UTM10) | HEIGHT ABOVE MSL (m) |
|---|---|---|---|---|---|---|---|---|---|---|---|---|
| 126 | elevated bridge roll | 600w x 2300l x 900h | monitor | steep ramp but easily rolled. Minimal deflection when walked on. | y | 3 | y | 3 | DSCN7139.JPG | 5547405 | 662372 | 1269 |

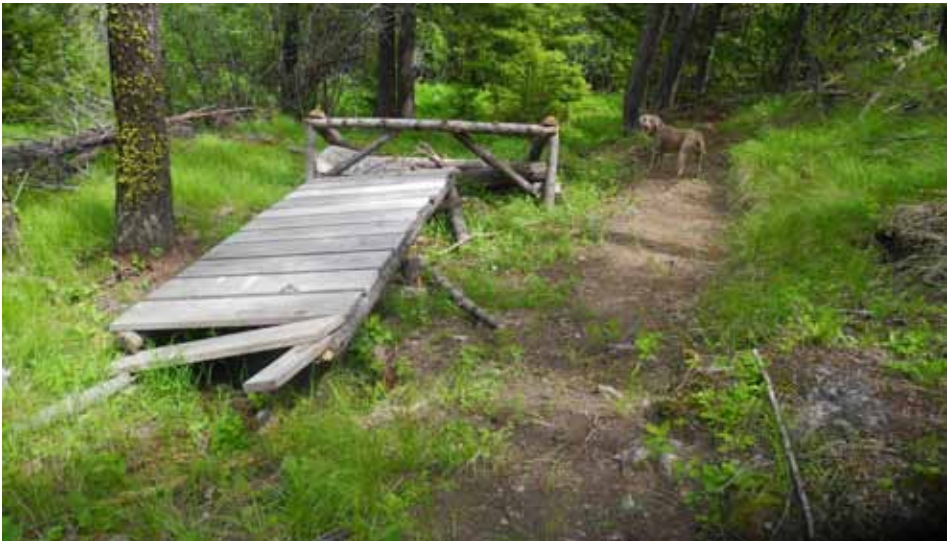
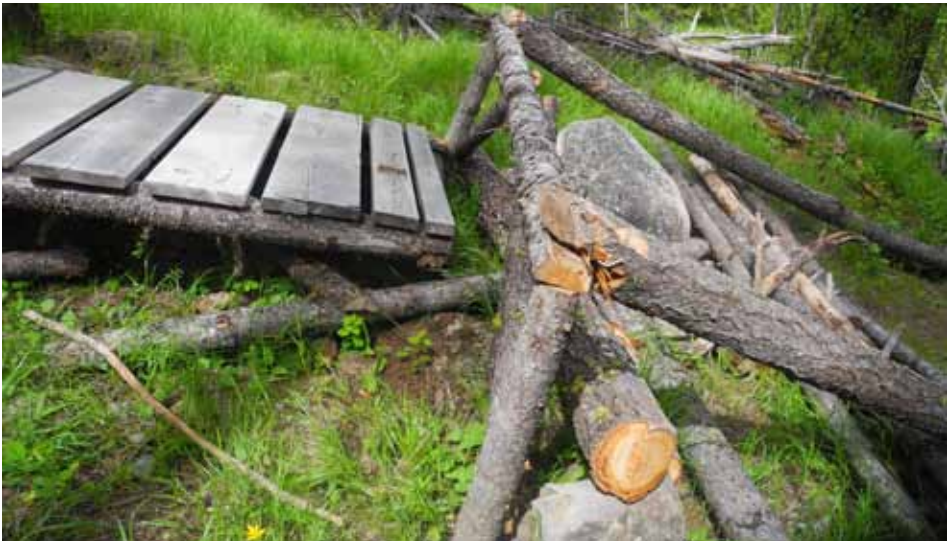
| NO. | ITEM | DIMENSION (MM) | PRESCRIPTION | IMPROVEMNT | MEETS STANDARD | LIFE (YEARS) | MANDATORY | FALL_ZONE (1 - POOR, 5 - GOOD) | IMAGE | NORTHING (UTM10) | EASTING (UTM10) | HEIGHT ABOVE MSL (m) |
|---|---|---|---|---|---|---|---|---|---|---|---|---|
| 127 | elevated bridge drop | 1340w x 900h x 3700l | monitor | re-assess the structure, height of stunt, and fall zone once construction is complete | y | 1 | n | 2 | DSCN7142.JPG | 5547407 | 662387 | 1265 |

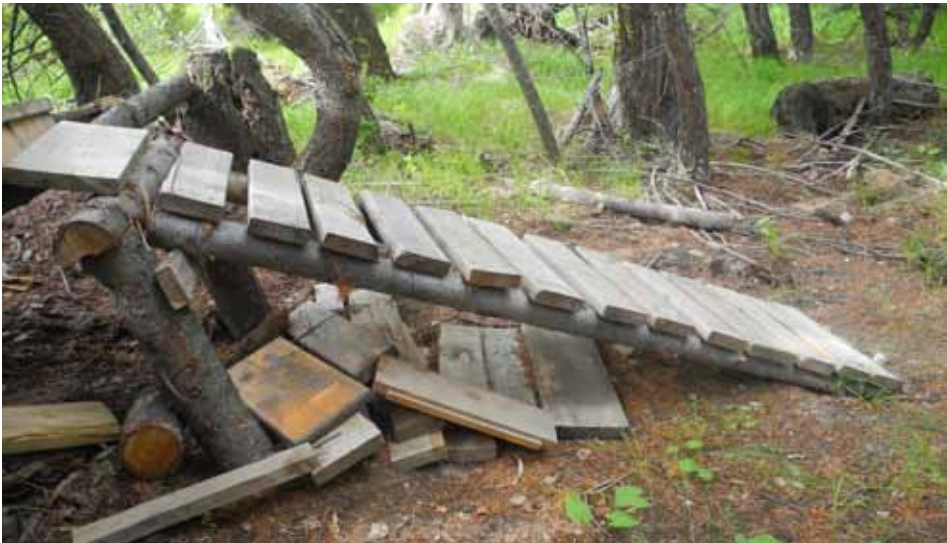
| NO. | ITEM | DIMENSION (MM) | PRESCRIPTION | IMPROVEMNT | MEETS STANDARD | LIFE (YEARS) | MANDATORY | FALL_ZONE (1 - POOR, 5 - GOOD) | IMAGE | NORTHING (UTM10) | EASTING (UTM10) | HEIGHT ABOVE MSL (M) |
|---|---|---|---|---|---|---|---|---|---|---|---|---|
| 128 | elevated bridge roll | 910w x 3800l x 900h | monitor | solid structure, minimal deflection in stringers | y | 3 | y | 3 | DSCN7151.JPG | 5547602 | 662532 | 1223 |

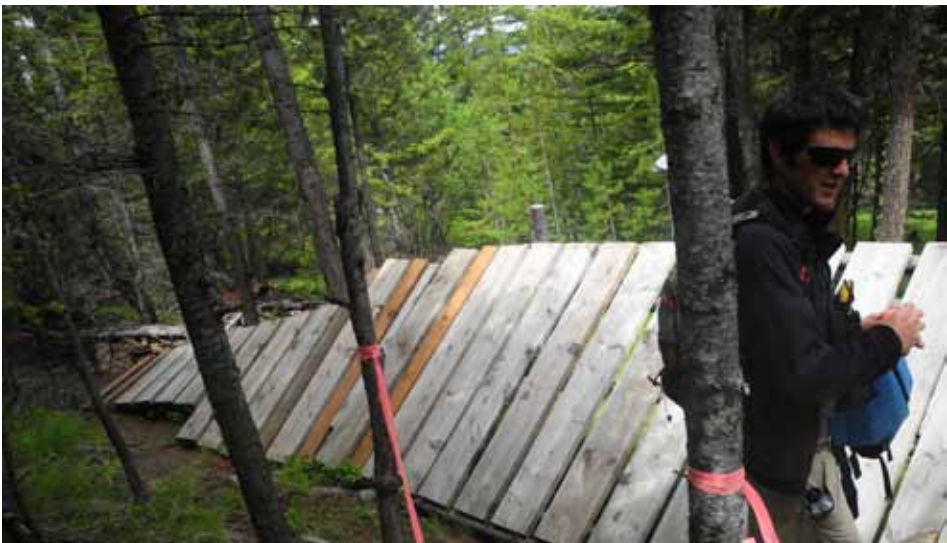
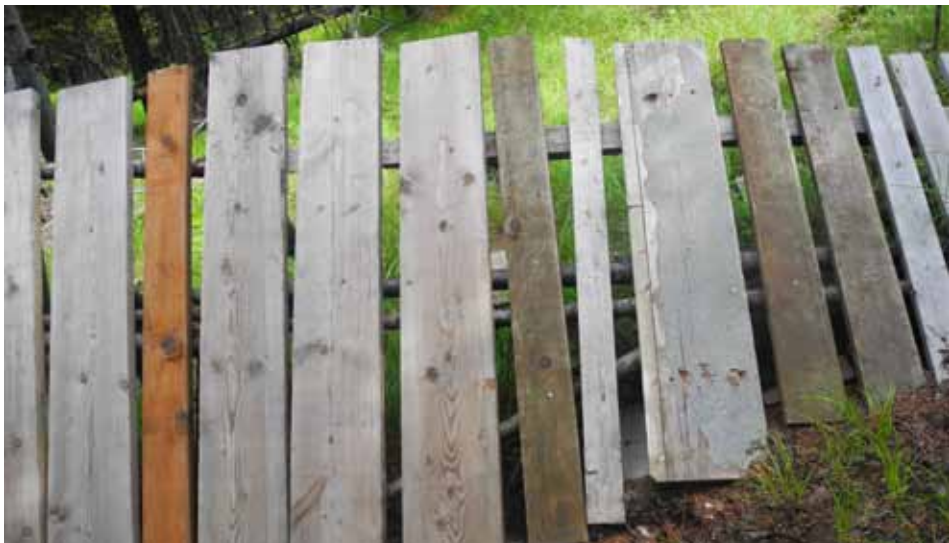
| NO. | ITEM | DIMENSION (MM) | PRESCRIPTION | IMPROVEMNT | MEETS STANDARD | LIFE (YEARS) | MANDATORY | FALL_ZONE (1 - POOR, 5 - GOOD) | IMAGE | NORTHING (UTM10) | EASTING (UTM10) | HEIGHT ABOVE MSL (M) |
|---|---|---|---|---|---|---|---|---|---|---|---|---|
| 129 | wall ride | 1780w x 1200l x 1750h | monitor | solid structure, minimal deflection, non-galvanized nails | N | 5 | y | 5 | DSCN7154.JPG | 5547612 | 662543 | 1217 |

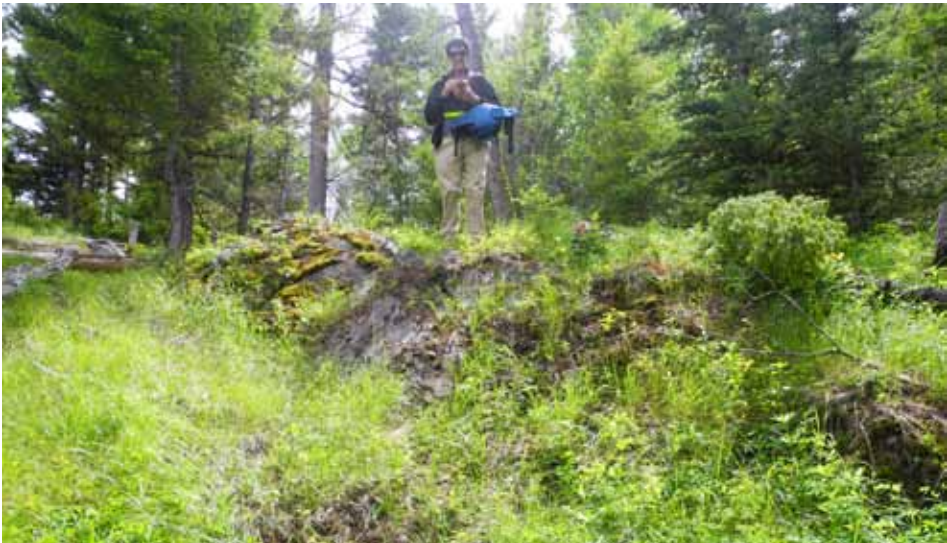
| 130 | drop | 2000h | monitor | good natural feature but need a ridearound or trail requires gateway | y | 5 | y | 3 | DSCN7157.JPG | 5547705 | 662500 | 1206 |

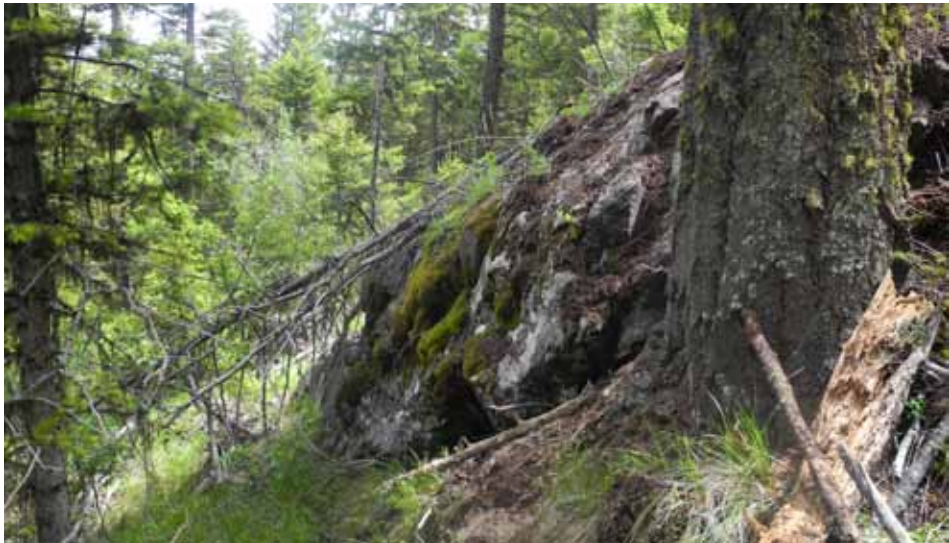
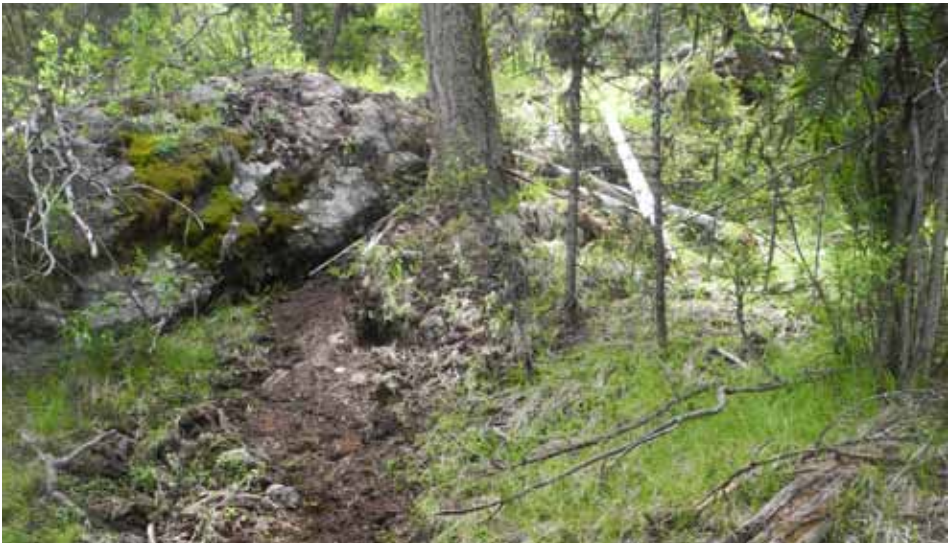
| NO. | ITEM | DIMENSION (MM) | DESCRIPTION | IMPROVEMNT | MEETS STANDARD | LIFE (YEARS) | MANDATORY | FALL_ZONE (1 - POOR, 5 - GOOD) | IMAGE | NORTHING (UTM10) | EASTING (UTM10) | HEIGHT ABOVE MSL (m) |
|---|---|---|---|---|---|---|---|---|---|---|---|---|
| 99 | rock drop | mandatory drop x 3000h | improve | good natural feature but needs ridearound and improved fall zones | n | 1 | y | 1 | DSCN7011.JPG | 5548128 | 661472 | 1283 |

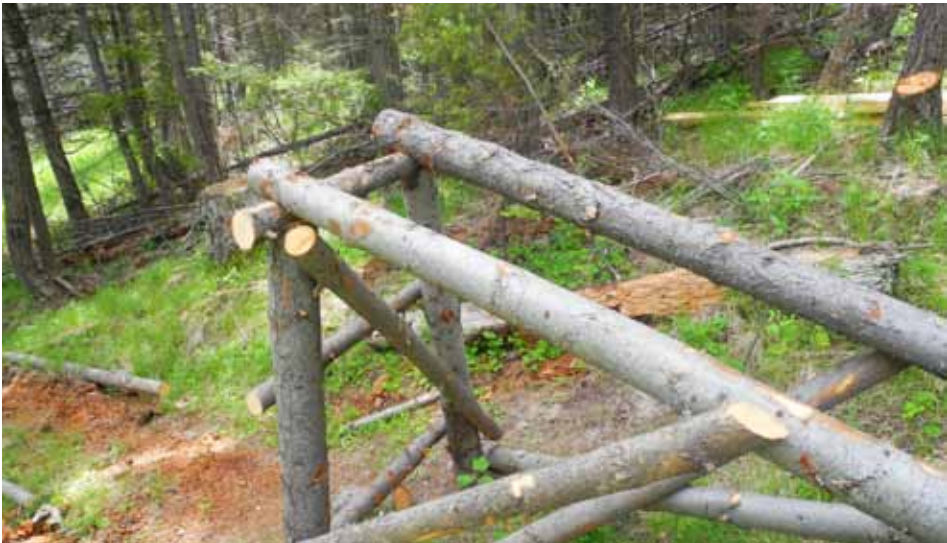
| NO. | ITEM | DIMENSION (MM) | PRESCRIPTION | IMPROVEMNT | MEETS STANDARD | LIFE (YEARS) | MANDATORY | FALL_ZONE (1 - POOR, 5 - GOOD) | IMAGE | NORTHING (UTM10) | EASTING (UTM10) | HEIGHT ABOVE MSL (M) |
|---|---|---|---|---|---|---|---|---|---|---|---|---|
| 118 | elevated bridge drop | 750w x 1680h x 3140l | monitor | re-assess the structure, height of stunt, and fall zone once construction is complete | y | 5 | n | 3 | DSCN7109.JPG | 5547811 | 662072 | 1252 |

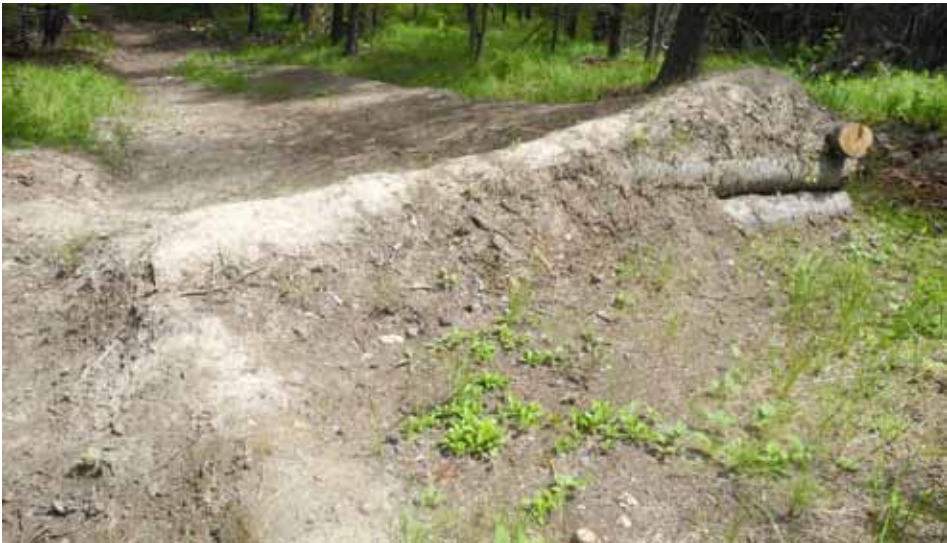
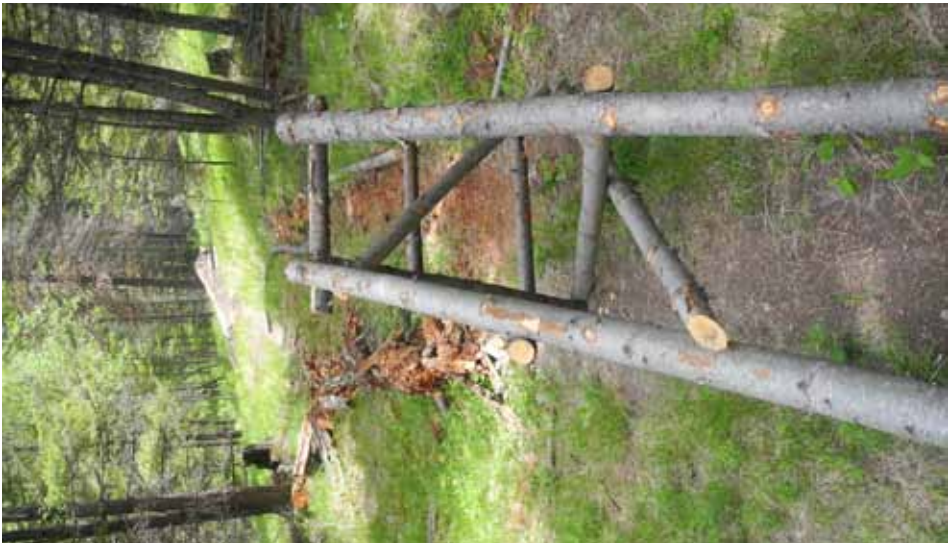
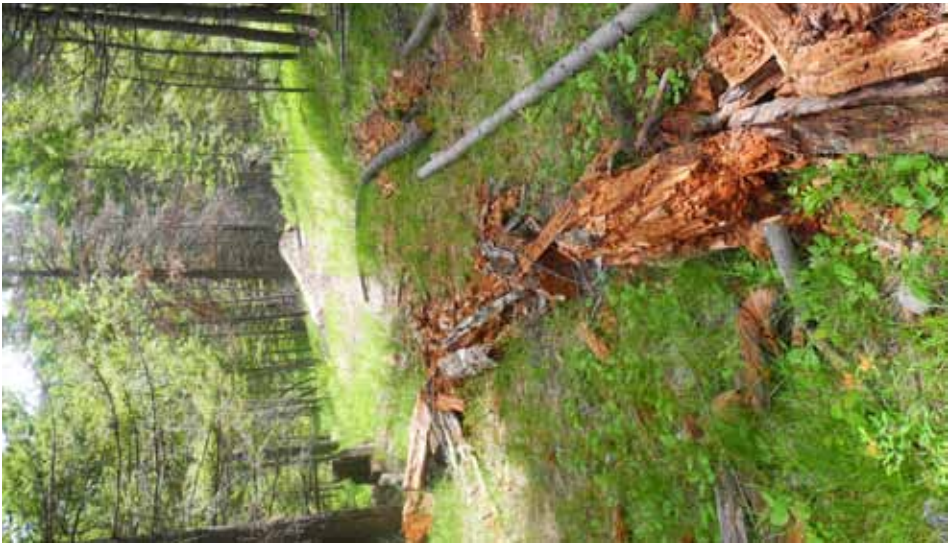
| NO. | ITEM | DIMENSION (MM) | PRESCRIPTION | IMPROVEMNT | MEETS STANDARD | LIFE (YEARS) | MANDATORY | FALL_ZONE (1 - POOR, 5 - GOOD) | IMAGE | NORTHING (UTM10) | EASTING (UTM10) | HEIGHT ABOVE MSL (M) |
|---|---|---|---|---|---|---|---|---|---|---|---|---|
| 119 | drop | Landing for previous stunt | monitor | re-assess the structure, height of stunt, and fall zone once construction is complete | y | 5 | n | 2 | DSCN7112.JPG | 5547806 | 662090 | 1258 |

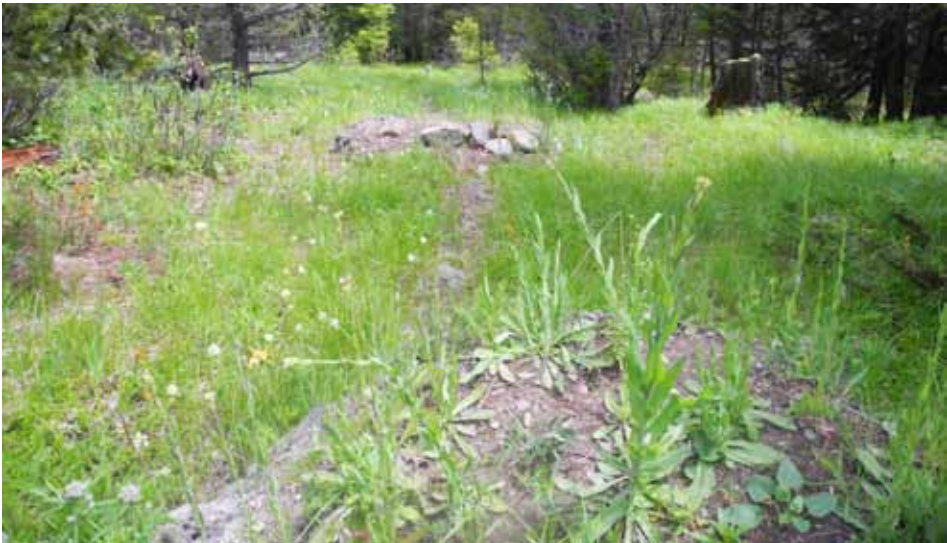
| NO. | ITEM | DIMENSION (MM) | PREScription | IMPROVEMNT | MEETS STANDARD | LIFE (YEARS) | MANDATORY | FALL_ZONE (1 - POOR, 5 - GOOD) | IMAGE | NORTHING (UTM10) | EASTING (UTM10) | HEIGHT ABOVE MSL (M) |
|---|---|---|---|---|---|---|---|---|---|---|---|---|
| 120 | gap jump | 900 lip x 3540 gap - good FZ | monitor | good fall zones, and ride-around exists | n | 5 | n | 2 | DSCN7113.JPG | 5547830 | 662130 | 1248 |
