# MOUNTAIN BIKE TRAIL & TECHNICAL TRAIL FEATURE INSPECTION

IRON MOUNTAIN, MERRITT, BC

Ministry of Ministry of Forests, Lands and  
Natural Resource Operations

Cascades District – Recreation Sites & Trails  
August 2012

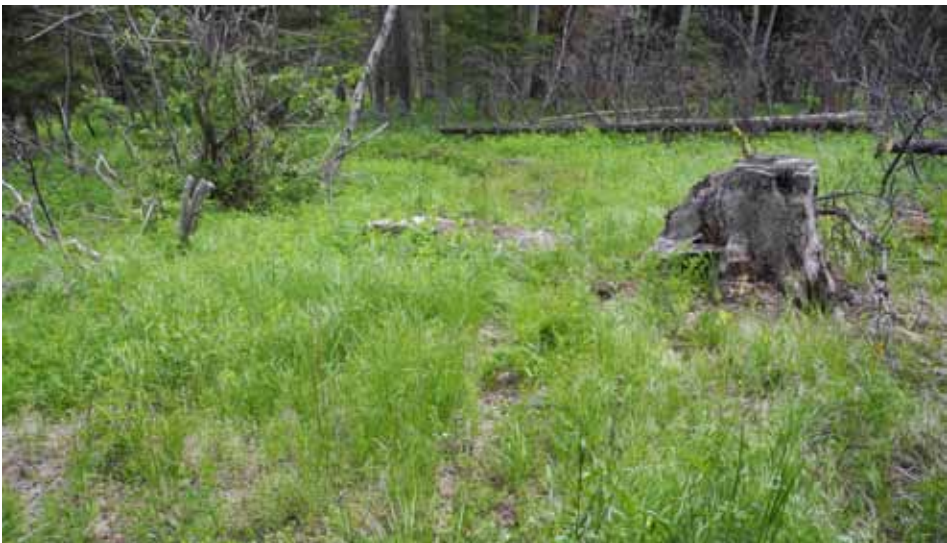
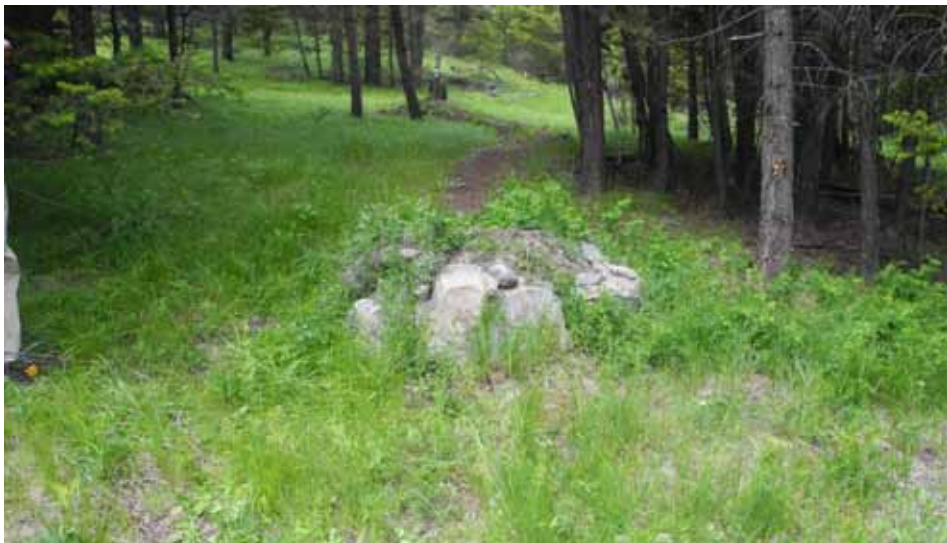
| NO. | ITEM | DIMENSION (MM) | PREScription | IMPROVEMNT | MEETS STANDARD | LIFE (YEARS) | MANDATORY | FALL_ZONE (1 - POOR, 5 - GOOD) | IMAGE | NORTHING (UTM10) | EASTING (UTM10) | HEIGHT ABOVE MSL (M) |
|---|---|---|---|---|---|---|---|---|---|---|---|---|
| 121 | gap jump | 900h x 5000 gap | improve | good falls zones and ride-around exists | n | 5 | n | 3 | DSCN7116.JPG | 5547849 | 662173 | 1237 |

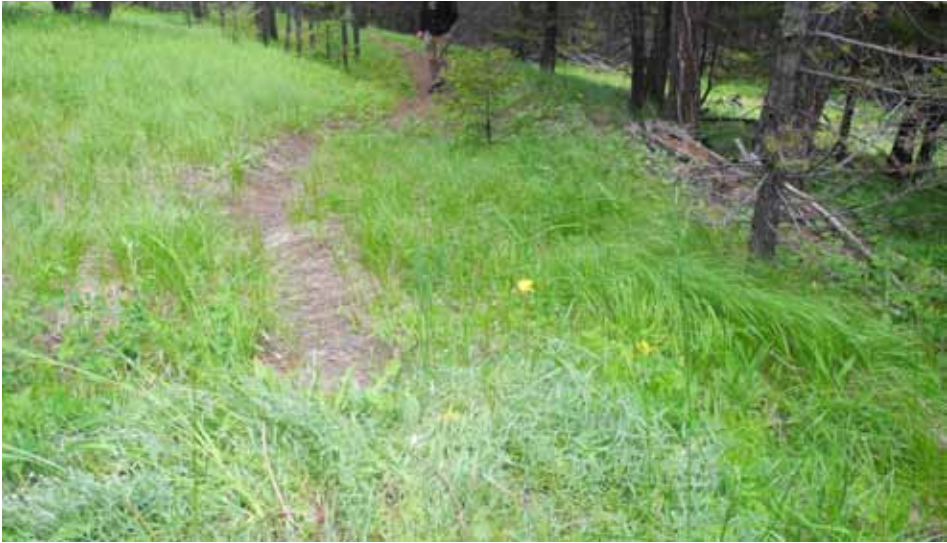
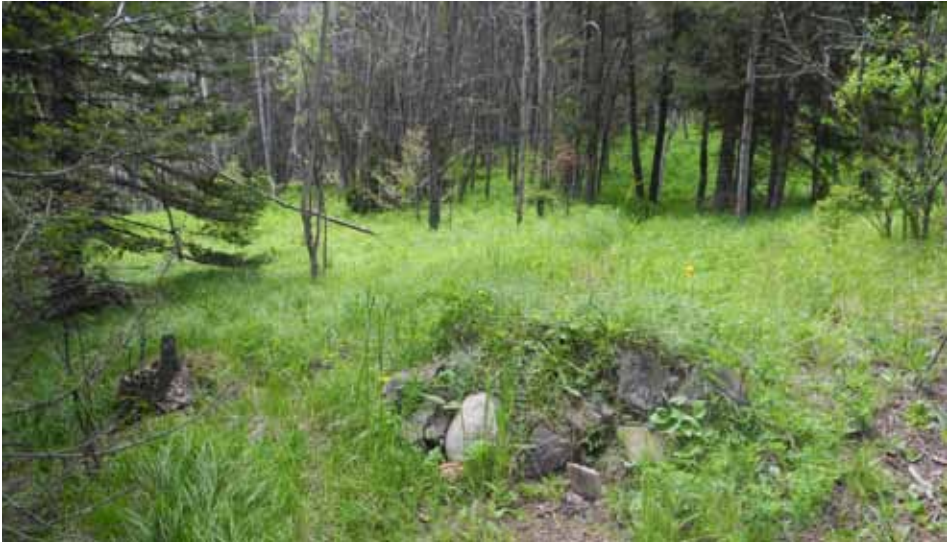
| NO. | ITEM | DIMENSION (MM) | PRESCRIPTION | IMPROVEMNT | MEETS STANDARD | LIFE (YEARS) | MANDATORY | FALL_ZONE (1 - POOR, 5 - GOOD) | IMAGE | NORTHING (UTM10) | EASTING (UTM10) | HEIGHT ABOVE MSL (m) |
|---|---|---|---|---|---|---|---|---|---|---|---|---|
| 122 | dirt jump | 600h | monitor | good fall zone and sight lines | n | 5 | n | 4 | DSCN7119.JPG | 5547866 | 662210 | 1232 |

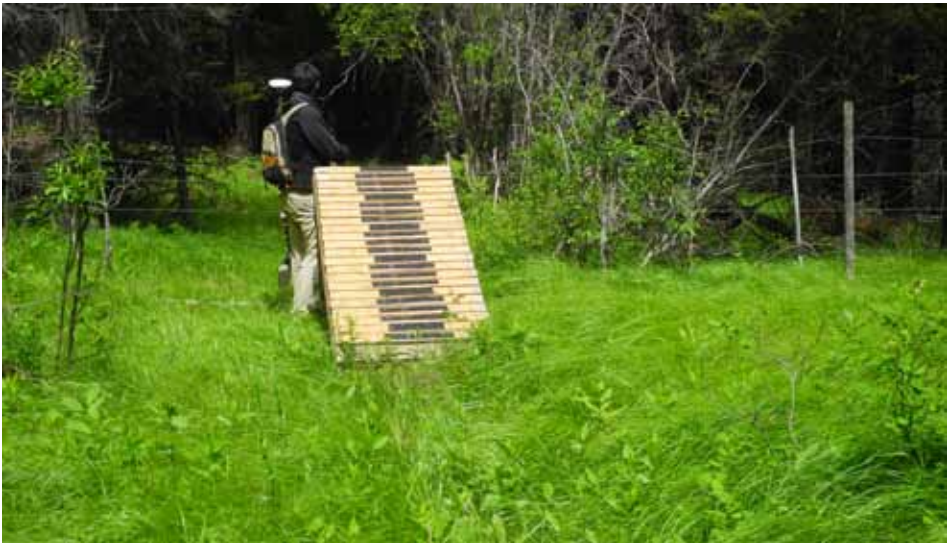
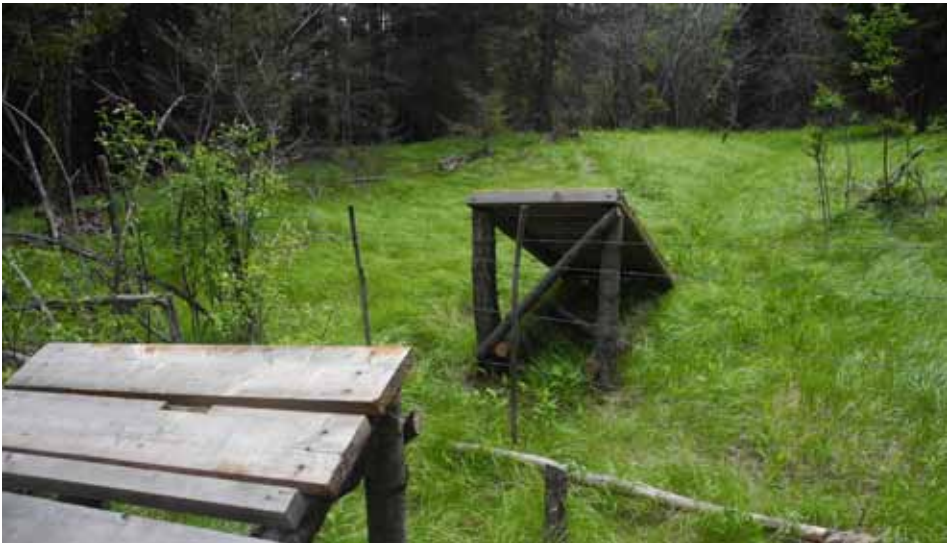
| NO. | ITEM | DIMENSION (MM) | PRESCRIPTION | IMPROVEMNT | MEETS STANDARD | LIFE (YEARS) | MANDATORY | FALL_ZONE (1 - POOR, 5 - GOOD) | IMAGE | NORTHING (UTM10) | EASTING (UTM10) | HEIGHT ABOVE MSL (m) |
|---|---|---|---|---|---|---|---|---|---|---|---|---|
| 123 | gap jump | 920w x 1000h x 2900gap | improve | gap jump to clear barb-wire fence -- no standard for consequential gap jumps, build turnstyle. | n | 5 | y | 1 | DSCN7123.JPG | 5547979 | 662240 | 1210 |

This trail is under construction but stunt #123 should be replaced with a turnstyle through the fence.

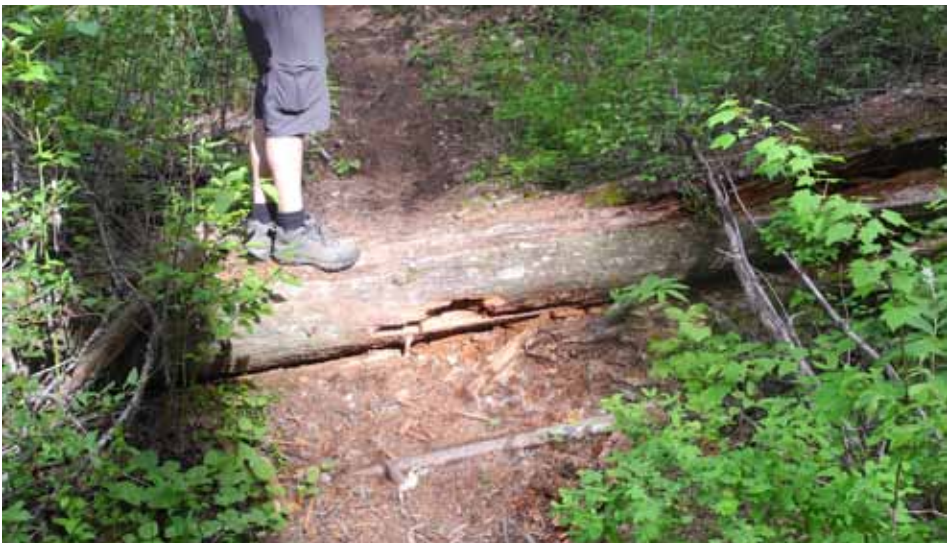
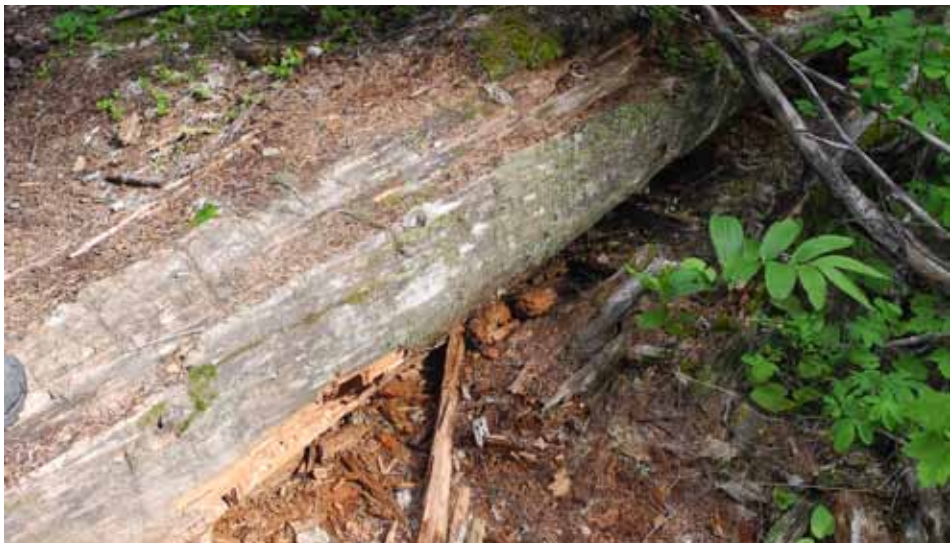
| NO. | ITEM | DIMENSION (MM) | DESCRIPTION | IMPROVEMNT | MEETS STANDARD | LIFE (YEARS) | MANDATORY | FALL_ZONE (1 - POOR, 5 - GOOD) | IMAGE | NORTHING (UTM10) | EASTING (UTM10) | HEIGHT ABOVE MSL (m) |
|---|---|---|---|---|---|---|---|---|---|---|---|---|
| 11 | log drop | 500h | improve | good natural feature but wood in contact with ground is rotting | y | 3 | y | 3 | DSCN6238.JPG | 5549150 | 662323 | 915 |

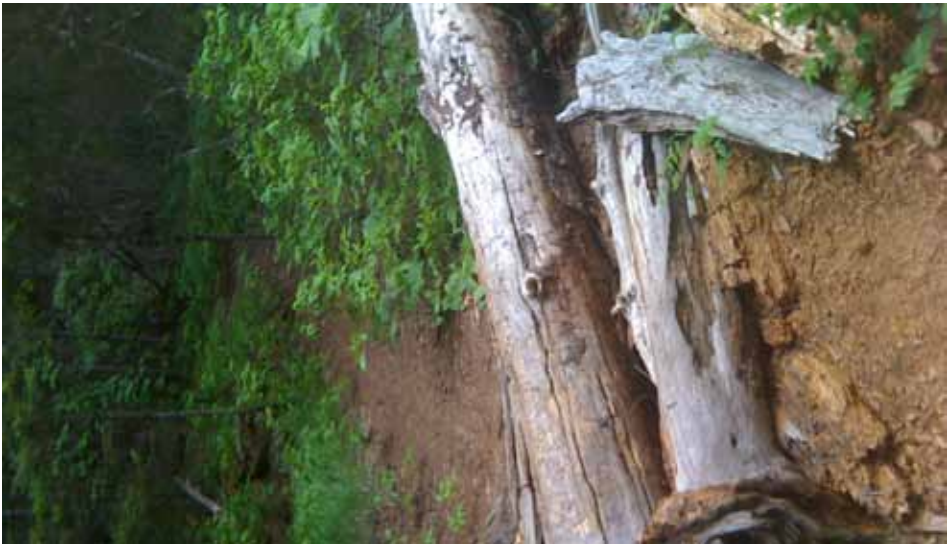
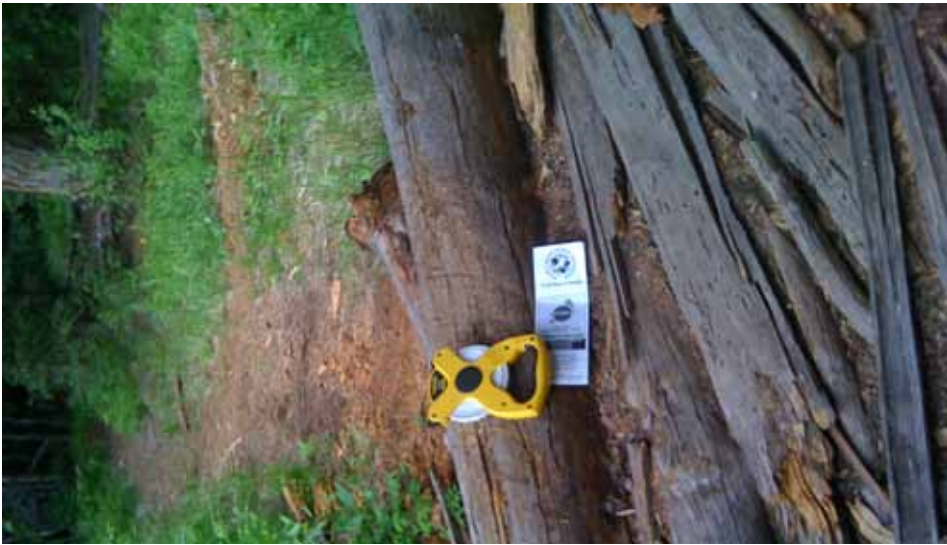
| NO. | ITEM | DIMENSION (MM) | PRESCRIPTION | IMPROVEMNT | MEETS STANDARD | LIFE (YEARS) | MANDATORY | FALL_ZONE (1 - POOR, 5 - GOOD) | IMAGE | NORTHING (UTM10) | EASTING (UTM10) | HEIGHT ABOVE MSL (m) |
|---|---|---|---|---|---|---|---|---|---|---|---|---|
| 12 | log drop | 680h | improve | good natural feature but wood in contact with ground is rotting | y | 3 | y | 3 | IMG_0706.JPG | 5549125 | 662393 | 929 |

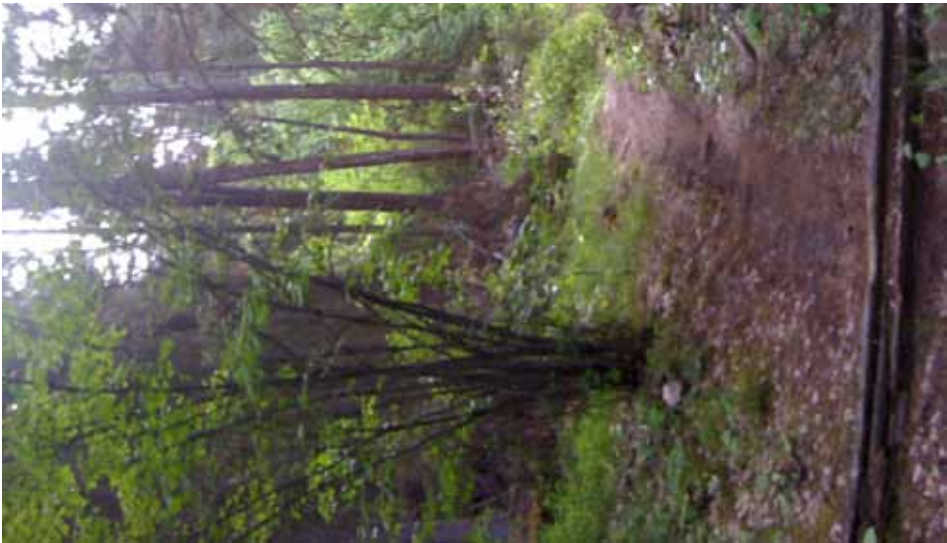
| NO. | ITEM | DIMENSION (MM) | PRESCRIPTION | IMPROVEMNT | MEETS STANDARD | LIFE (YEARS) | MANDATORY | FALL_ZONE (1 - POOR, 5 - GOOD) | IMAGE | NORTHING (UTM10) | EASTING (UTM10) | HEIGHT ABOVE MSL (m) |
|---|---|---|---|---|---|---|---|---|---|---|---|---|
| 13 | log drop | 680h | improve | good natural feature but wood in contact with ground is rotting | y | 3 | y | 3 | IMG_0718.JPG | 5549123 | 662438 | 936 |

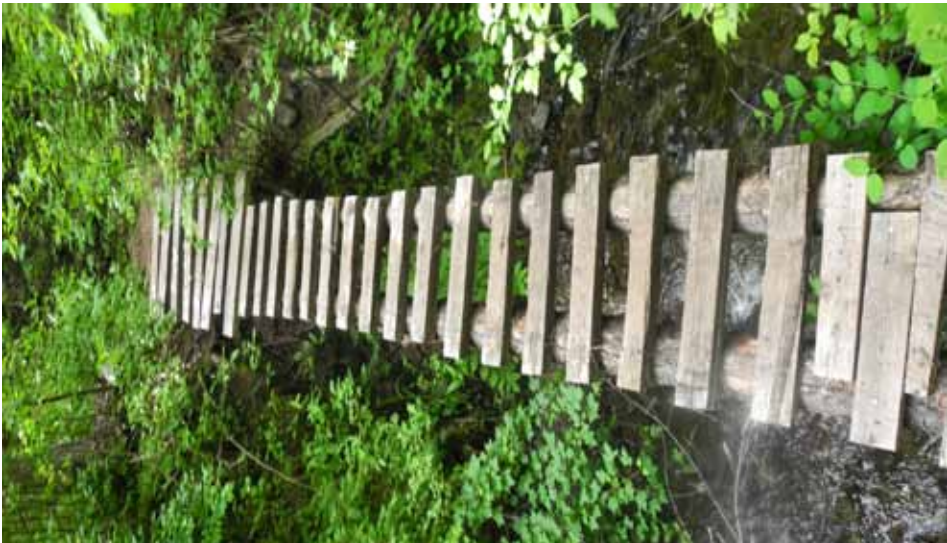
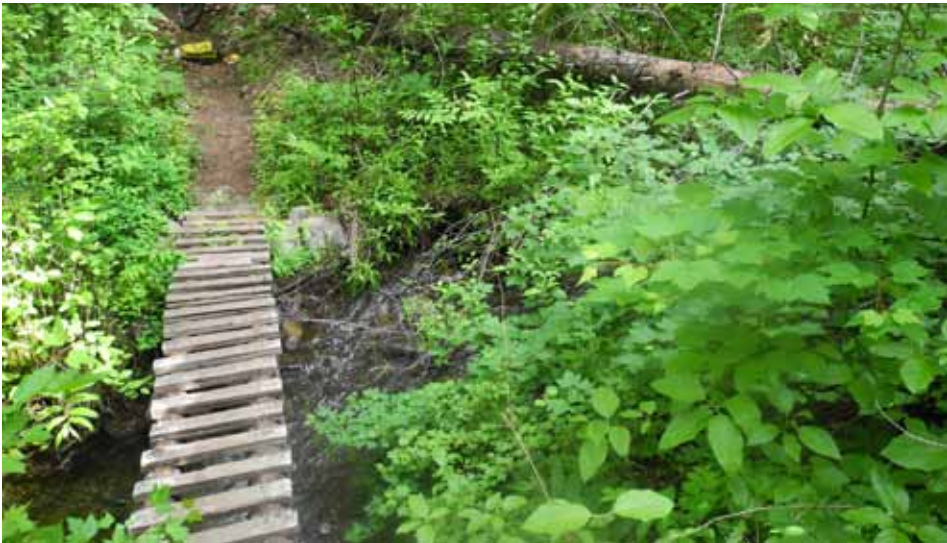
| NO. | ITEM | DIMENSION (MM) | PRESCRIPTION | IMPROVEMNT | MEETS STANDARD | LIFE (YEARS) | MANDATORY | FALL_ZONE (1 - POOR, 5 - GOOD) | IMAGE | NORTHING (UTM10) | EASTING (UTM10) | HEIGHT ABOVE MSL (m) |
|---|---|---|---|---|---|---|---|---|---|---|---|---|
| 58 | bridge | 320w x 6200l x 1100h | replace | steep ramp, widely spaced deck boards, stringers showing signs of decay and large amount of deflection | y | 2 | y | 1 | DSCN6722, 23, 24 | 5549154 | 662070 | 909 |

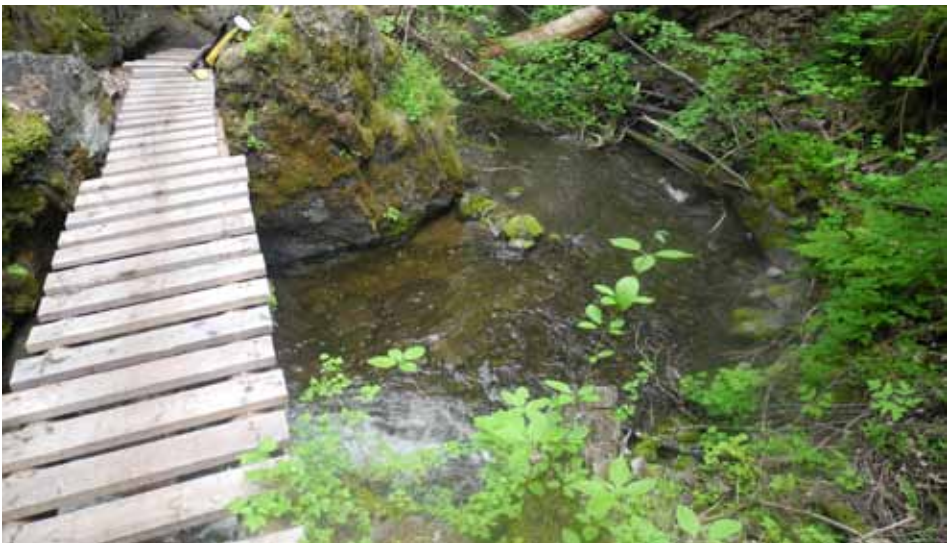
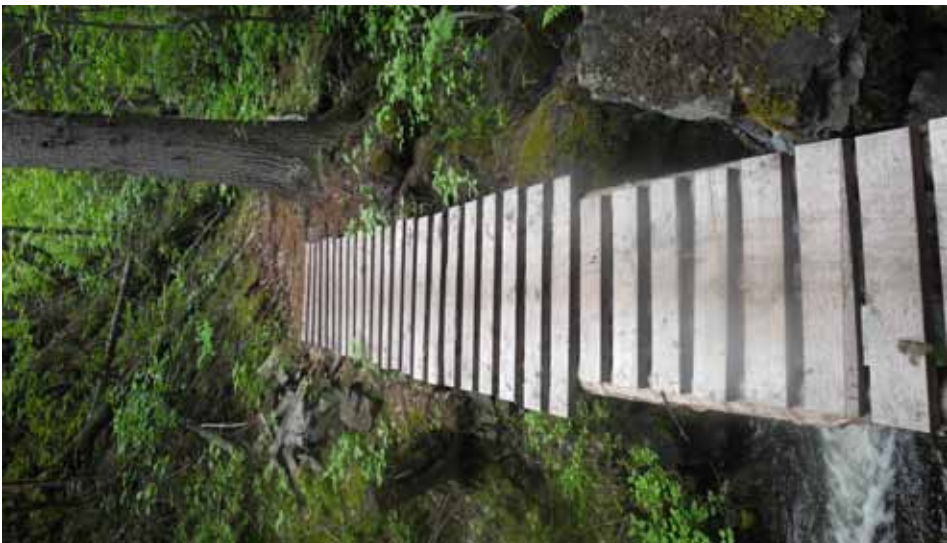
| NO. | ITEM | DIMENSION (MM) | PRESCRIPTION | IMPROVEMNT | MEETS STANDARD | LIFE (YEARS) | MANDATORY | FALL_ZONE (1 - POOR, 5 - GOOD) | IMAGE | NORTHING (UTM10) | EASTING (UTM10) | HEIGHT ABOVE MSL (m) |
|---|---|---|---|---|---|---|---|---|---|---|---|---|
| 59 | bridge | 660w x 7600l x 2000h | replace | stringers deflecting greatly, tread boards are not level, and deck boards are broken | n | 2 | y | 1 | DSCN6725, 26, 27 | 5549222 | 661982 | 896 |

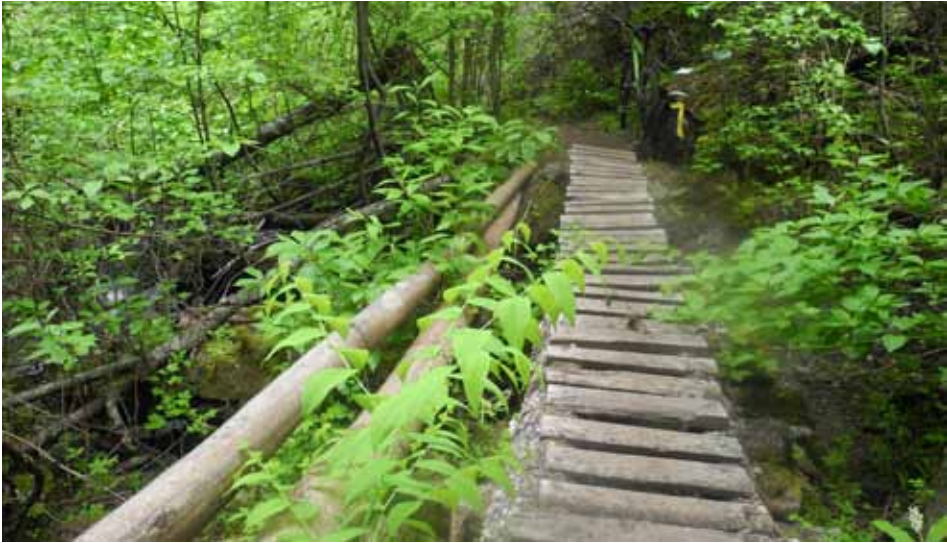
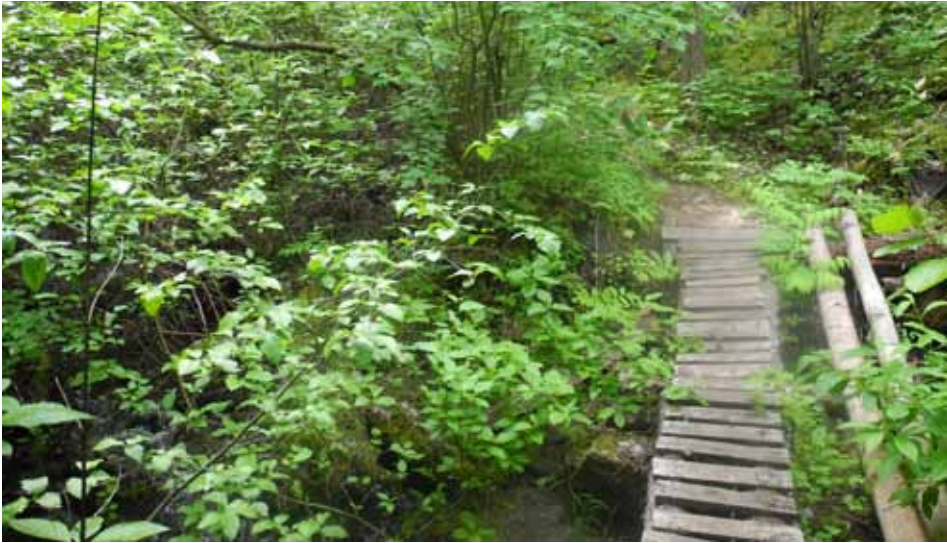
| NO. | ITEM | DIMENSION (MM) | PRESCRIPTION | IMPROVEMNT | MEETS STANDARD | LIFE (YEARS) | MANDATORY | FALL_ZONE (1 - POOR, 5 - GOOD) | IMAGE | NORTHING (UTM10) | EASTING (UTM10) | HEIGHT ABOVE MSL (m) |
|---|---|---|---|---|---|---|---|---|---|---|---|---|
| 60 | bridge | 500w x 5800l x 1000h | improve | Okay condition, although bridge is sloping from bank to bank, minimal deflection in stringers | y | 2 | y | 1 | DSCN6728, 29, 30, 31 | 5549236 | 661956 | 890 |

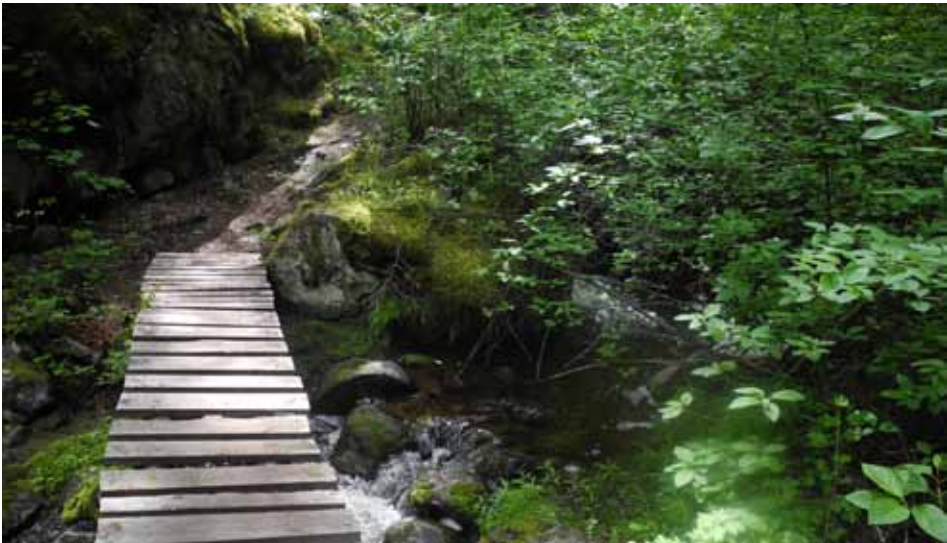
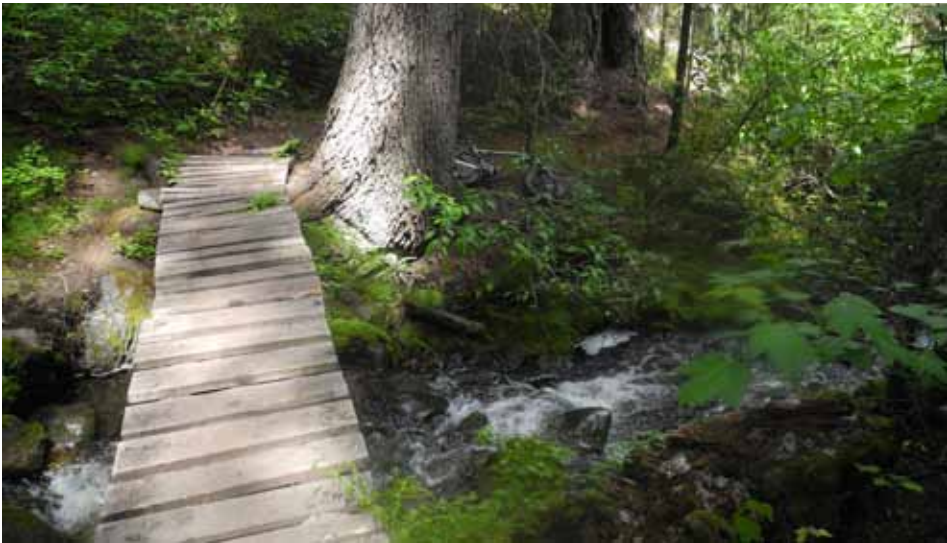
| NO. | ITEM | DIMENSION (MM) | PRESCRIPTION | IMPROVEMNT | MEETS STANDARD | LIFE (YEARS) | MANDATORY | FALL_ZONE (1 - POOR, 5 - GOOD) | IMAGE | NORTHING (UTM10) | EASTING (UTM10) | HEIGHT ABOVE MSL (m) |
|---|---|---|---|---|---|---|---|---|---|---|---|---|
| 61 | bridge | 800w x 6500l x 800h | improve | non-galvanized nails, minimal deflection in stringers, good fall zones | y | 5 | y | 3 | DSCN6732, 33, 34, 35 | 5549278 | 661910 | 881 |

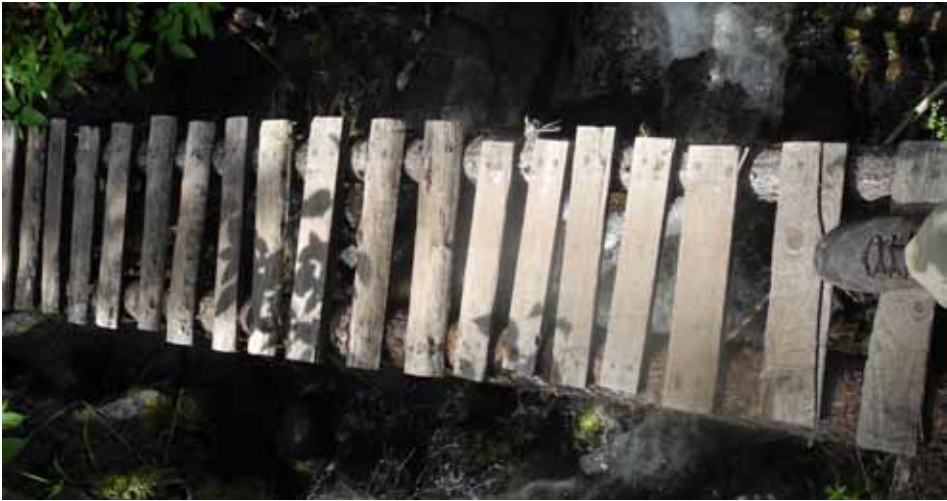
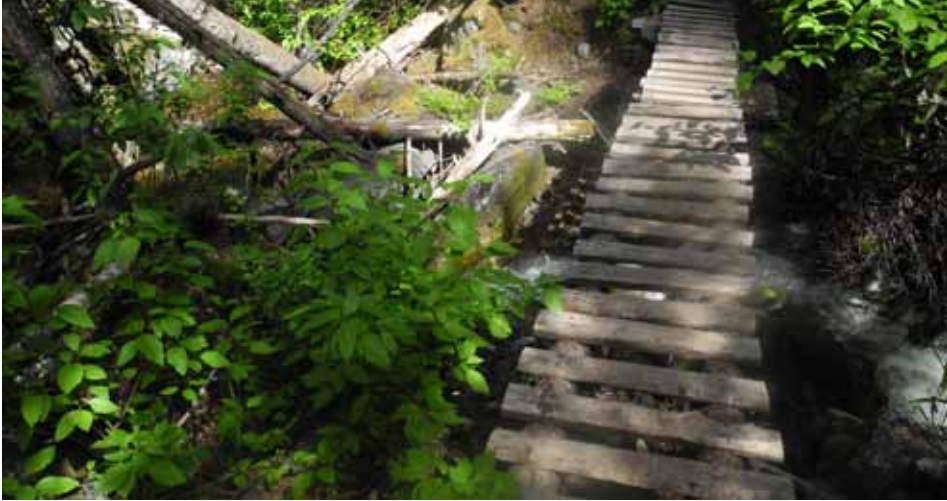
| NO. | ITEM | DIMENSION (MM) | PRESCRIPTION | IMPROVEMNT | MEETS STANDARD | LIFE (YEARS) | MANDATORY | FALL_ZONE (1 - POOR, 5 - GOOD) | IMAGE | NORTHING (UTM10) | EASTING (UTM10) | HEIGHT ABOVE MSL (m) |
|---|---|---|---|---|---|---|---|---|---|---|---|---|
| 62 | bridge | 460w x 5000l x 1000h | replace | drop to enter feature makes this stunt difficult to negotiate. Improve the fall zone, increase the size of the stringers and level the bridge from bank to bank., consequential fall zone, small stringers, sloping tread | n | 2 | y | 1 | DSCN6736 - 38 | 5549298 | 661905 | 882 |

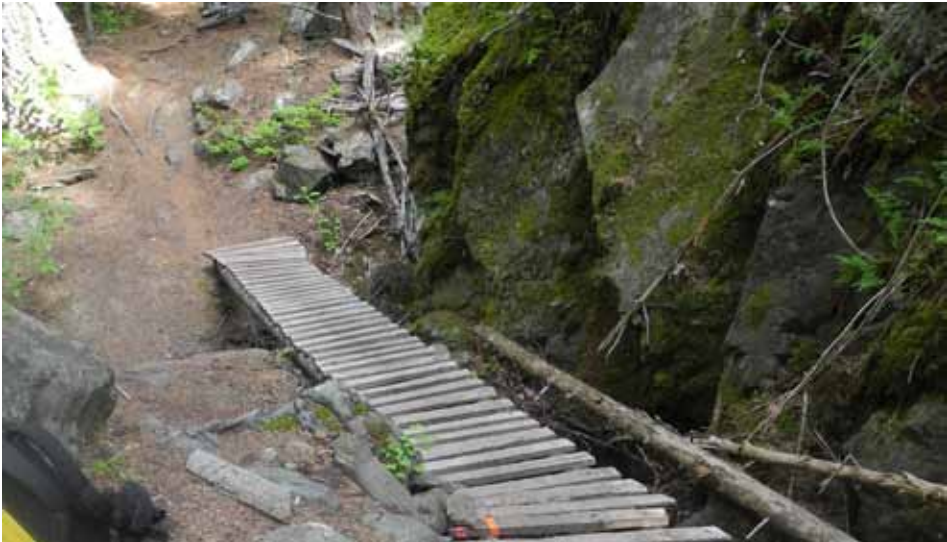
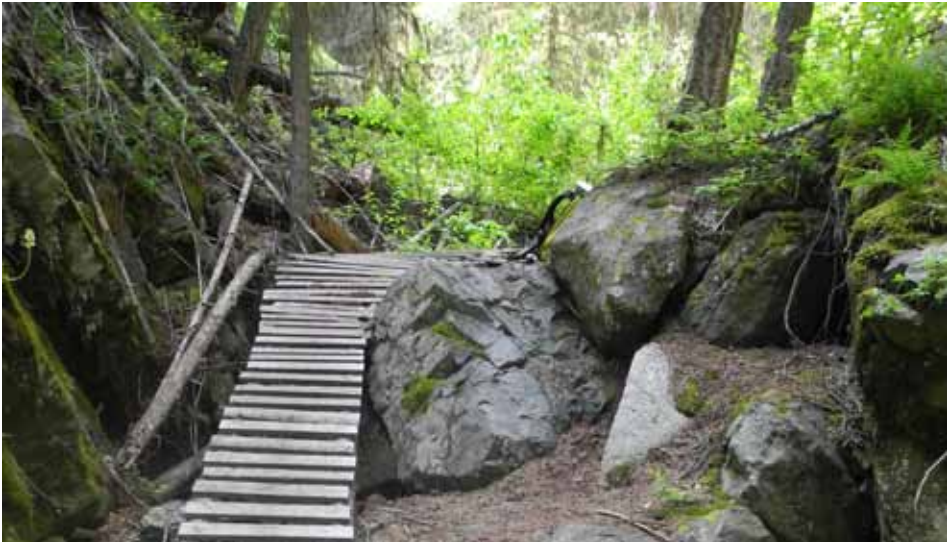
| NO. | ITEM | DIMENSION (MM) | PRESCRIPTION | IMPROVEMNT | MEETS STANDARD | LIFE (YEARS) | MANDATORY | FALL_ZONE (1 - POOR, 5 - GOOD) | IMAGE | NORTHING (UTM10) | EASTING (UTM10) | HEIGHT ABOVE MSL (m) |
|---|---|---|---|---|---|---|---|---|---|---|---|---|
| 63 | elevated bridge roll | 500w x 8600l x 800h | improve | Increase diameter of stringer, replace 1"x4" decking with 2" or greater, and replace non-galvanized nails, | y | 2 | y | 1 | DSCN6739-41 | 5549307 | 661904 | 879 |

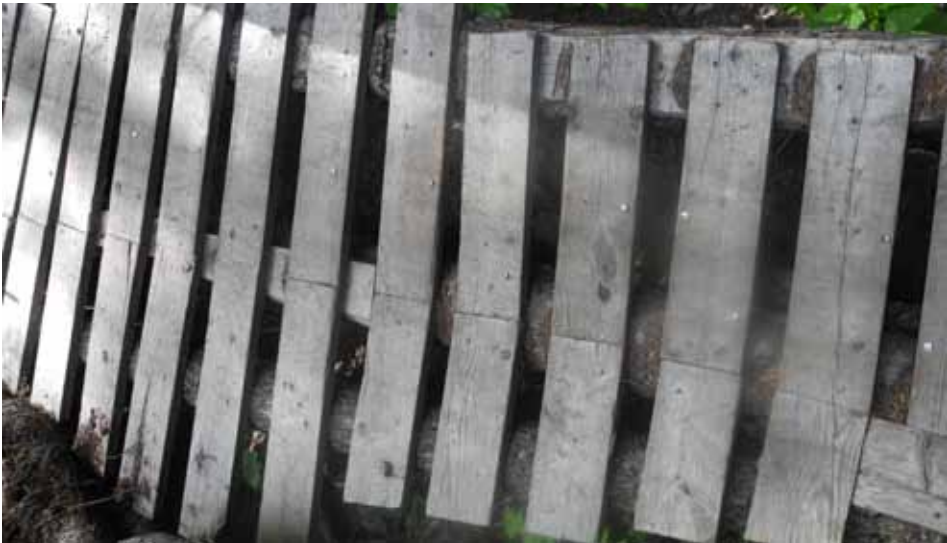
| NO. | ITEM | DIMENSION (MM) | PRESCRIPTION | IMPROVEMNT | MEETS STANDARD | LIFE (YEARS) | MANDATORY | FALL_ZONE (1 - POOR, 5 - GOOD) | IMAGE | NORTHING (UTM10) | EASTING (UTM10) | HEIGHT ABOVE MSL (m) |
|---|---|---|---|---|---|---|---|---|---|---|---|---|
| 64 | elevated bridge roll | 600w x 5000l x 600h | improve | Improve fall zones, increase the size of the stringers and replace the loose decking | y | 2 | y | 1 | DSCN6742-45 | 5549340 | 661879 | 869 |

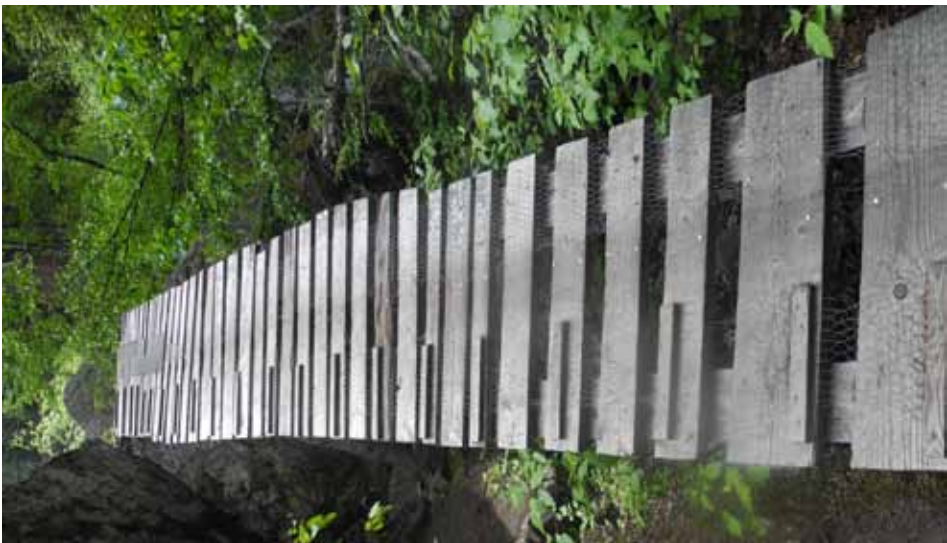
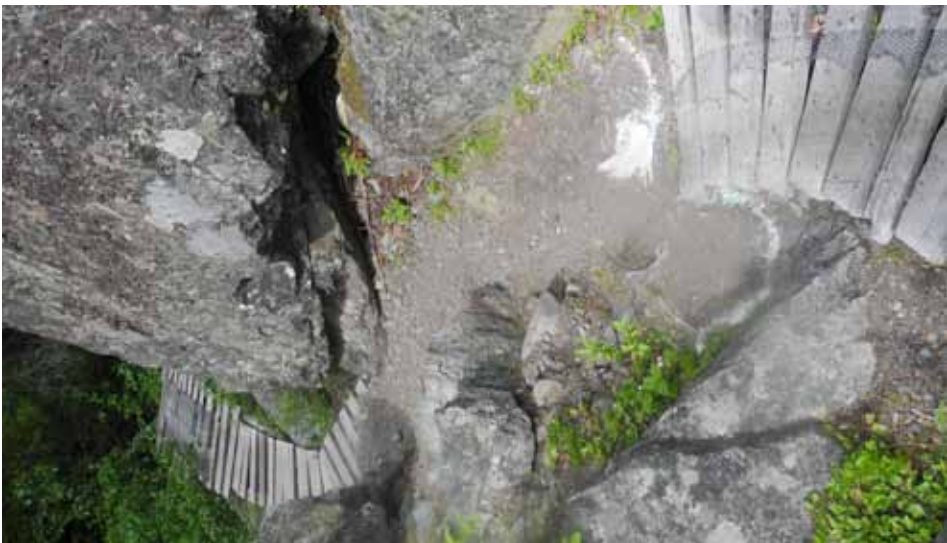
| NO. | ITEM | DIMENSION (MM) | PRESCRIPTION | IMPROVEMNT | MEETS STANDARD | LIFE (YEARS) | MANDATORY | FALL_ZONE (1 - POOR, 5 - GOOD) | IMAGE | NORTHING (UTM10) | EASTING (UTM10) | HEIGHT ABOVE MSL (m) |
|---|---|---|---|---|---|---|---|---|---|---|---|---|
| 65 | elevated bridge roll | 920w x 12000l x 2000h | replace | stringers deflect under foot traffic, shingles and chicken wire on decking should be replaced with a "cleated" boardwalk, and stringers are broken at base of stunt | y | 2 | y | 1 | DSCN6752.JPG | 5549374 | 661832 | 862 |

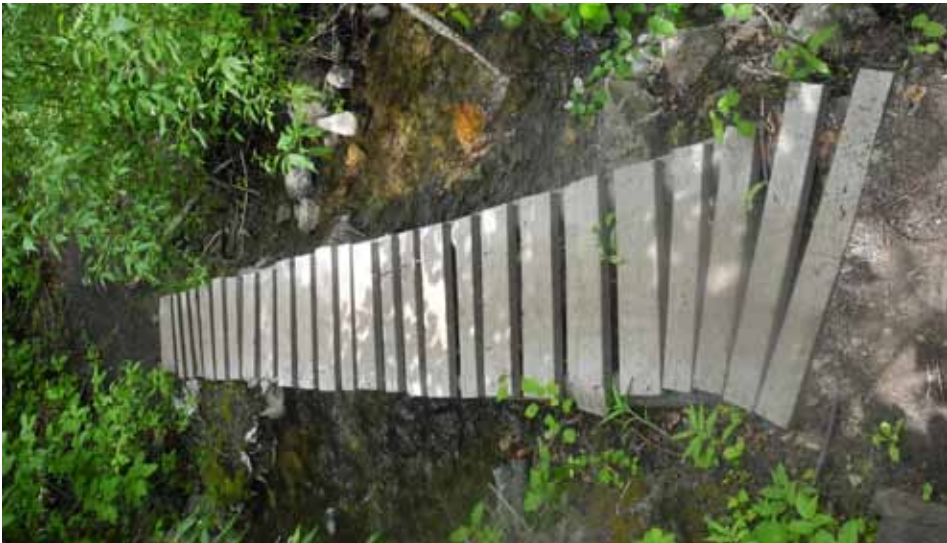
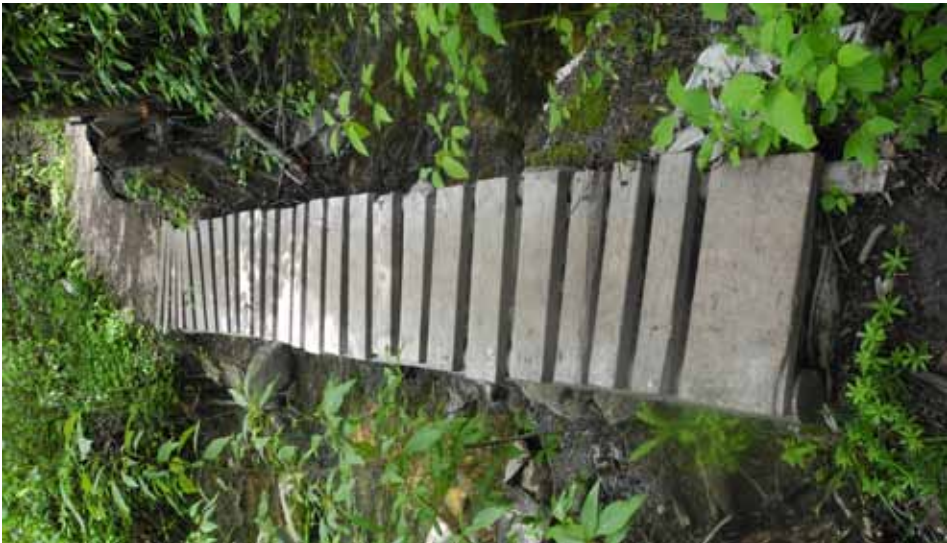
| NO. | ITEM | DIMENSION (MM) | PRESCRIPTION | IMPROVEMNT | MEETS STANDARD | LIFE (YEARS) | MANDATORY | FALL_ZONE (1 - POOR, 5 - GOOD) | IMAGE | NORTHING (UTM10) | EASTING (UTM10) | HEIGHT ABOVE MSL (m) |
|---|---|---|---|---|---|---|---|---|---|---|---|---|
| 68 | bridge | 500w x 5000l x 600h | improve | overspanned stringers and much deflection under foot traffic improve by increasing the size of the stringers | y | 1 | y | 1 | DSCN6759.JPG | 5549739 | 661162 | 770 |

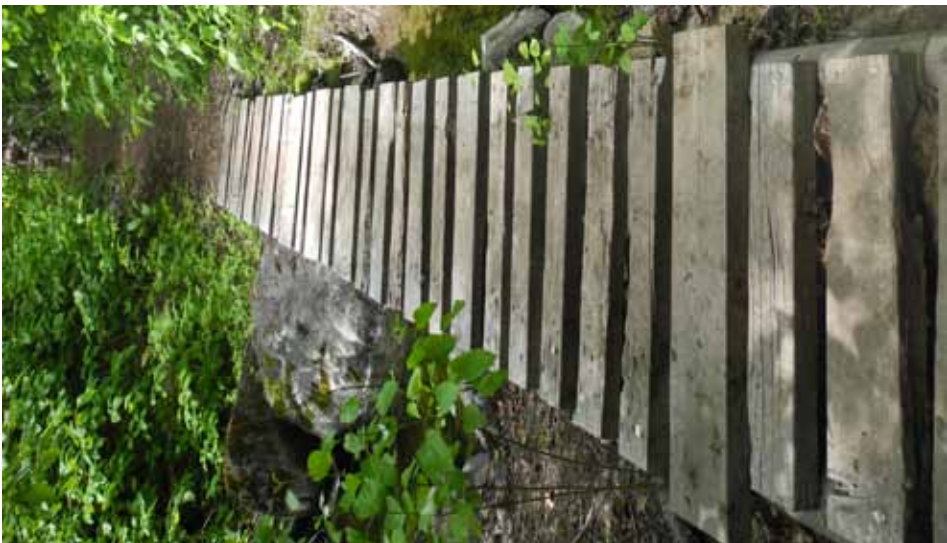
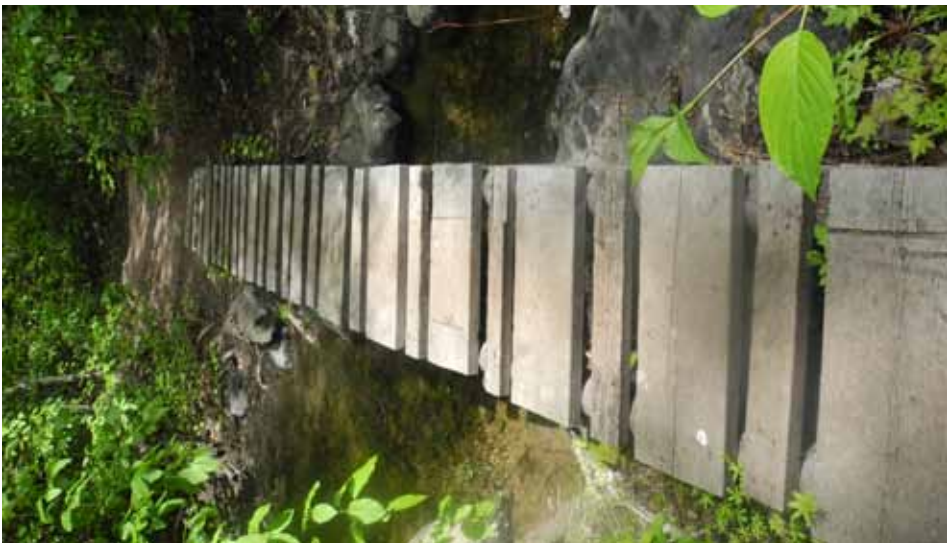
| NO. | ITEM | DIMENSION (MM) | PRESCRIPTION | IMPROVEMNT | MEETS STANDARD | LIFE (YEARS) | MANDATORY | FALL_ZONE (1 - POOR, 5 - GOOD) | IMAGE | NORTHING (UTM10) | EASTING (UTM10) | HEIGHT ABOVE MSL (m) |
|---|---|---|---|---|---|---|---|---|---|---|---|---|
| 69 | bridge | 600w x 7000l x 600h | improve | minimal deflection, but stunt built with non-galvanized deck nails | y | 2 | y | 2 | DSCN6762.JPG | 5549790 | 661142 | 766 |

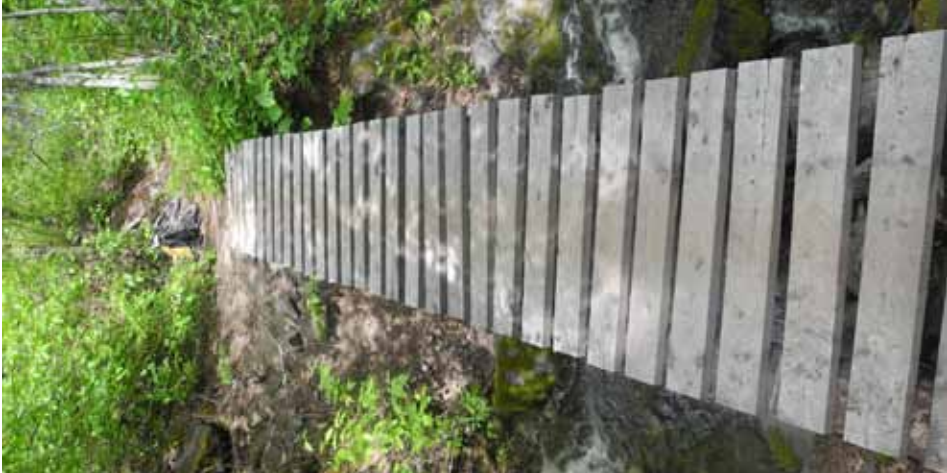
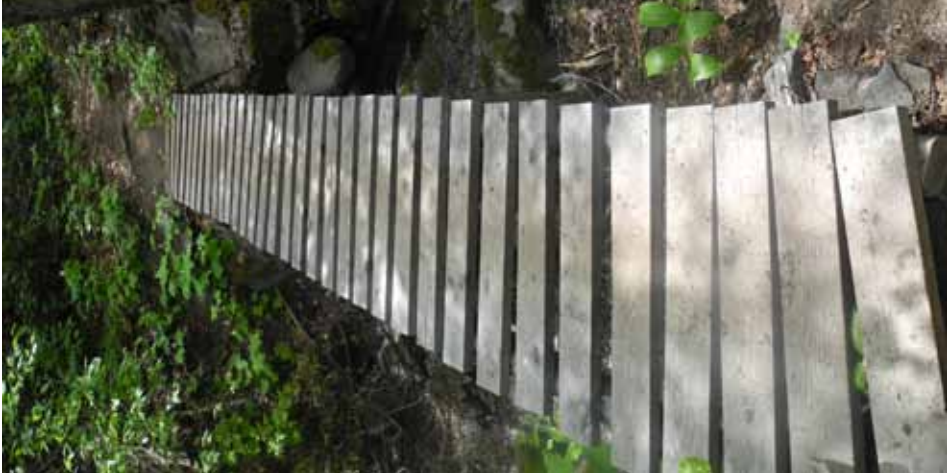
| NO. | ITEM | DIMENSION (MM) | PRESCRIPTION | IMPROVEMNT | MEETS STANDARD | LIFE (YEARS) | MANDATORY | FALL_ZONE (1 - POOR, 5 - GOOD) | IMAGE | NORTHING (UTM10) | EASTING (UTM10) | HEIGHT ABOVE MSL (m) |
|---|---|---|---|---|---|---|---|---|---|---|---|---|
| 70 | bridge | 1000w x 7000l x 1500h | improve | bridge is supported by a header that is located mid-span of the bridge. The header is supported by a post located in the creek bed and will fail due to decay. Recommend increasing the size of the stringers to allow for a clear span. | y | 2 | y | 2 | DSCN6767.JPG | 5549815 | 661123 | 765 |

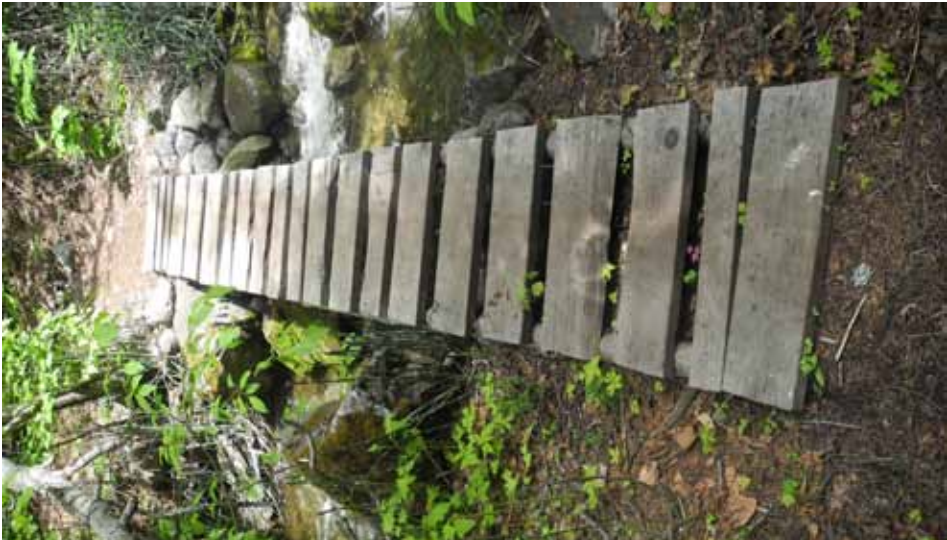
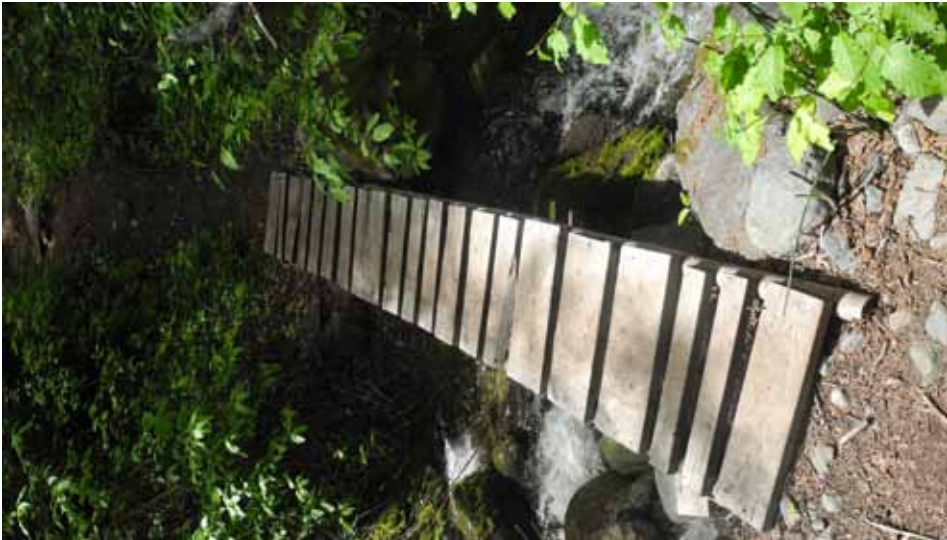
| NO. | ITEM | DIMENSION (MM) | PRESCRIPTION | IMPROVEMNT | MEETS STANDARD | LIFE (YEARS) | MANDATORY | FALL_ZONE (1 - POOR, 5 - GOOD) | IMAGE | NORTHING (UTM10) | EASTING (UTM10) | HEIGHT ABOVE MSL (m) |
|---|---|---|---|---|---|---|---|---|---|---|---|---|
| 71 | bridge | 600w x 6000l x 600h | improve | increase the diameter of the stringers to reduce the amount of deflection for the otherwise overspanned bridge | y | 2 | y | 1 | DSCN6769.JPG | 5549864 | 661120 | 756 |

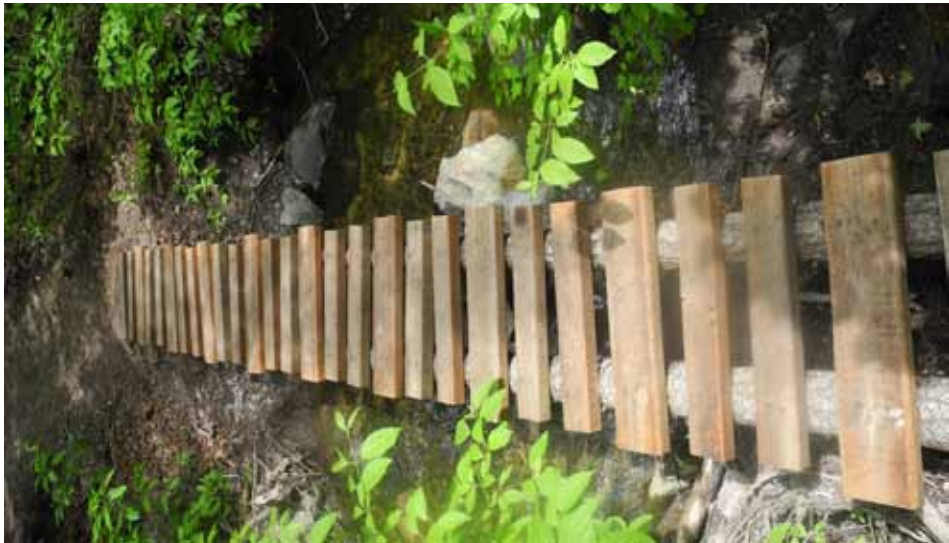
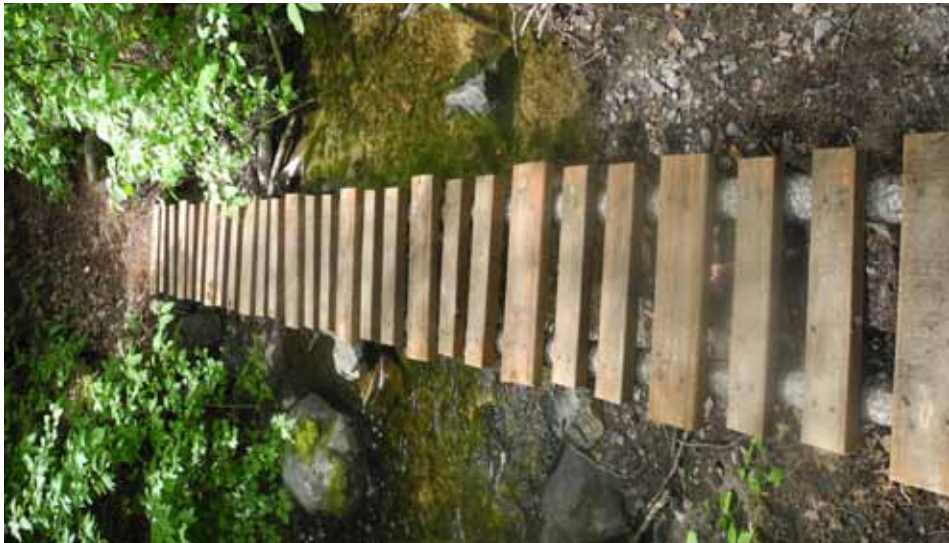
| NO. | ITEM | DIMENSION (MM) | DESCRIPTION | IMPROVEMNT | MEETS STANDARD | LIFE (YEARS) | MANDATORY | FALL_ZONE (1 - POOR, 5 - GOOD) | IMAGE | NORTHING (UTM10) | EASTING (UTM10) | HEIGHT ABOVE MSL (m) |
|---|---|---|---|---|---|---|---|---|---|---|---|---|
| 67 | bridge | 600w x 8000l x 640h | improve | overspanned stringers, newly constructed, improve by adding another stringer or mid-span support | y | 3 | y | 2 | DSCN6756.JPG | 5549514 | 661294 | 792 |

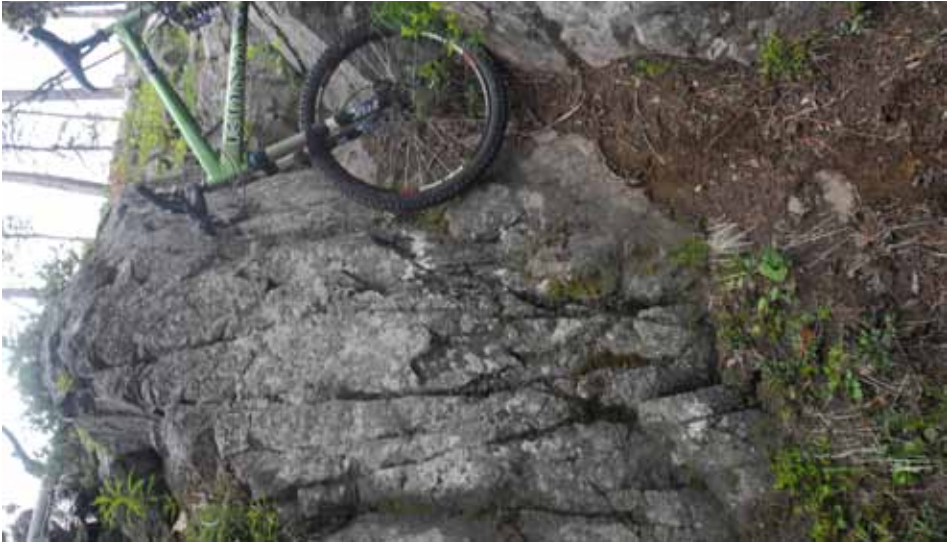
| No. | ITEM | DIMENSION (MM) | DESCRIPTION | IMPROVEMNT | MEETS STANDARD | LIFE (YEARS) | MANDATORY | FALL_ZONE (1 - POOR, 5 - GOOD) | IMAGE | NORTHING (UTM10) | EASTING (UTM10) | HEIGHT ABOVE MSL (m) |
|---|---|---|---|---|---|---|---|---|---|---|---|---|
| 131 | drop | 3000h | Monitor | Difficult feature but serves as gateway for trail | Y | 5 | Y | 2 | DSCN7163.JPG | 5546573 | 660189 | 1661 |

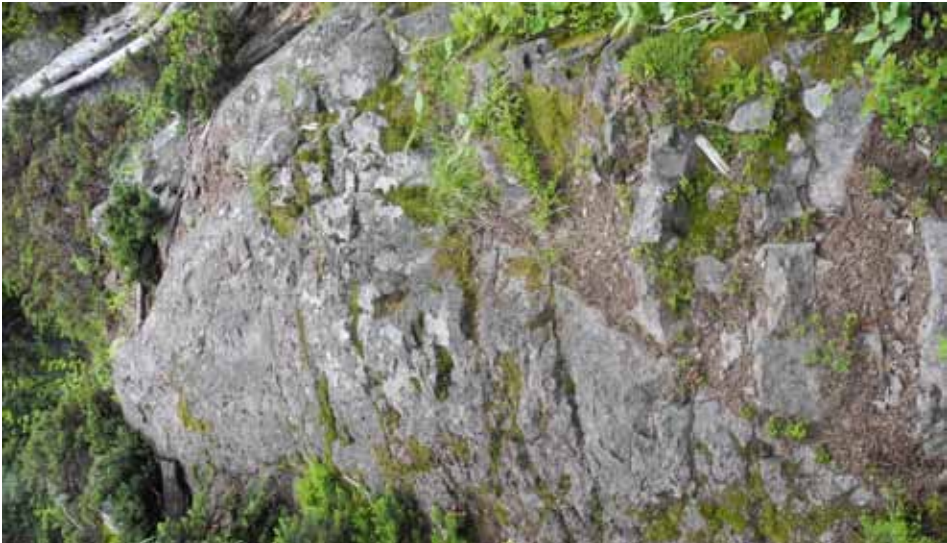
| No. | ITEM | DIMENSION (MM) | DESCRIPTION | IMPROVEMNT | MEETS STANDARD | LIFE (YEARS) | MANDATORY | FALL_ZONE (1 - POOR, 5 - GOOD) | IMAGE | NORTHING (UTM10) | EASTING (UTM10) | HEIGHT ABOVE MSL (m) |
|---|---|---|---|---|---|---|---|---|---|---|---|---|
| 132 | drop | 3000h | monitor | difficult feature but serves as gateway for trail | y | 5 | y | 2 | DSCN7163.JPG | 5546573 | 660189 | 1661 |

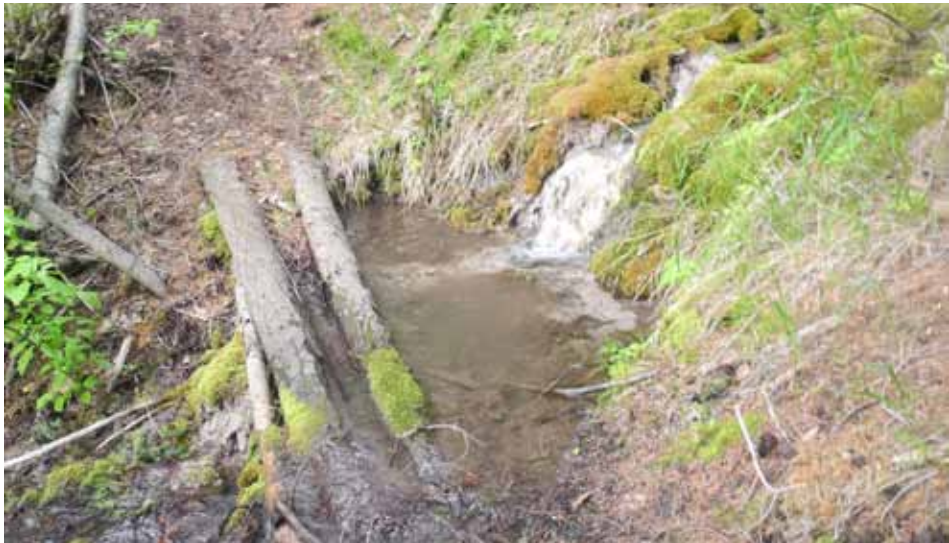
| NO. | ITEM | DIMENSION (MM) | DESCRIPTION | IMPROVEMNT | MEETS STANDARD | LIFE (YEARS) | MANDATORY | FALL_ZONE (1 - POOR, 5 - GOOD) | IMAGE | NORTHING (UTM10) | EASTING (UTM10) | HEIGHT ABOVE MSL (M) |
|---|---|---|---|---|---|---|---|---|---|---|---|---|
| 179 | bridge | 250w x 650l x 200h | improve | improve by crafting a riding surface, or remove | n | 2 | n | 2 | DSCN6507.JPG | 5547406 | 658650 | 1130 |
