# MOUNTAIN BIKE TRAIL & TECHNICAL TRAIL FEATURE INSPECTION

IRON MOUNTAIN, MERRITT, BC

Ministry of Ministry of Forests, Lands and  
Natural Resource Operations

Cascades District – Recreation Sites & Trails  
August 2012

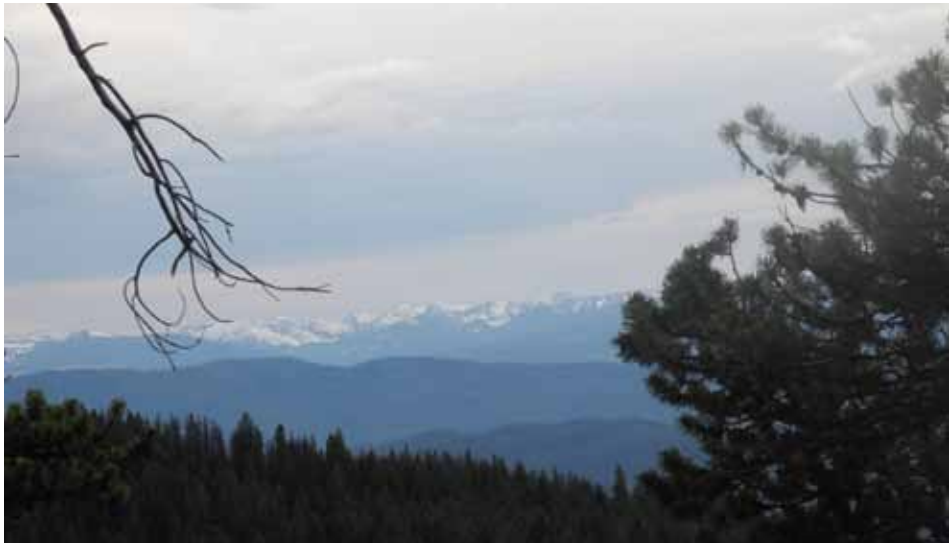
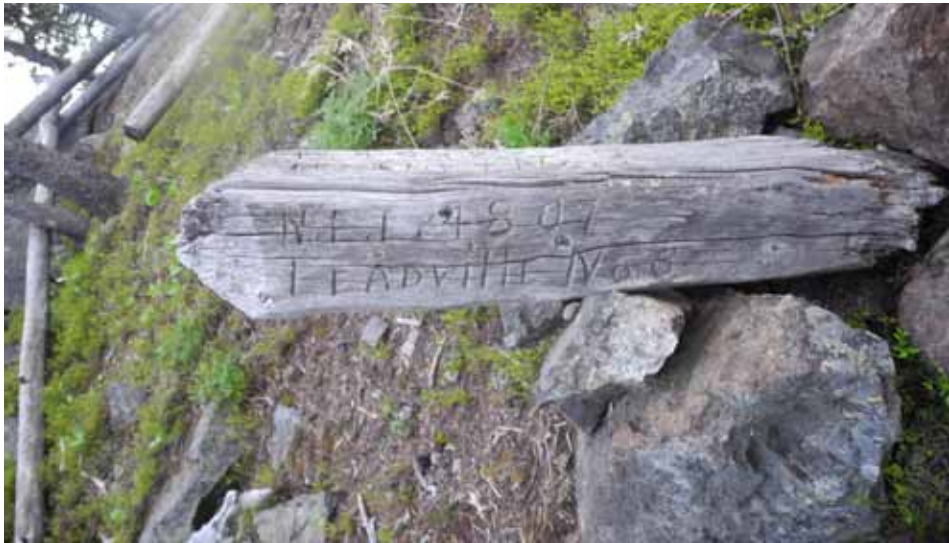
| NO. | ITEM | DIMENSION (MM) | DESCRIPTION | IMPROVEMNT | MEETS STANDARD | LIFE (YEARS) | MANDATORY | FALL_ZONE (1 - POOR, 5 - GOOD) | IMAGE | NORTHING (UTM10) | EASTING (UTM10) | HEIGHT ABOVE MSL (M) |
|---|---|---|---|---|---|---|---|---|---|---|---|---|
| 164 | rock drop | | monitor | good natural feature | y | 5 | y | 2 | DSCN6541.JPG | 5546331 | 660111 | 1680 |

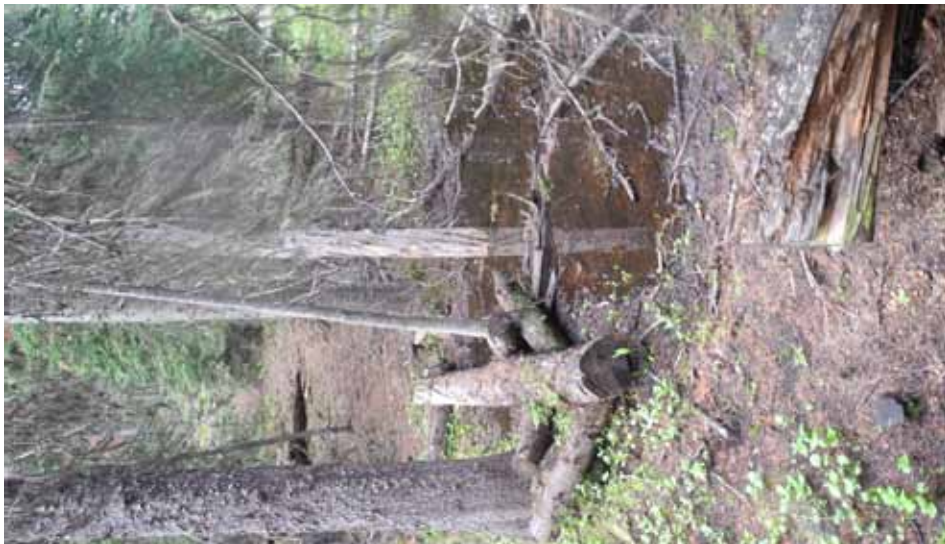
| NO. | ITEM | DIMENSION (MM) | PREScription | IMPROVEMNT | MEETS STANDARD | LIFE (YEARS) | MANDATORY | FALL_ZONE (1 - POOR, 5 - GOOD) | IMAGE | NORTHING (UTM10) | EASTING (UTM10) | HEIGHT ABOVE MSL (M) |
|---|---|---|---|---|---|---|---|---|---|---|---|---|
| 165 | bridge | | improve | logs stringer rotting and loose, could build a new crossing 6000-long | n | 2 | y | 2 | DSCN6535.JPG | 5546061 | 660073 | 1655 |

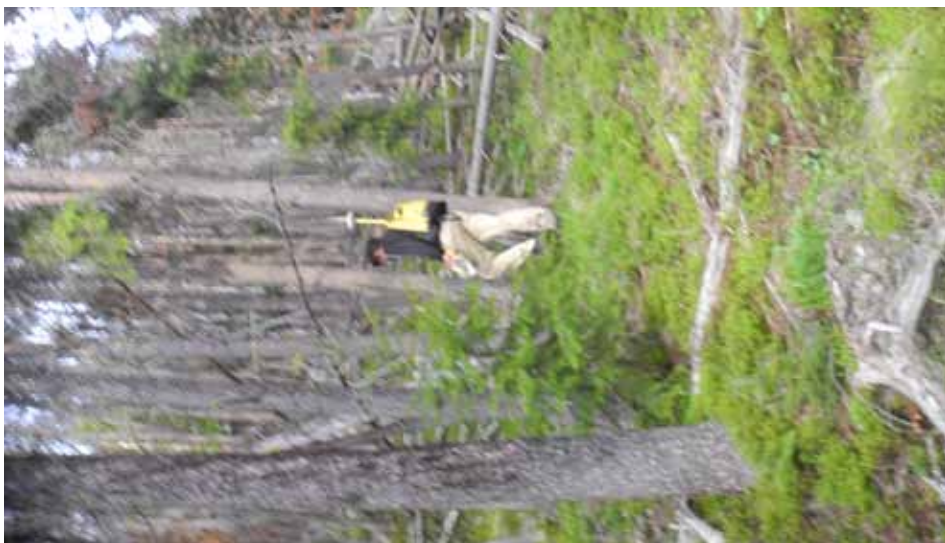
| 167 | rock drop | | monitor | good natural feature | y | 5 | y | 2 | DSCN6530.JPG | 5546321 | 659611 | 1594 |

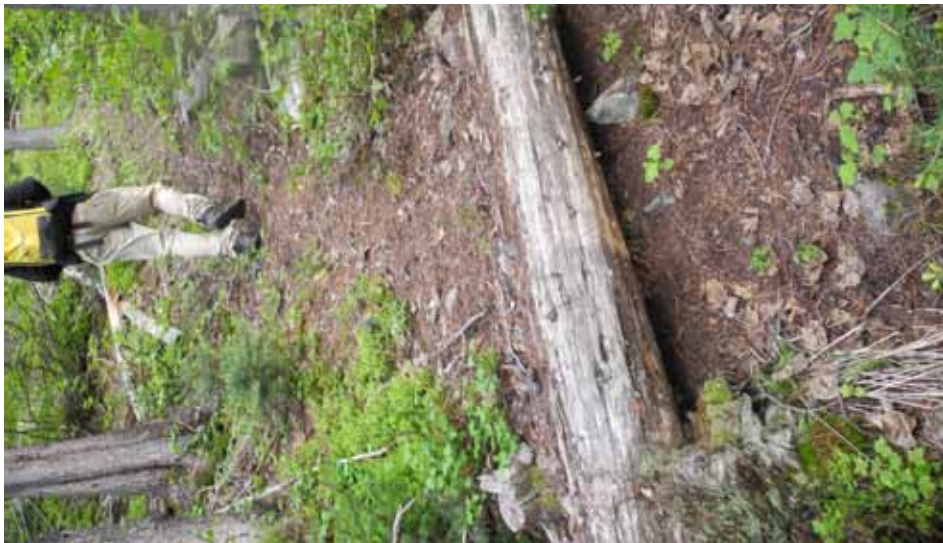
| NO. | ITEM | DIMENSION (MM) | PREScription | IMPROVEMNT | MEETS STANDARD | LIFE (YEARS) | MANDATORY | FALL_ZONE (1 - POOR, 5 - GOOD) | IMAGE | NORTHING (UTM10) | EASTING (UTM10) | HEIGHT ABOVE MSL (M) |
|---|---|---|---|---|---|---|---|---|---|---|---|---|
| 168 | log drop | | monitor | good natural feature | y | 3 | y | 2 | DSCN6529.JPG | 5546352 | 659530 | 1554 |

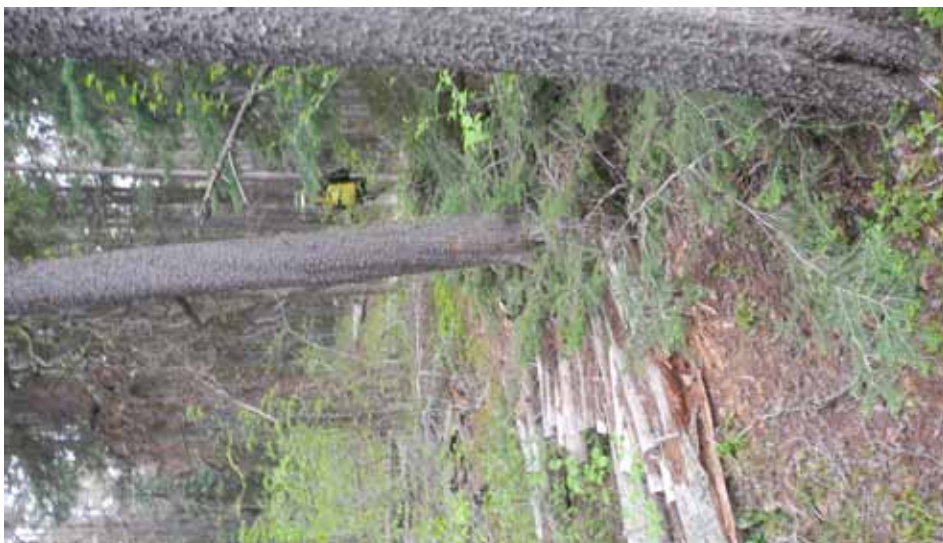
| 170 | log ride | | improve | natural elements are rotting and could be removed | y | 0 | y | 2 | DSCN6525.JPG | 5546488 | 659432 | 1535 |

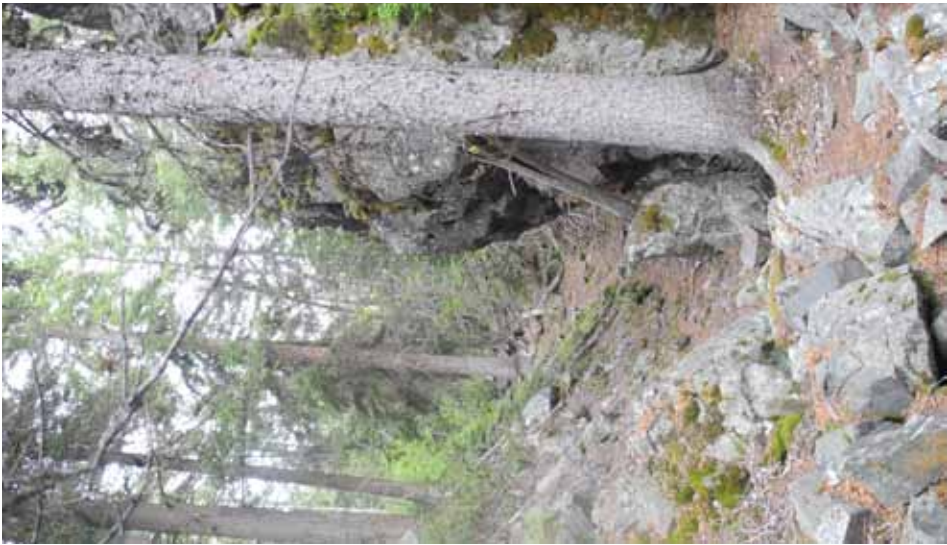
| NO. | ITEM | DIMENSION (MM) | PRESCRIPTION | IMPROVEMNT | MEETS STANDARD | LIFE (YEARS) | MANDATORY | FALL_ZONE (1 - POOR, 5 - GOOD) | IMAGE | NORTHING (UTM10) | EASTING (UTM10) | HEIGHT ABOVE MSL (M) |
|---|---|---|---|---|---|---|---|---|---|---|---|---|
| 173 | rock roll | slot canyon | monitor | naturally steep grade | y | 0 | | 1 | DSCN6520.JPG | 5546822 | 659350 | 1500 |

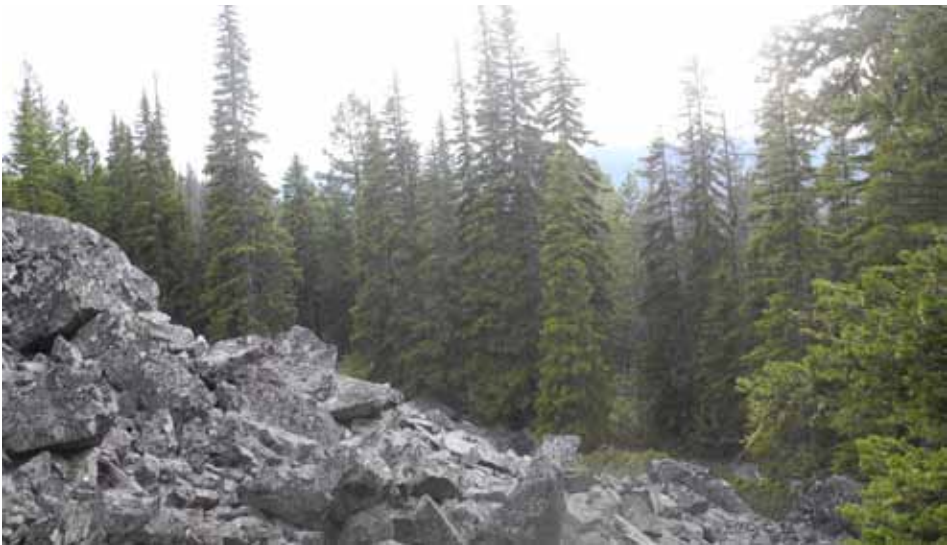
| NO. | ITEM | DIMENSION (MM) | PRESCRIPTION | IMPROVEMNT | MEETS STANDARD | LIFE (YEARS) | MANDATORY | FALL_ZONE (1 - POOR, 5 - GOOD) | IMAGE | NORTHING (UTM10) | EASTING (UTM10) | HEIGHT ABOVE MSL (M) |
|---|---|---|---|---|---|---|---|---|---|---|---|---|
| 174 | rock roll | scree slop | monitor | naturally steep grade | y | 0 | y | 2 | DSCN6518.JPG | 5546896 | 659303 | 1465 |

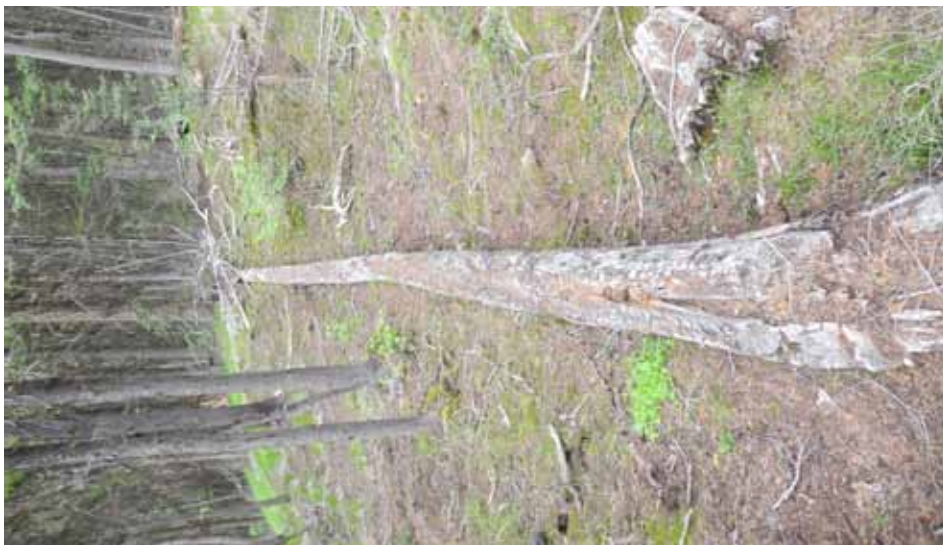
| NO. | ITEM | DIMENSION (MM) | PRESCRIPTION | IMPROVEMNT | MEETS STANDARD | LIFE (YEARS) | MANDATORY | FALL_ZONE (1 - POOR, 5 - GOOD) | IMAGE | NORTHING (UTM10) | EASTING (UTM10) | HEIGHT ABOVE MSL (M) |
|---|---|---|---|---|---|---|---|---|---|---|---|---|
| 176 | log ride | unused x 15000l | remove | old log ride, decomission | n | 0 | | 1 | DSCN6514.JPG | 5547122 | 659152 | 1389 |

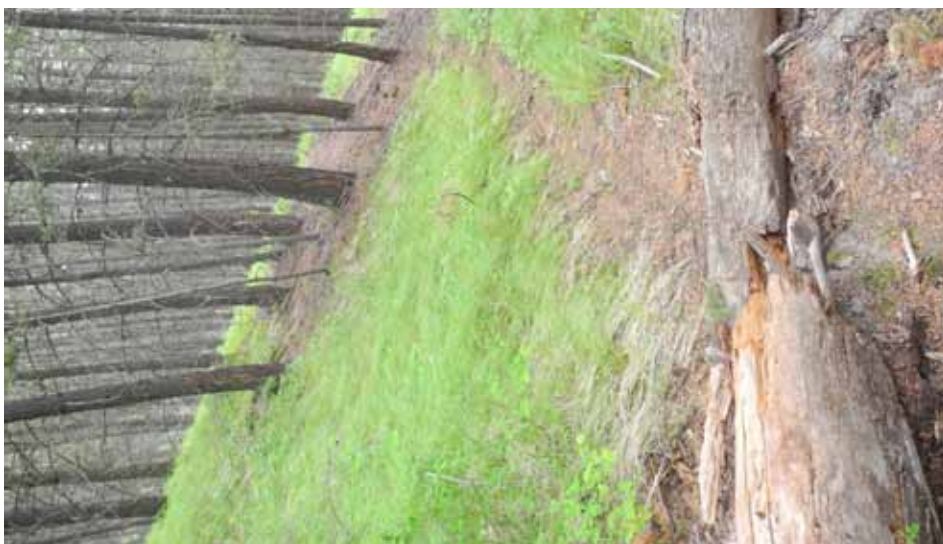
180 log drop remove shakey log across trail is rotting should be remove

y 3 y 2 DSCN6503.JPG 5547545 658467 1024

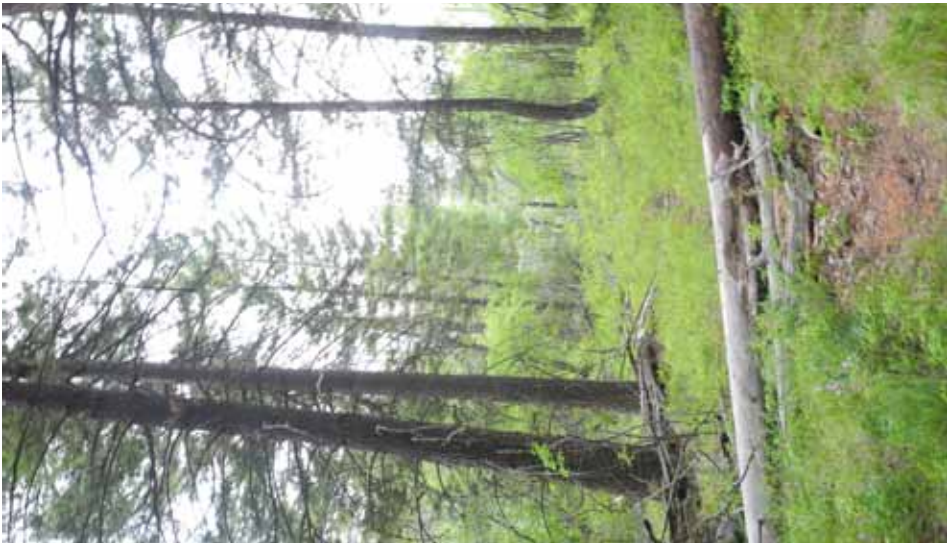
| NO. | ITEM | DIMENSION (MM) | PREScription | IMPROVEMNT | MEETS STANDARD | LIFE (YEARS) | MANDATORY | FALL_ZONE (1 - POOR, 5 - GOOD) | IMAGE | NORTHING (UTM10) | EASTING (UTM10) | HEIGHT ABOVE MSL (M) |
|---|---|---|---|---|---|---|---|---|---|---|---|---|
| 181 | log drop | | monitor | good natural feature will decay over time | y | 5 | y | 3 | DSCN6495.JPG | 5547852 | 658509 | 978 |

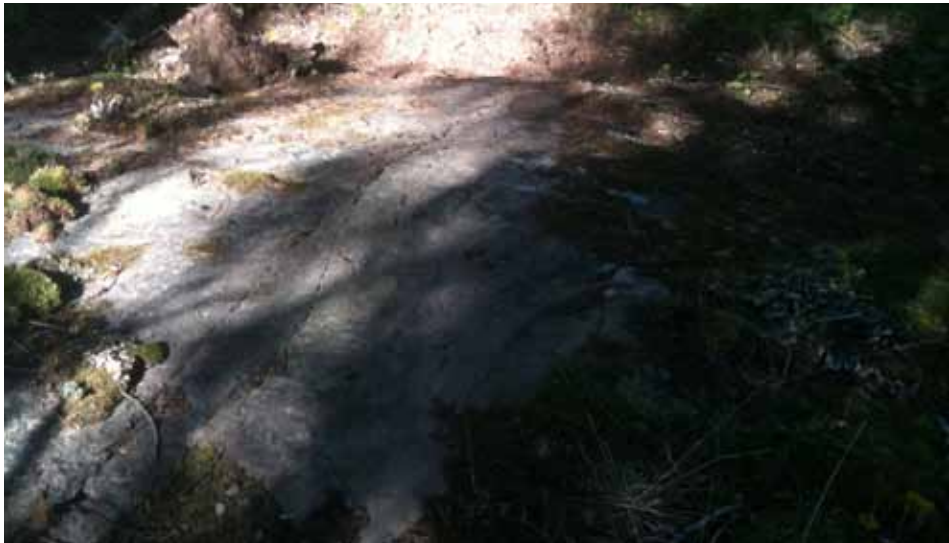
| NO. | ITEM | DIMENSION (MM) | DESCRIPTION | IMPROVEMNT | MEETS STANDARD | LIFE (YEARS) | MANDATORY | FALL_ZONE (1 - POOR, 5 - GOOD) | IMAGE | NORTHING (UTM10) | EASTING (UTM10) | HEIGHT ABOVE MSL (m) |
|---|---|---|---|---|---|---|---|---|---|---|---|---|
| 248 | rock drop | 2000 high | monitor | good natural feature | n | 5 | y | 1 | | | | |

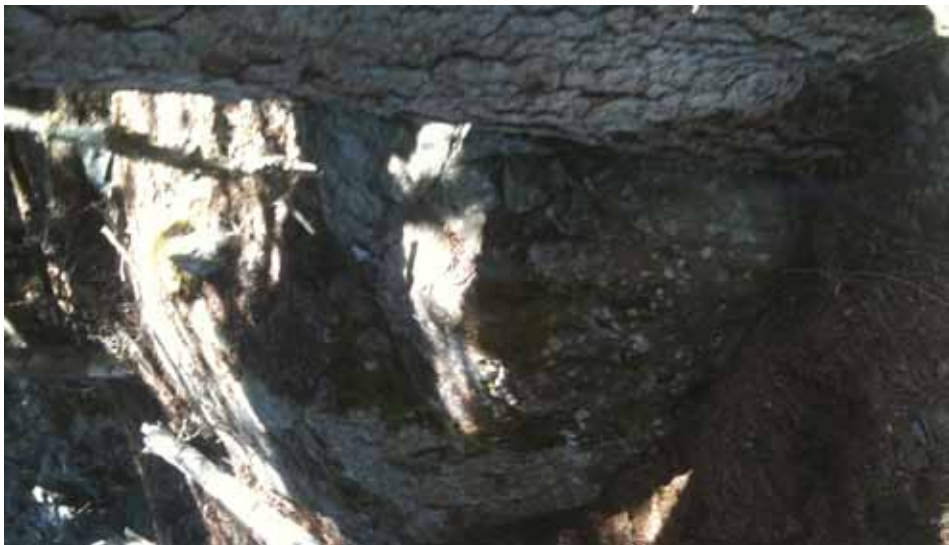
| NO. | ITEM | DIMENSION (MM) | DESCRIPTION | IMPROVEMNT | MEETS STANDARD | LIFE (YEARS) | MANDATORY | FALL_ZONE (1 - POOR, 5 - GOOD) | IMAGE | NORTHING (UTM10) | EASTING (UTM10) | HEIGHT ABOVE MSL (m) |
|---|---|---|---|---|---|---|---|---|---|---|---|---|
| 249 | rock drop | 1500 high | monitor | good natural feature | n | 5 | y | 1 | | | | |

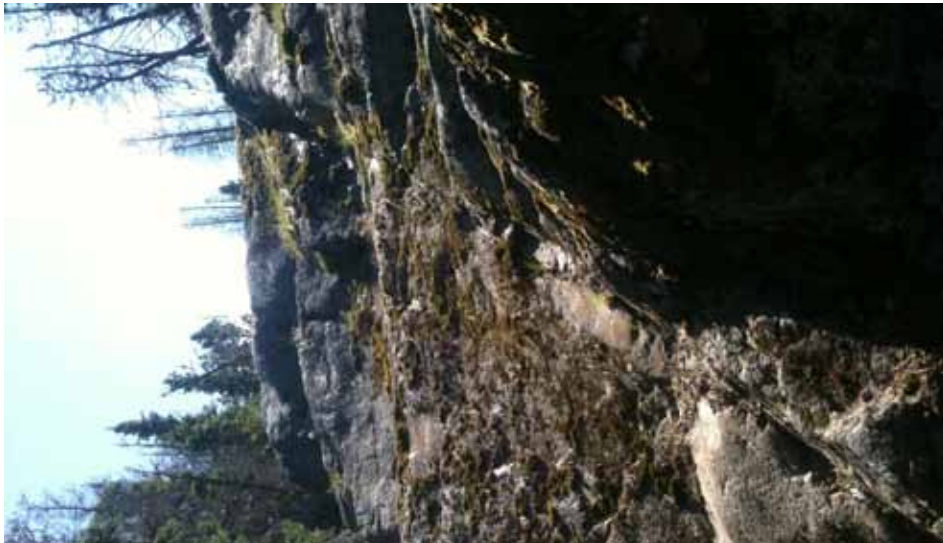
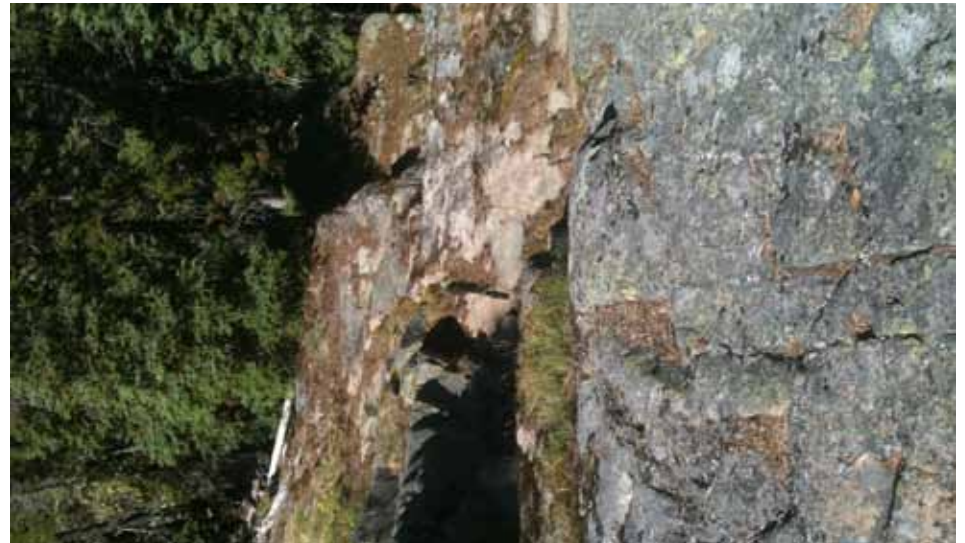
| NO. | ITEM | DIMENSION (MM) | PREScription | IMPROVEMNT | MEETS STANDARD | LIFE (YEARS) | MANDATORY | FALL_ZONE (1 - POOR, 5 - GOOD) | IMAGE | NORTHING (UTM10) | EASTING (UTM10) | HEIGHT ABOVE MSL (m) |
|---|---|---|---|---|---|---|---|---|---|---|---|---|
| 250 | rock drop | 130 metres | monitor | good natural feature although long and oversteep | n | 5 | y | 1 | | | | |

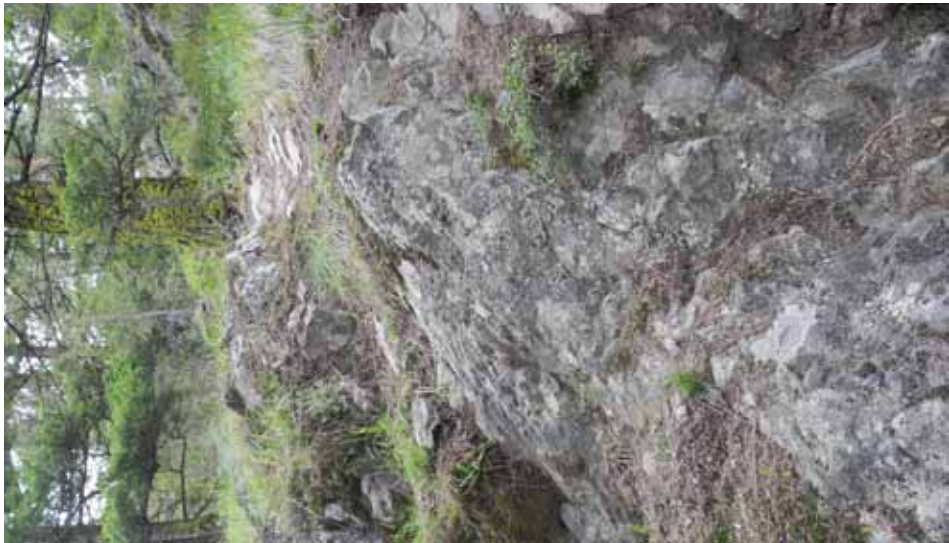
| NO. | ITEM | DIMENSION (MM) | DESCRIPTION | IMPROVEMNT | MEETS STANDARD | LIFE (YEARS) | MANDATORY | FALL_ZONE (1 - POOR, 5 - GOOD) | IMAGE | NORTHING (UTM10) | EASTING (UTM10) | HEIGHT ABOVE MSL (M) |
|---|---|---|---|---|---|---|---|---|---|---|---|---|
| 247 | Rock drop | | Monitor | Mandatory 2500h drop | Y | 5 | Y | 2 | DSCN7189.JPG | 5548731 | 660287 | 1067 |

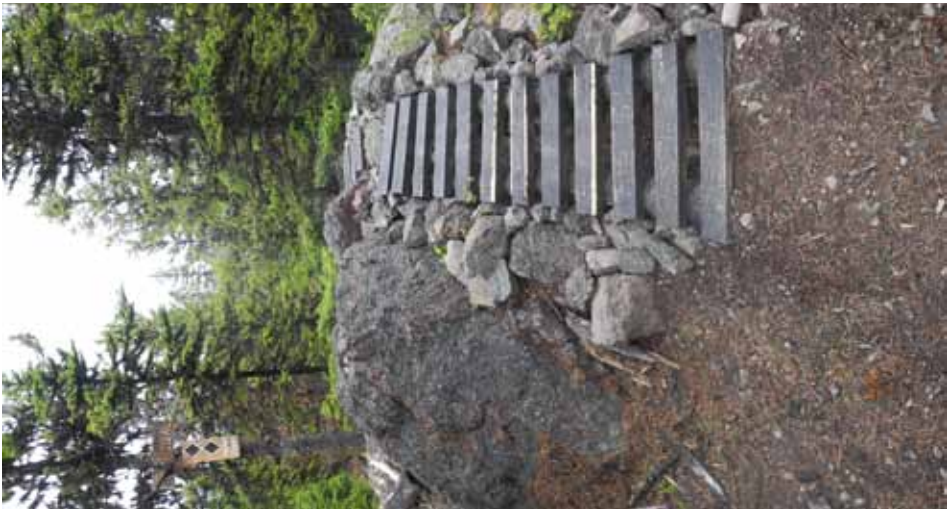
| 73 | elevated bridge roll | 240w x 2900l x 0 | monitor | ground level, good condition | y | 5 | y | 5 | DSCN6807.JPG | 5546474 | 660577 | 1691 |

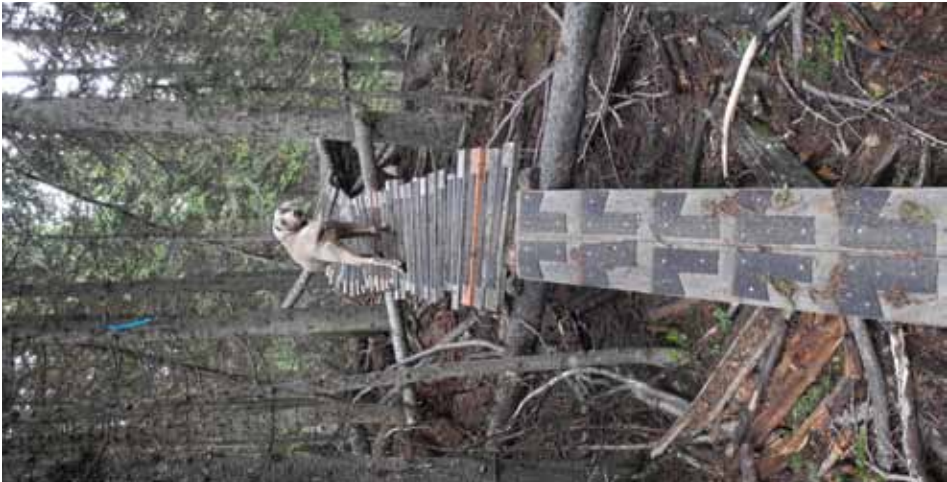
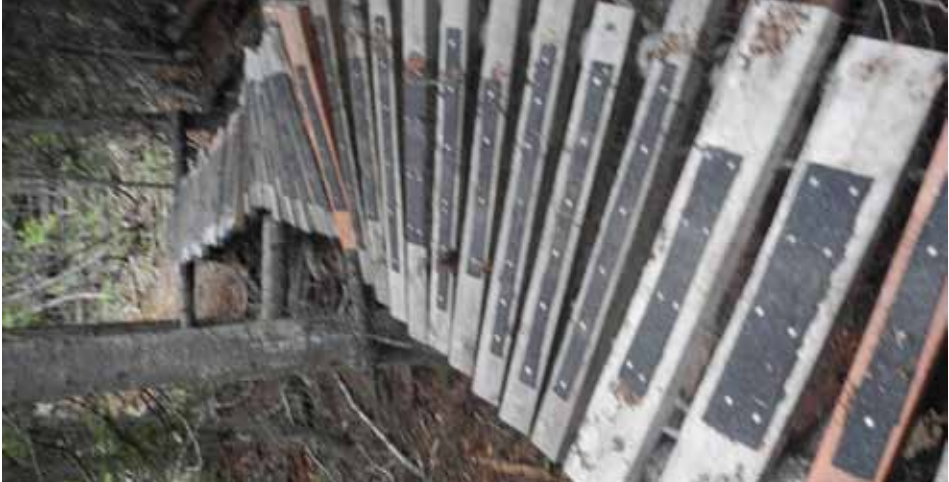
| 74 | elevated bridge roll | 630w x 17000l x 1200h | improve | improve by increasing the diameter of the stringers, removing the shingles, improve the fall zones, and replacing the non-galvanized nails. Also, stunt is fastened to live trees, recommend bracing stunt to ground Instead. | y | 3 | y | 2 | DSCN6811.JPG | 5546559 | 660591 | 1679 |

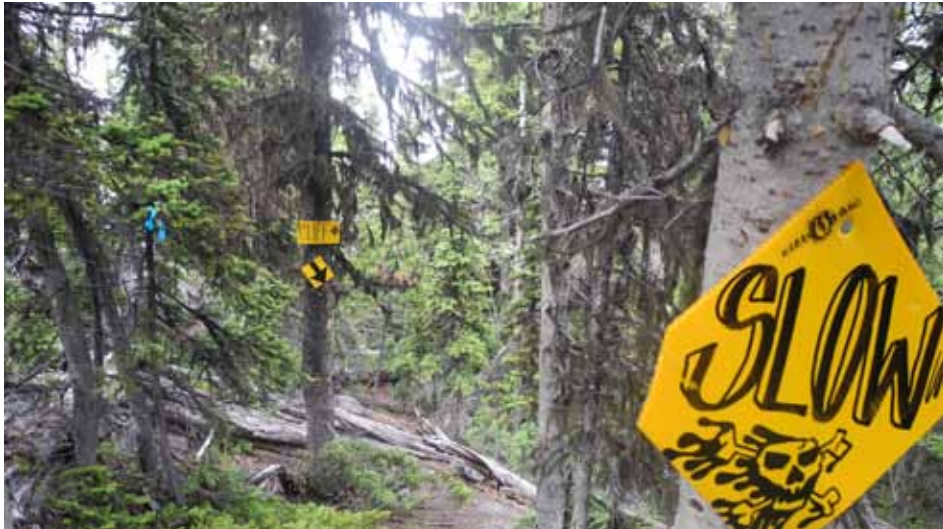
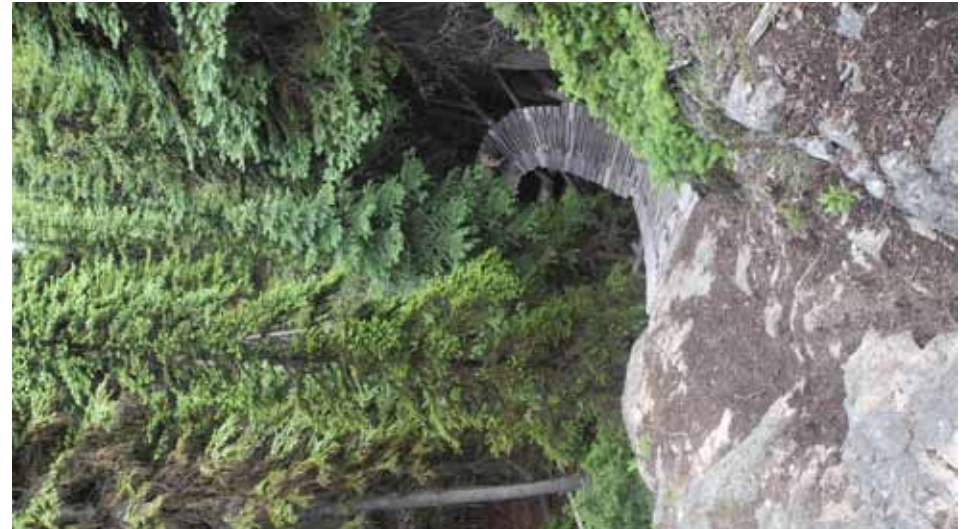
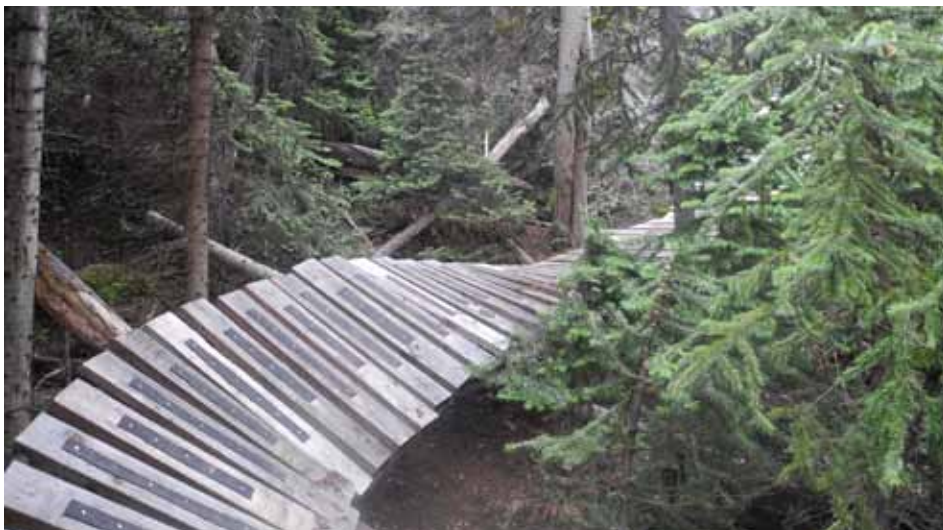
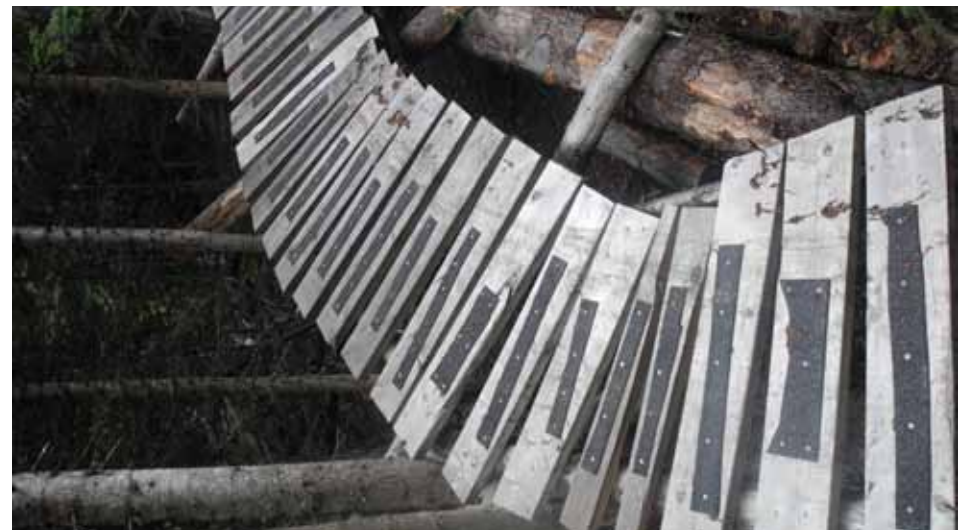
| NO. | ITEM | DIMENSION (MM) | PRESCRIPTION | IMPROVEMNT | MEETS STANDARD | LIFE (YEARS) | MANDATORY | FALL_ZONE (1 - POOR, 5 - GOOD) | IMAGE | NORTHING (UTM10) | EASTING (UTM10) | HEIGHT ABOVE MSL (m) |
|---|---|---|---|---|---|---|---|---|---|---|---|---|
| 75 | elevated bridge roll | 950w x 800h x 10000l | improve | <p>improve by increasing the diameter of the stringers, cleat the boardwalk instead of using shingles, improve the fall zones. Also, stunt is fastened to live trees and, recommend bracing stunt to ground instead.</p> <p>increase the diameter of the stringers, "cleat" the decking and remove the shingles. Replace non-galvanized nails and improve the fall zones</p> | y | 2 | y | 1 | DSCN6818.JPG | 5546595 | 660624 | 1661 |

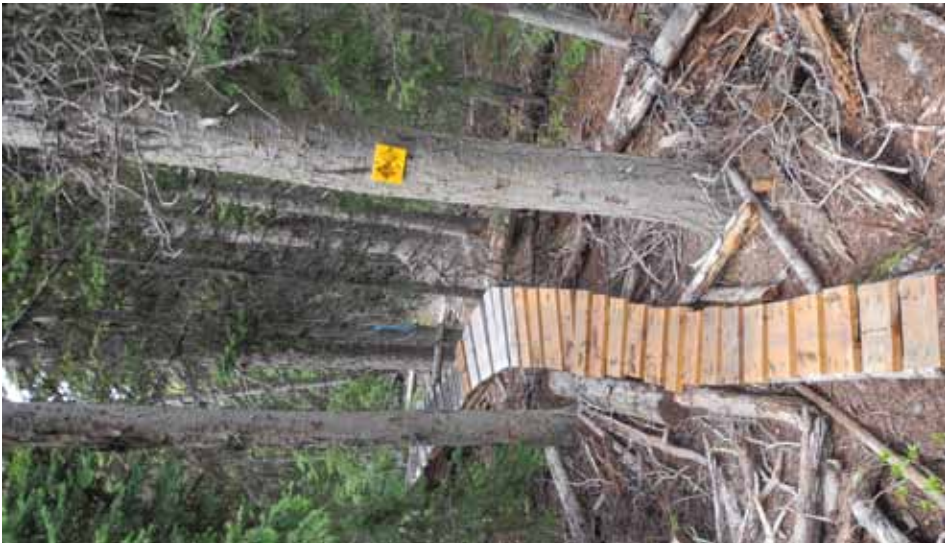
| NO. | ITEM | DIMENSION (MM) | PRESCRIPTION | IMPROVEMNT | MEETS STANDARD | LIFE (YEARS) | MANDATORY | FALL_ZONE (1 - POOR, 5 - GOOD) | IMAGE | NORTHING (UTM10) | EASTING (UTM10) | HEIGHT ABOVE MSL (m) |
|---|---|---|---|---|---|---|---|---|---|---|---|---|
| 76 | elevated bridge roll | 500w x 800h x 10000l | improve | increase the diameter of stringers to reduce the amount of deflection and improve the fall zones | y | 3 | y | 2 | DSCN6821.JPG | 5546617 | 660632 | 1659 |

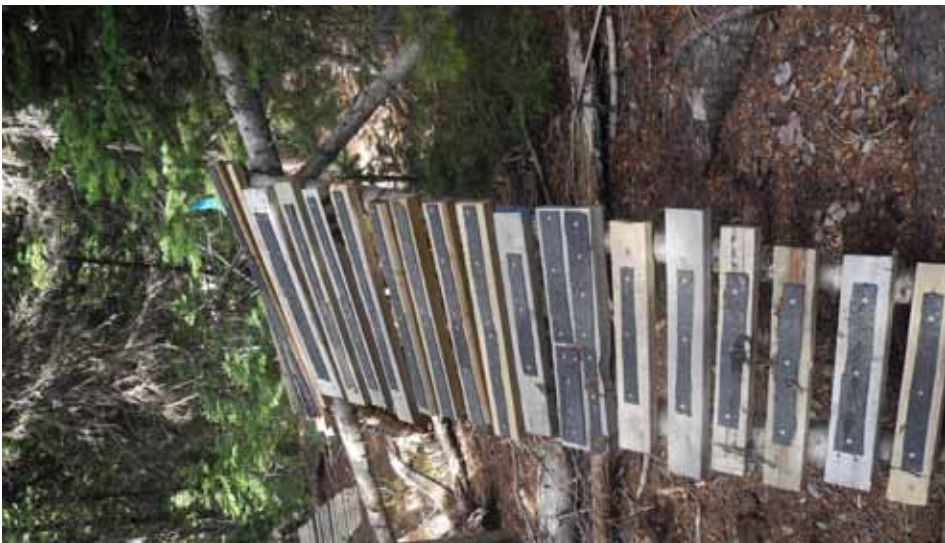
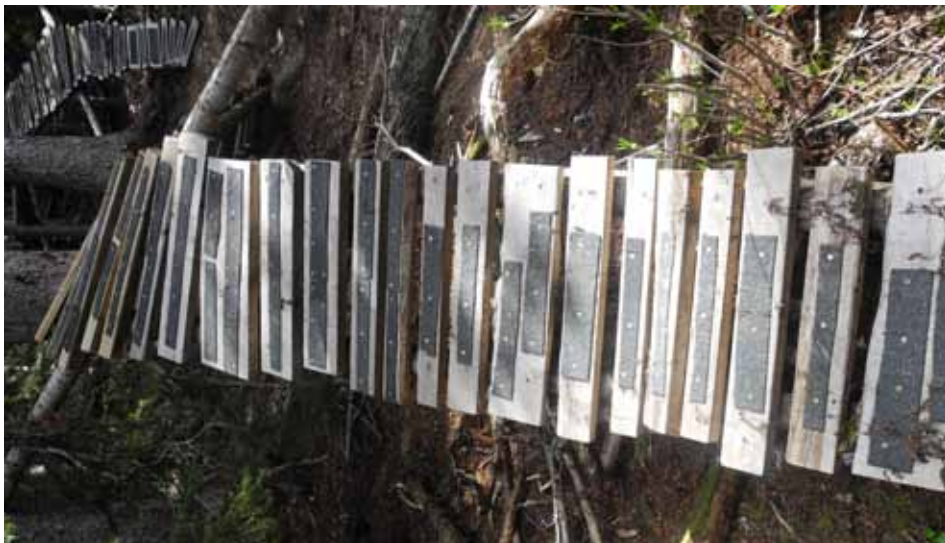
| NO. | ITEM | DIMENSION (MM) | PRESCRIPTION | IMPROVEMNT | MEETS STANDARD | LIFE (YEARS) | MANDATORY | FALL_ZONE (1 - POOR, 5 - GOOD) | IMAGE | NORTHING (UTM10) | EASTING (UTM10) | HEIGHT ABOVE MSL (m) |
|---|---|---|---|---|---|---|---|---|---|---|---|---|
| 77 | elevated bridge roll | 1000w x 1200h x 4000l | improve | increase the diameter of the stringers, "cleat" the decking and remove the shingles. Replace non-galvanized nails and improve the fall zones | y | 2 | y | 1 | DSCN6828.JPG | 5546640 | 660631 | 1660 |

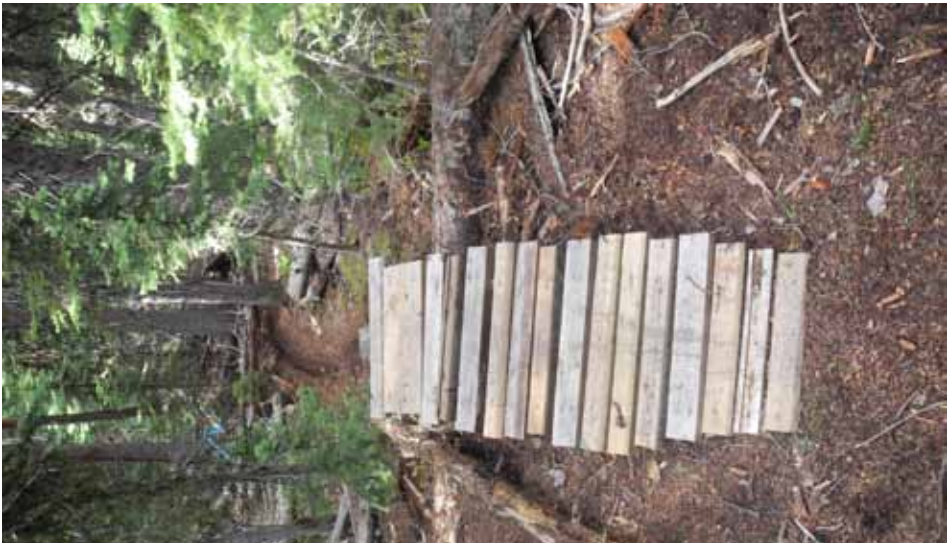
| NO. | ITEM | DIMENSION (MM) | PRESCRIPTION | IMPROVEMNT | MEETS STANDARD | LIFE (YEARS) | MANDATORY | FALL_ZONE (1 - POOR, 5 - GOOD) | IMAGE | NORTHING (UTM10) | EASTING (UTM10) | HEIGHT ABOVE MSL (m) |
|---|---|---|---|---|---|---|---|---|---|---|---|---|
| 78 | elevated bridge drop | 560w x 1700h x 500 drop | monitor | sound stringers | n | 3 | y | 3 | DSCN6830.JPG | 5546631 | 660625 | 1653 |

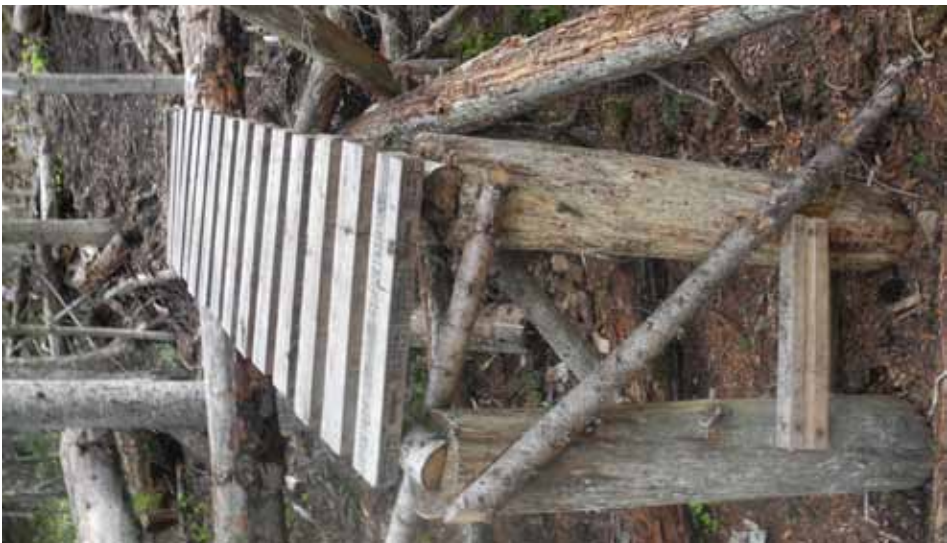
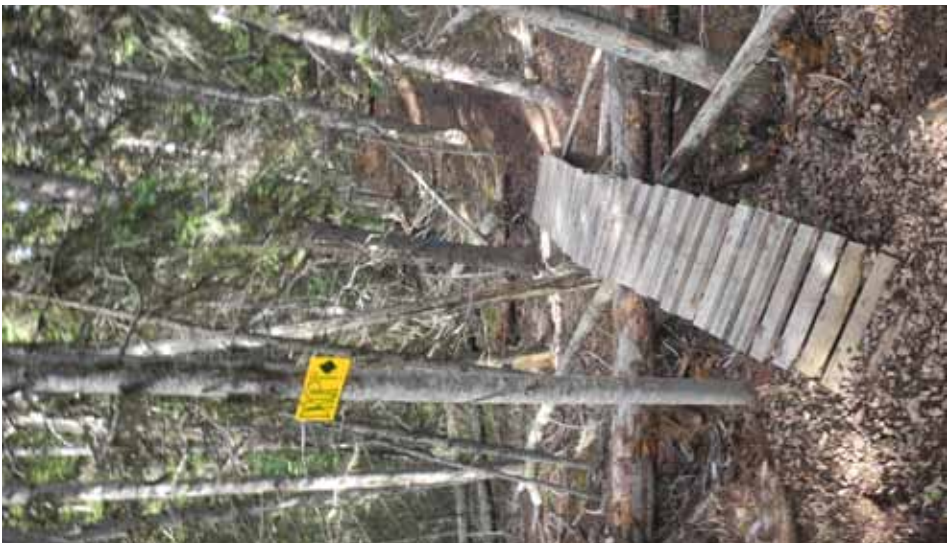
| NO. | ITEM | DIMENSION (MM) | PRESCRIPTION | IMPROVEMNT | MEETS STANDARD | LIFE (YEARS) | MANDATORY | FALL_ZONE (1 - POOR, 5 - GOOD) | IMAGE | NORTHING (UTM10) | EASTING (UTM10) | HEIGHT ABOVE MSL (m) |
|---|---|---|---|---|---|---|---|---|---|---|---|---|
| 79 | elevated bridge drop | 600w x 1200h x 4000l | improve | increase the diameter of the stringers to reduce the amount of deflection for the otherwise overspanned bridge | y | 3 | y | 1 | DSCN6836.JPG | 5546736 | 660634 | 1638 |

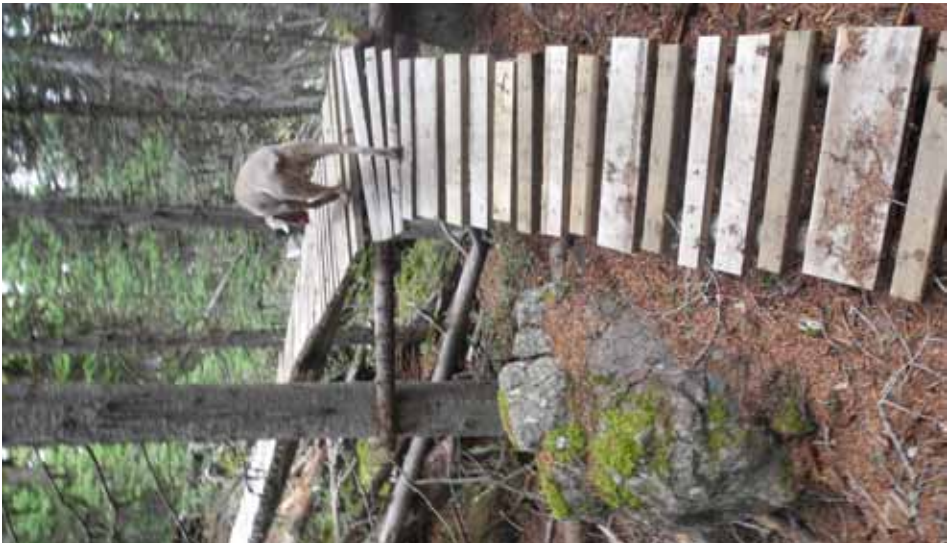
| NO. | ITEM | DIMENSION (MM) | PRESCRIPTION | IMPROVEMNT | MEETS STANDARD | LIFE (YEARS) | MANDATORY | FALL_ZONE (1 - POOR, 5 - GOOD) | IMAGE | NORTHING (UTM10) | EASTING (UTM10) | HEIGHT ABOVE MSL (m) |
|---|---|---|---|---|---|---|---|---|---|---|---|---|
| 80 | elevated bridge roll | 460w x 1700h x 18000l | improve | increase the diameter of the stringers, level the tread, replace non-galvanized nails and improve ground anchoring to remove reliance on live trees | n | 2 | y | 1 | DSCN6838.JPG | 5546866 | 660648 | 1605 |

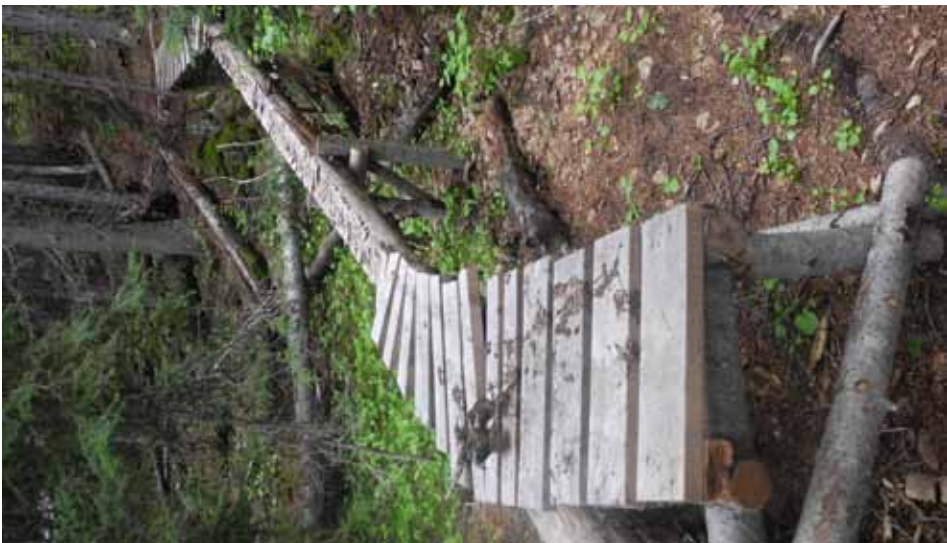
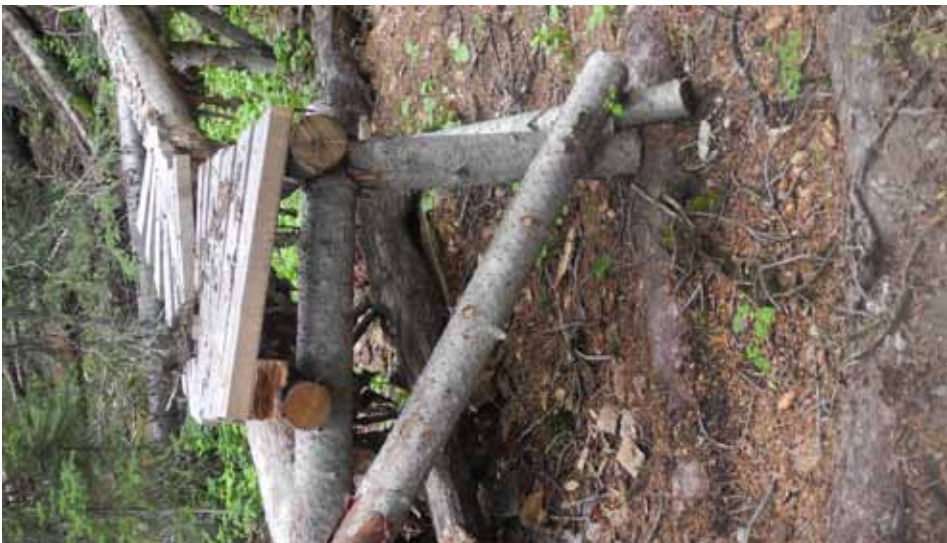
| NO. | ITEM | DIMENSION (MM) | PRESCRIPTION | IMPROVEMNT | MEETS STANDARD | LIFE (YEARS) | MANDATORY | FALL_ZONE (1 - POOR, 5 - GOOD) | IMAGE | NORTHING (UTM10) | EASTING (UTM10) | HEIGHT ABOVE MSL (m) |
|---|---|---|---|---|---|---|---|---|---|---|---|---|
| 84 | elevated bridge drop / log ride | 200w x 900h x 14000l | improve | log shattered at north-end, improve by creating ride-around | n | 3 | y | 3 | DSCN6853.JPG | 5547036 | 660712 | 1545 |

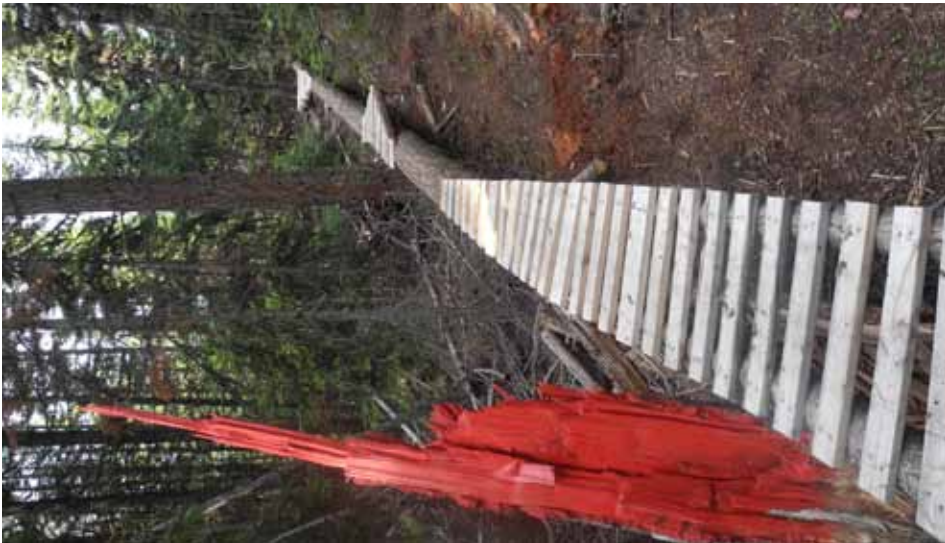
| NO. | ITEM | DIMENSION (MM) | PRESCRIPTION | IMPROVEMNT | MEETS STANDARD | LIFE (YEARS) | MANDATORY | FALL_ZONE (1 - POOR, 5 - GOOD) | IMAGE | NORTHING (UTM10) | EASTING (UTM10) | HEIGHT ABOVE MSL (m) |
|---|---|---|---|---|---|---|---|---|---|---|---|---|
| 85 | elevated bridge drop / log ride | | improve | complex stunt built on two fallen logs, and combination bridge and log ride. Newly constructed and in good condition, improve fall zones. | n | 2 | y | 1 | DSCN6864.JPG | 5547264 | 660701 | 1508 |

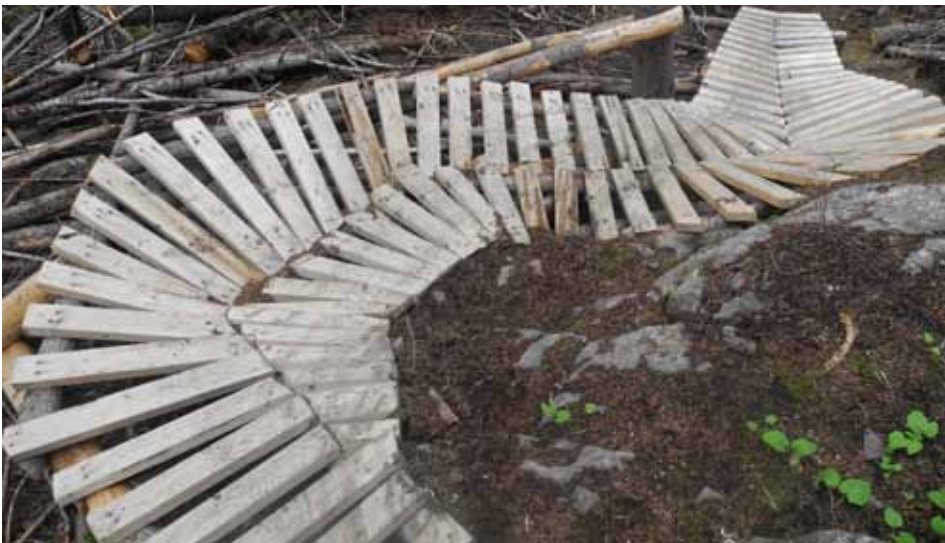
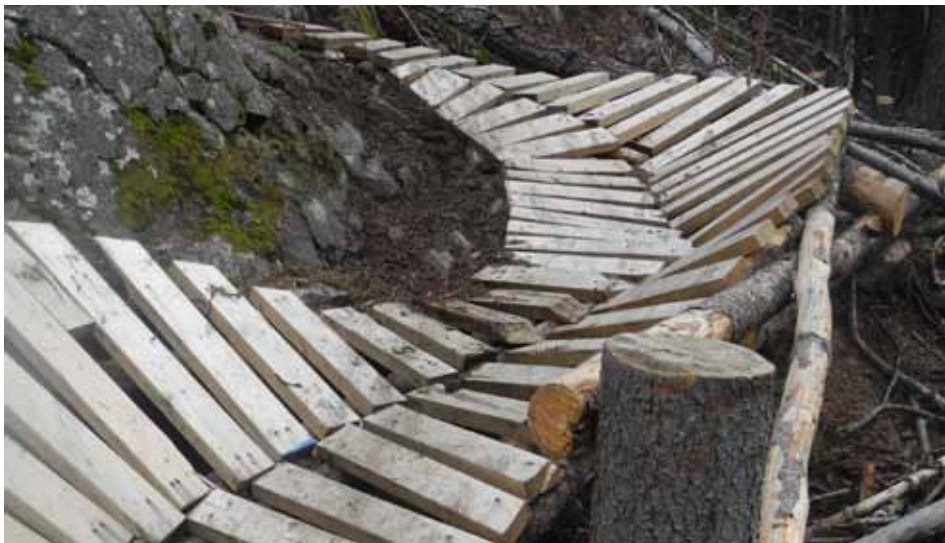
| NO. | ITEM | DIMENSION (MM) | PRESCRIPTION | IMPROVEMNT | MEETS STANDARD | LIFE (YEARS) | MANDATORY | FALL_ZONE (1 - POOR, 5 - GOOD) | IMAGE | NORTHING (UTM10) | EASTING (UTM10) | HEIGHT ABOVE MSL (m) |
|---|---|---|---|---|---|---|---|---|---|---|---|---|
| 86 | elevated bridge drop | | monitor | complex stunt with ramped corners, replace non-galvanized nails and improve fall zones | y | 3 | y | 1 | DSCN6874.JPG | 5547301 | 660722 | 1473 |

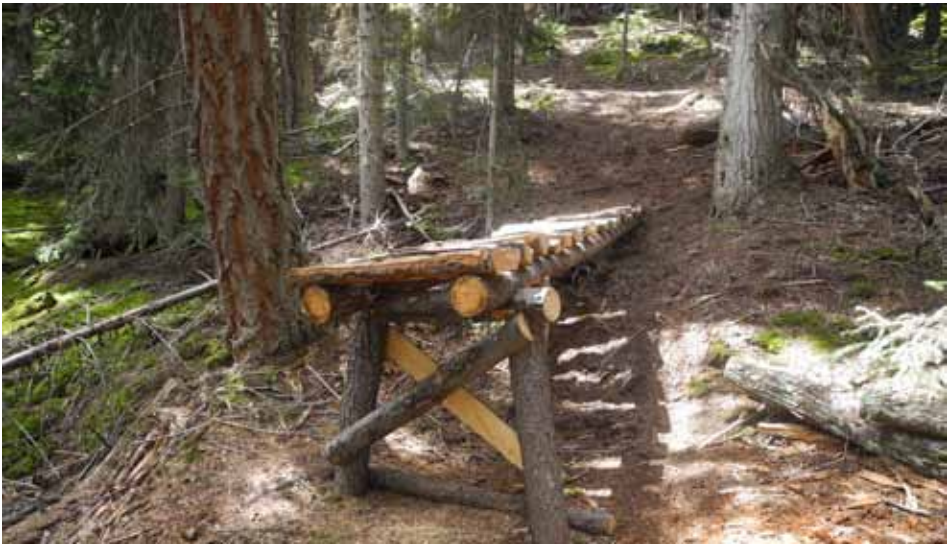
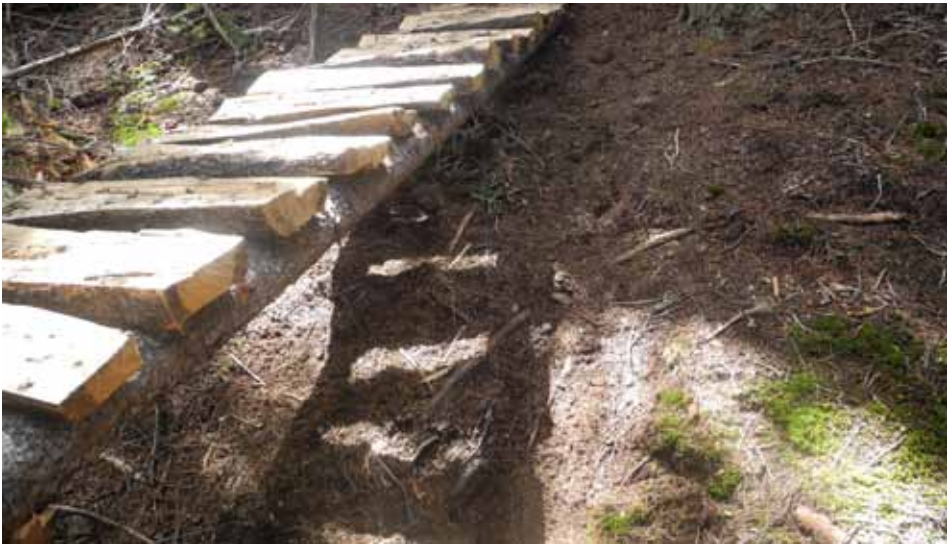
| NO. | ITEM | DIMENSION (MM) | PRESCRIPTION | IMPROVEMNT | MEETS STANDARD | LIFE (YEARS) | MANDATORY | FALL_ZONE (1 - POOR, 5 - GOOD) | IMAGE | NORTHING (UTM10) | EASTING (UTM10) | HEIGHT ABOVE MSL (m) |
|---|---|---|---|---|---|---|---|---|---|---|---|---|
| 87 | elevated bridge drop | 670w x 1750h x 4000l | improve | soundly built, ridearound available, improve fall zones | n | 3 | n | 1 | DSCN6950.JPG | 5547324 | 660729 | 1476 |

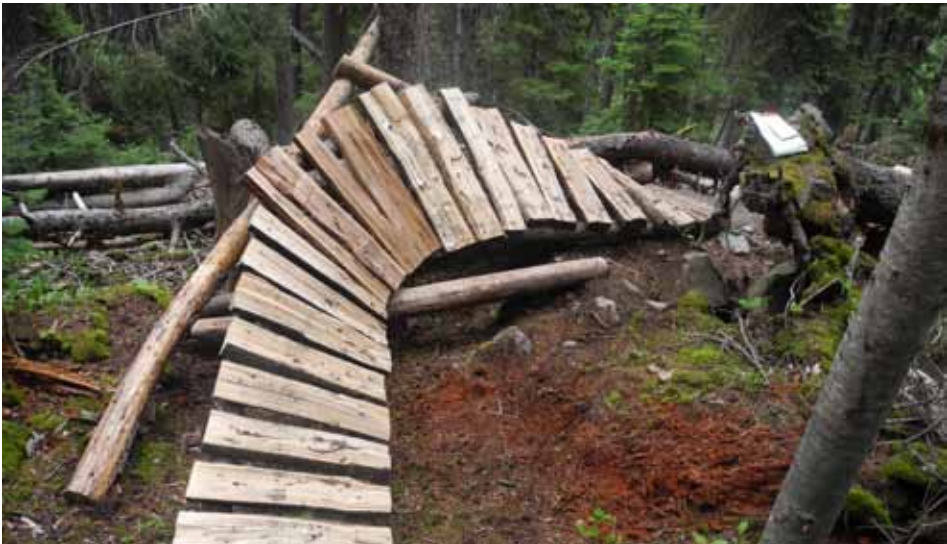
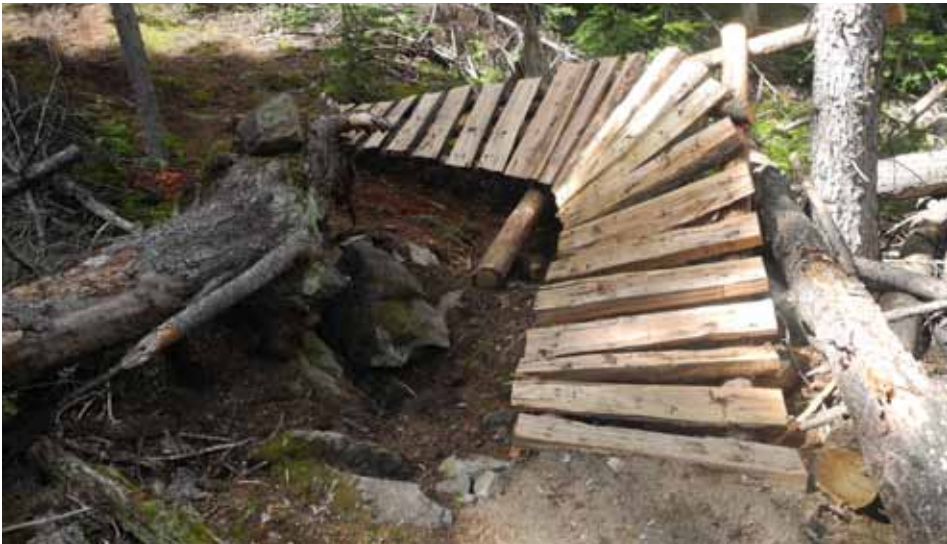
| NO. | ITEM | DIMENSION (MM) | PRESCRIPTION | IMPROVEMNT | MEETS STANDARD | LIFE (YEARS) | MANDATORY | FALL_ZONE (1 - POOR, 5 - GOOD) | IMAGE | NORTHING (UTM10) | EASTING (UTM10) | HEIGHT ABOVE MSL (m) |
|---|---|---|---|---|---|---|---|---|---|---|---|---|
| 88 | wall ride | | monitor | newly constructed with split log, replace non-galvanized nails, improve fall zones | y | 5 | y | 1 | DSCN6880.JPG | 5547341 | 660737 | 1474 |
