# MOUNTAIN BIKE TRAIL & TECHNICAL TRAIL FEATURE INSPECTION

IRON MOUNTAIN, MERRITT, BC

Ministry of Ministry of Forests, Lands and  
Natural Resource Operations

Cascades District – Recreation Sites & Trails  
August 2012

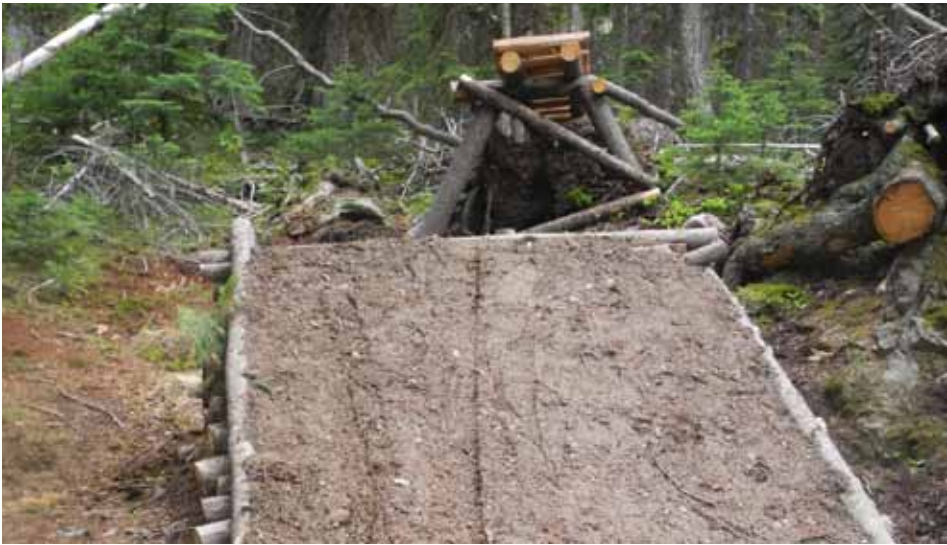
| NO. | ITEM | DIMENSION (MM) | PRESCRIPTION | IMPROVEMNT | MEETS STANDARD | LIFE (YEARS) | MANDATORY | FALL_ZONE (1 - POOR, 5 - GOOD) | IMAGE | NORTHING (UTM10) | EASTING (UTM10) | HEIGHT ABOVE MSL (M) |
|---|---|---|---|---|---|---|---|---|---|---|---|---|
| 89 | gap jump | 660w x 4500l x 1600h x 5000gap | improve | improve by widening the decking, improve the sight lines, and improve the ride-around | n | 5 | y | 1 | DSCN6889.JPG | 5547352 | 660755 | 1468 |

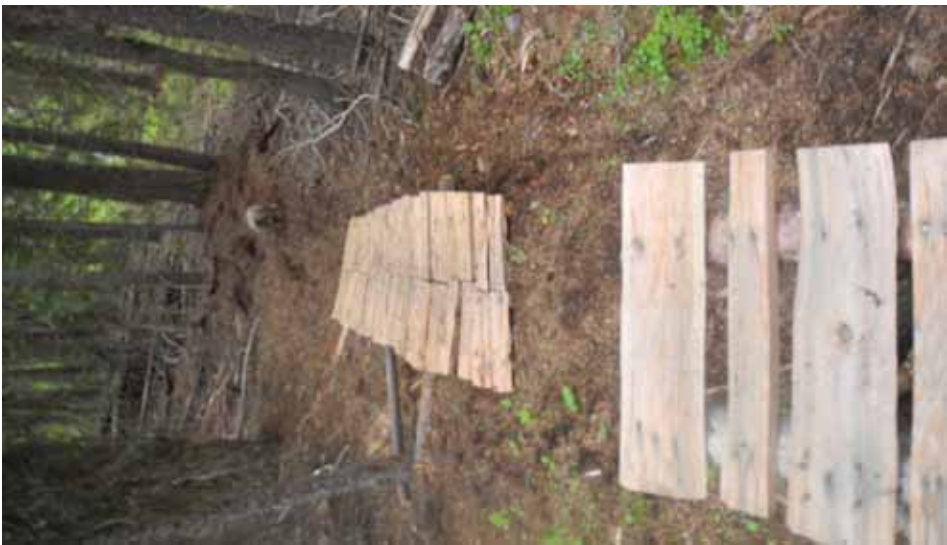
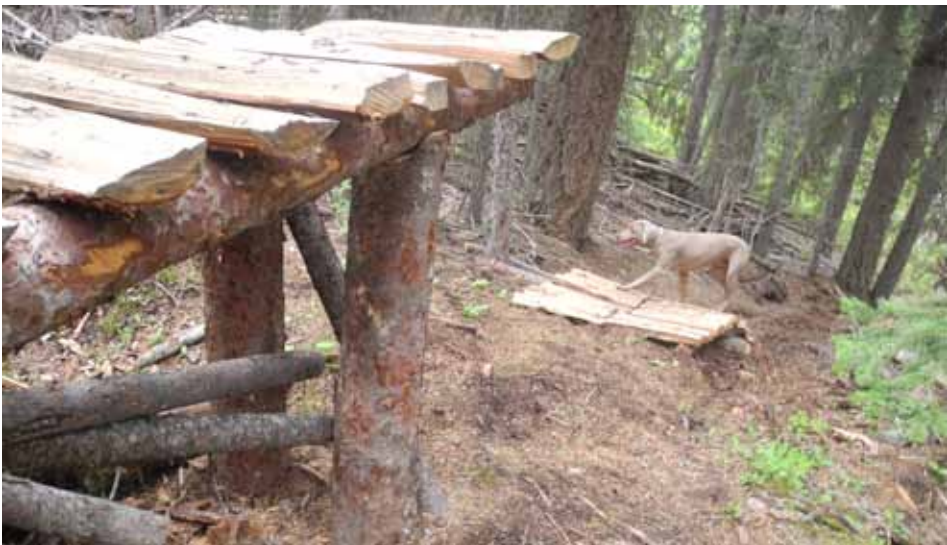
| NO. | ITEM | DIMENSION (MM) | PRESCRIPTION | IMPROVEMNT | MEETS STANDARD | LIFE (YEARS) | MANDATORY | FALL_ZONE (1 - POOR, 5 - GOOD) | IMAGE | NORTHING (UTM10) | EASTING (UTM10) | HEIGHT ABOVE MSL (M) |
|---|---|---|---|---|---|---|---|---|---|---|---|---|
| 90 | elevated bridge drop | 700w x 1200h x 4000l | monitor | split log construction in good condition, ground level-boardwalk landing okay | y | 5 | y | 2 | DSCN6891.JPG | 5547391 | 660765 | 1448 |

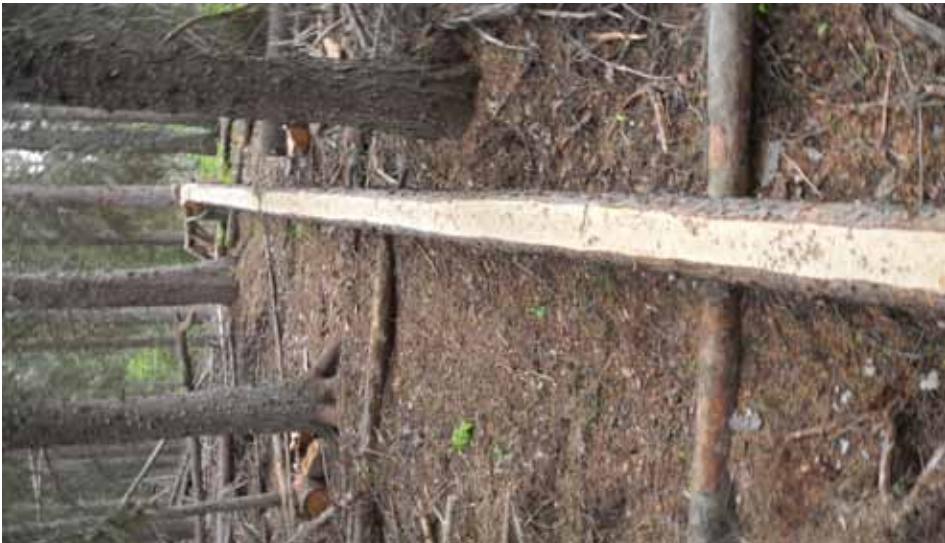
| NO. | ITEM | DIMENSION (MM) | PRESCRIPTION | IMPROVEMNT | MEETS STANDARD | LIFE (YEARS) | MANDATORY | FALL_ZONE (1 - POOR, 5 - GOOD) | IMAGE | NORTHING (UTM10) | EASTING (UTM10) | HEIGHT ABOVE MSL (M) |
|---|---|---|---|---|---|---|---|---|---|---|---|---|
| 91 | elevated bridge roll / log ride | 620w x 1000h x 28000l | monitor | complex stunt consisting of ramps onto log ride and ramp to ground level, newly constructed and in good condition | y | 5 | y | 3 | DSCN6898.JPG | 5547418 | 660777 | 1490 |

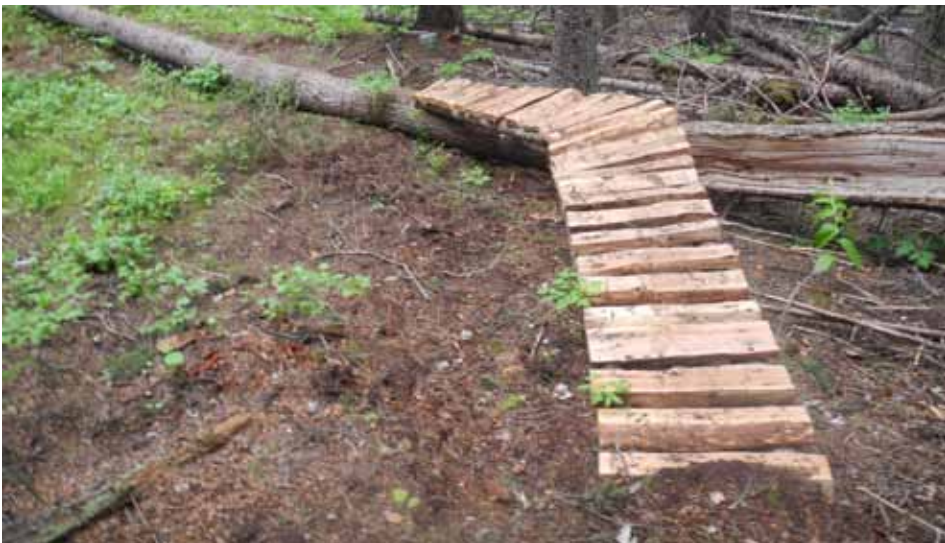
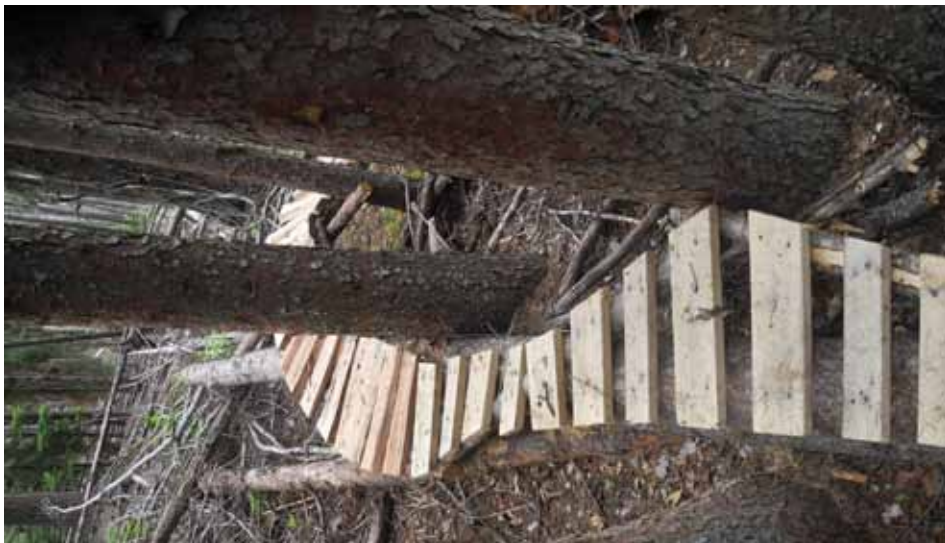
| NO. | ITEM | DIMENSION (MM) | PRESCRIPTION | IMPROVEMNT | MEETS STANDARD | LIFE (YEARS) | MANDATORY | FALL_ZONE (1 - POOR, 5 - GOOD) | IMAGE | NORTHING (UTM10) | EASTING (UTM10) | HEIGHT ABOVE MSL (M) |
|---|---|---|---|---|---|---|---|---|---|---|---|---|
| 92 | elevated bridge roll / log ride | | monitor | complex stunt consisting of ramps onto fallen log rand ramp to ground level, newly constructed and in good condition | n | 5 | y | 2 | DSCN6903.JPG | 5547457 | 660797 | 1430 |

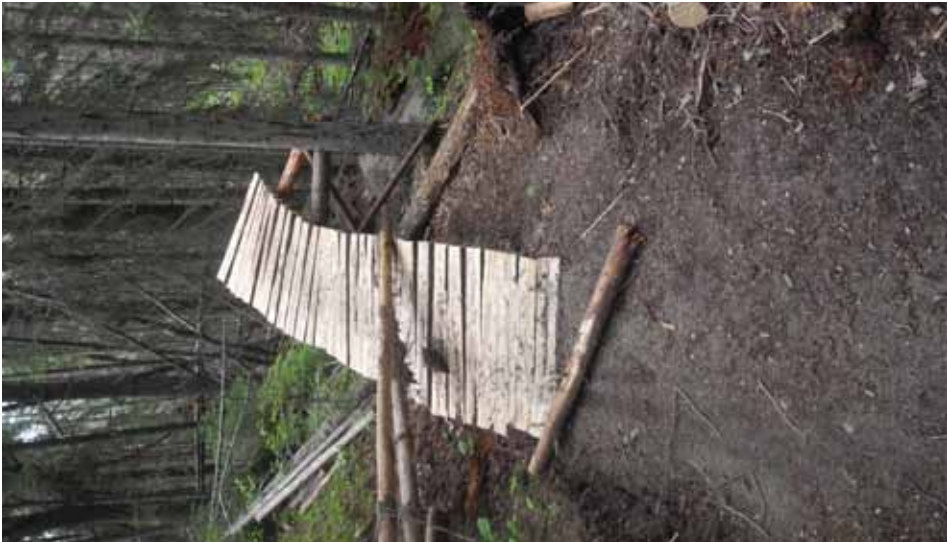
| NO. | ITEM | DIMENSION (MM) | PRESCRIPTION | IMPROVEMNT | MEETS STANDARD | LIFE (YEARS) | MANDATORY | FALL_ZONE (1 - POOR, 5 - GOOD) | IMAGE | NORTHING (UTM10) | EASTING (UTM10) | HEIGHT ABOVE MSL (m) |
|---|---|---|---|---|---|---|---|---|---|---|---|---|
| 94 | gap jump | 1040w x 3000h x 300gap | improve | Newly constructed Gap jump onto hip landing in good condition. Improve by reducing the gap, or creating a ridearound | n | 5 | y | 1 | DSCN6915.JPG | 5547513 | 660866 | 1397 |

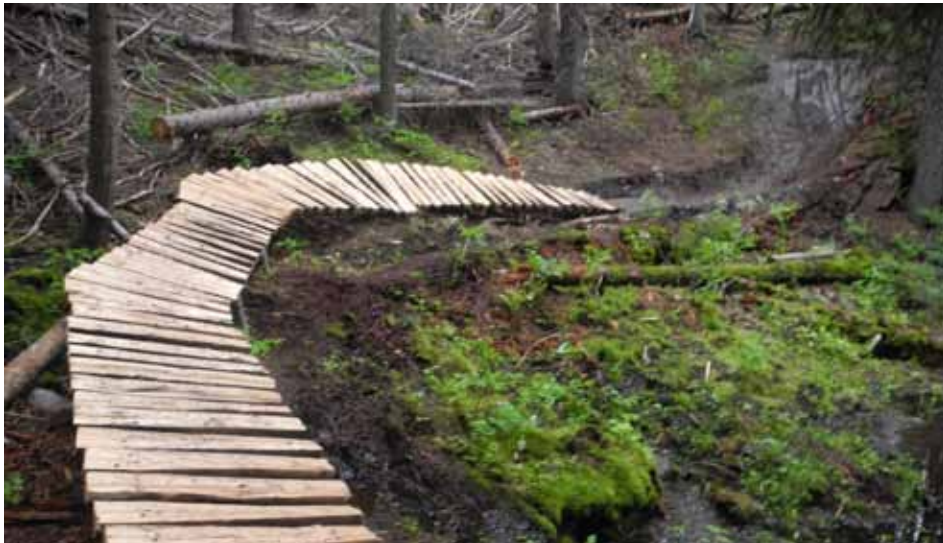
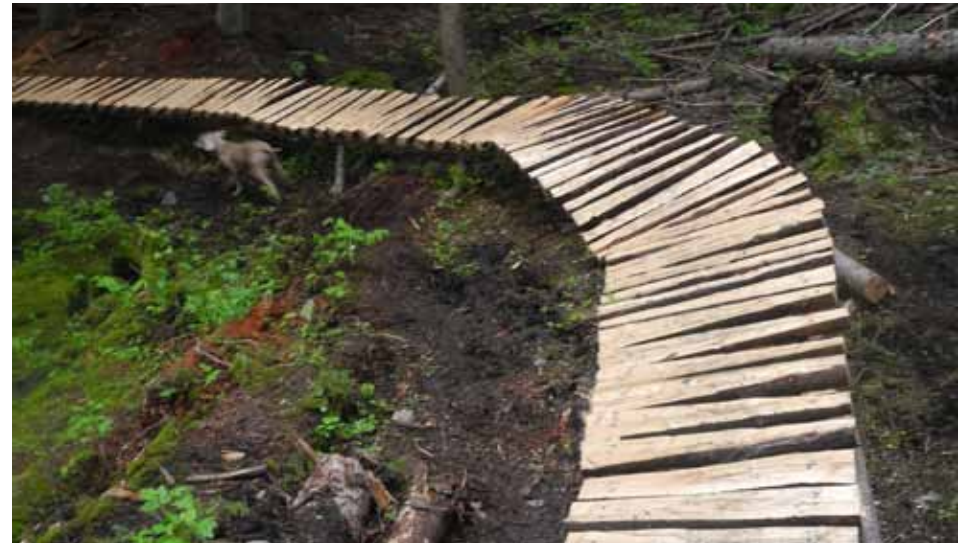
| 96 | elevated bridge roll | 760w x 500h x 10000h | monitor | Newly constructed ground level boardwalk in good condition. | y | 5 | y | 3 | DSCN6919.JPG | 5547518 | 660883 | 1390 |

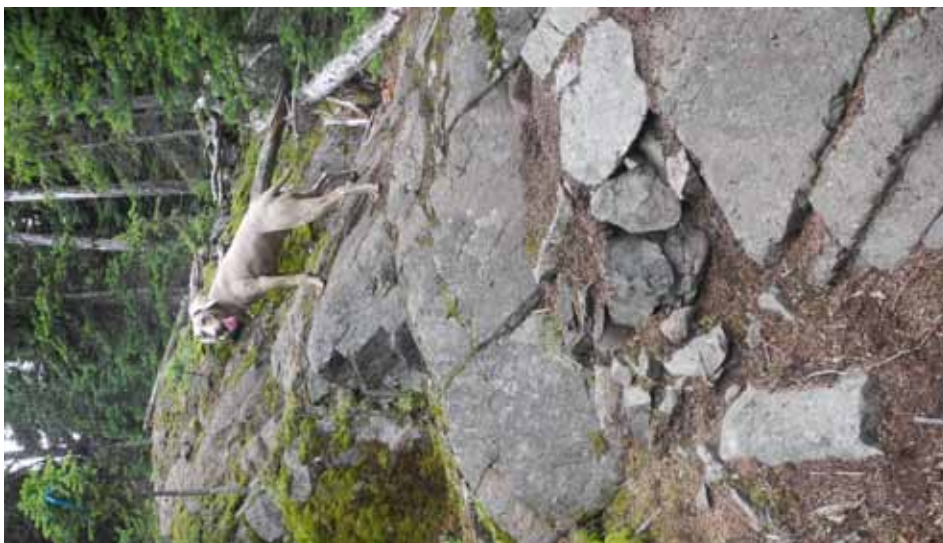
| 134 | rock drop | | monitor | good natural feature, create ridearound or trail requires gateway | y | 5 | y | 2 | DSCN6841.JPG | 5546904 | 660672 | 1577 |

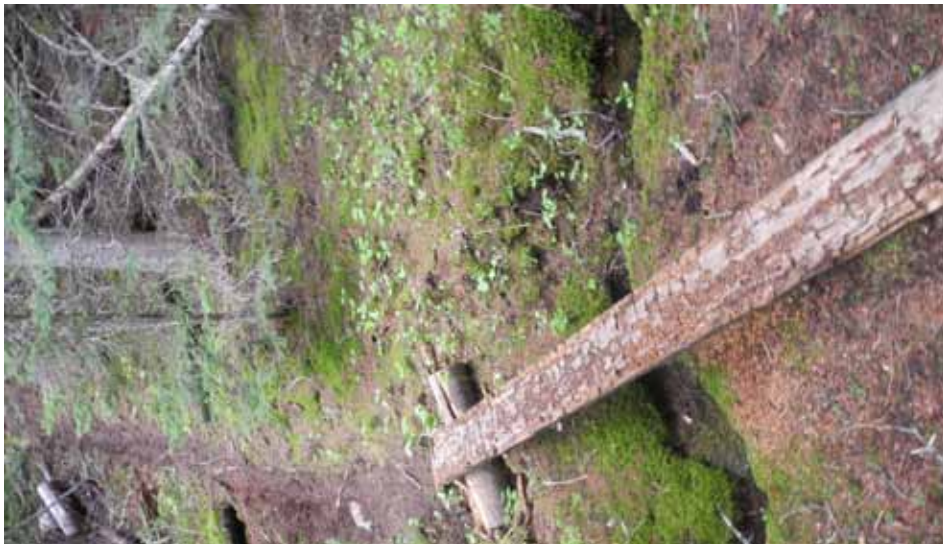
| NO. | ITEM | DIMENSION (MM) | PRESCRIPTION | IMPROVEMNT | MEETS STANDARD | LIFE (YEARS) | MANDATORY | FALL_ZONE (1 - POOR, 5 - GOOD) | IMAGE | NORTHING (UTM10) | EASTING (UTM10) | HEIGHT ABOVE MSL (m) |
|---|---|---|---|---|---|---|---|---|---|---|---|---|
| 135 | log ride | 200w x 500h x 3000l | improve | marshy log, adequate for now but should be replaced with something of larger dimension or remove of replace with dirt trail | y | 3 | y | 2 | DSCN6837.JPG | 5546856 | 660648 | 1602 |

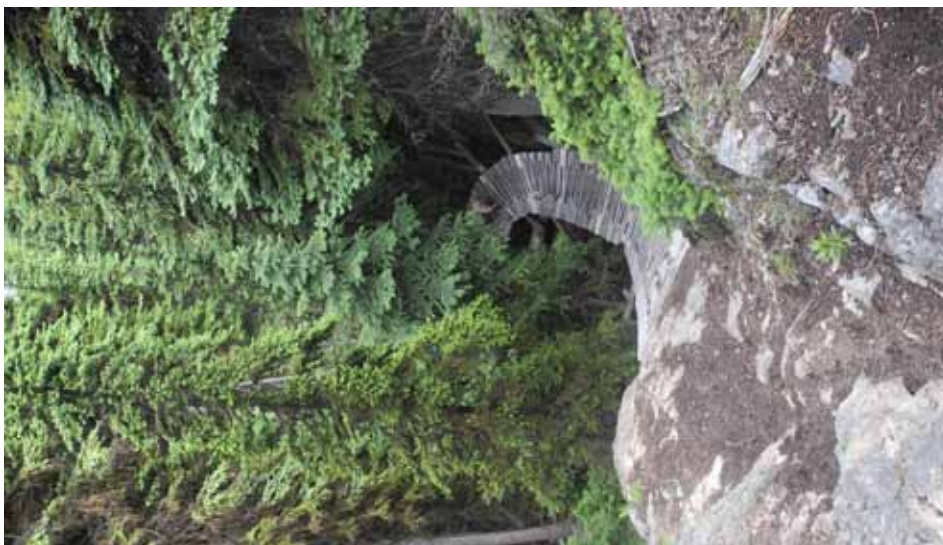
| 136 | rock drop | mandatory | monitor | Rock drop to stunt #75 is good natural feature but trail needs gateway feature | n | 1 | y | 2 | DSCN6818.JPG | 5546604 | 660619 | 1666 |

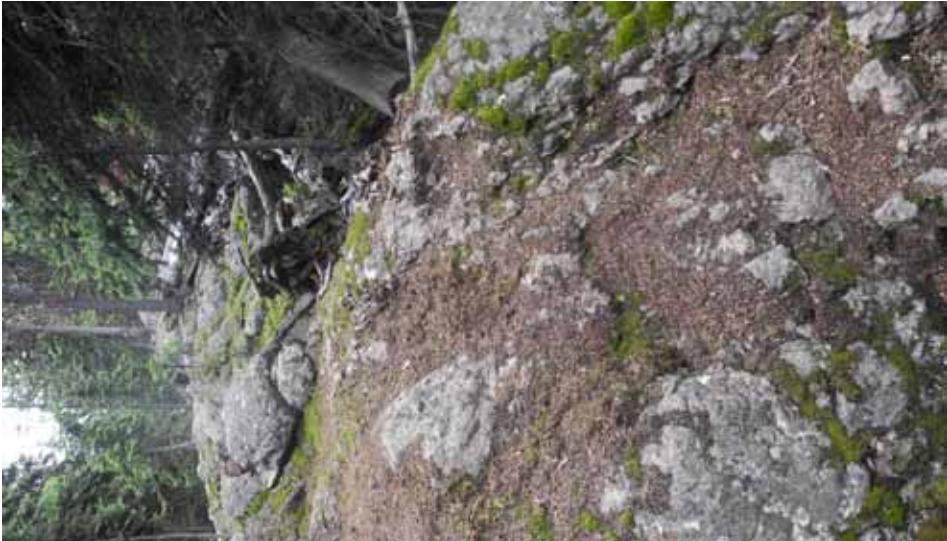
| NO. | ITEM | DIMENSION (MM) | PRESCRIPTION | IMPROVEMNT | MEETS STANDARD | LIFE (YEARS) | MANDATORY | FALL_ZONE (1 - POOR, 5 - GOOD) | IMAGE | NORTHING (UTM10) | EASTING (UTM10) | HEIGHT ABOVE MSL (M) |
|---|---|---|---|---|---|---|---|---|---|---|---|---|
| 137 | rock drop | 30m - not hard enough as gatew | monitor | good natural feature, create ridearound or trail requires gateway | y | 1 | y | 1 | DSCN6809.JPG | 5546537 | 660584 | 1680 |

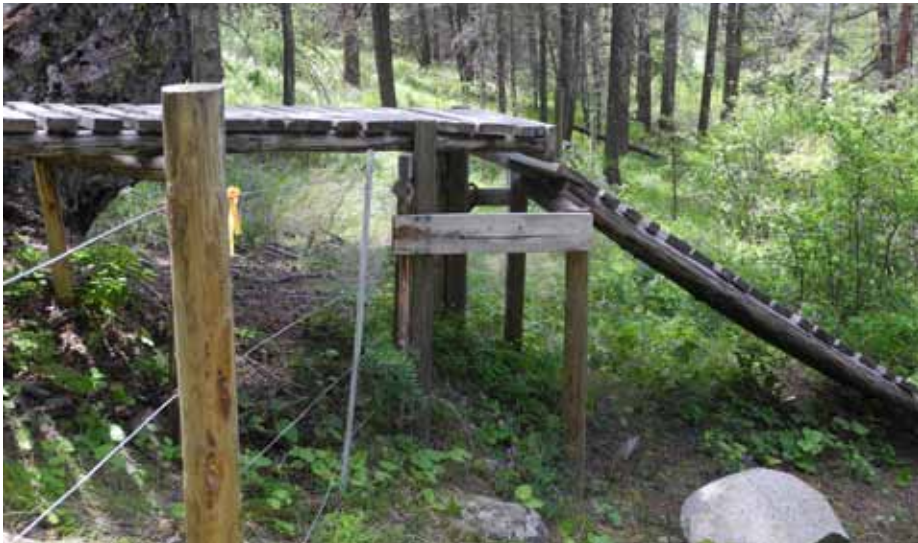
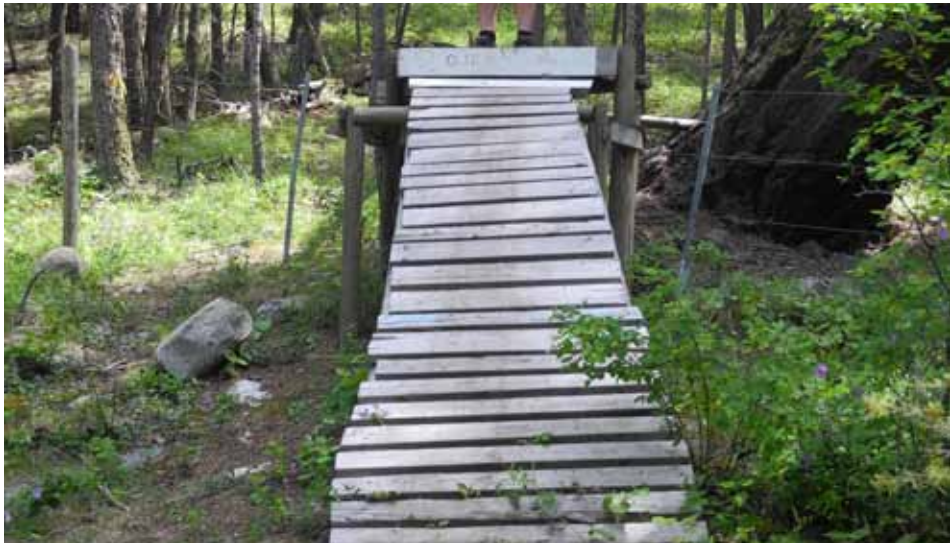
| NO. | ITEM | DIMENSION (MM) | DESCRIPTION | IMPROVEMNT | MEETS STANDARD | LIFE (YEARS) | MANDATORY | FALL_ZONE (1 - POOR, 5 - GOOD) | IMAGE | NORTHING (UTM10) | EASTING (UTM10) | HEIGHT ABOVE MSL (m) |
|---|---|---|---|---|---|---|---|---|---|---|---|---|
| 1 | elevated bridge roll | 875w x 4515l x 1510h | improve | create ride around by building a turnstyle through fence due to poor fall zones over barbed wire fence | y | 2 | y | 1 | DSCN6039.JPG | 5550413 | 661318 | 760 |

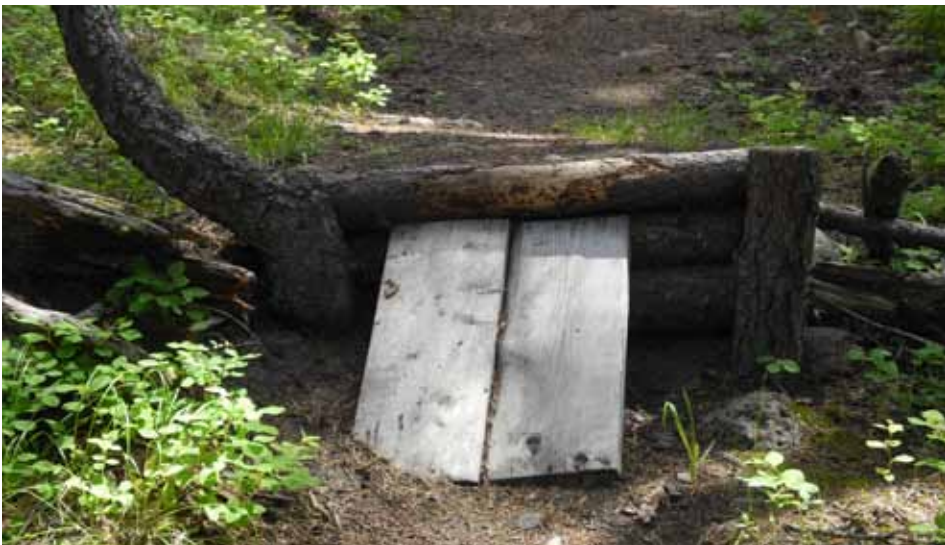
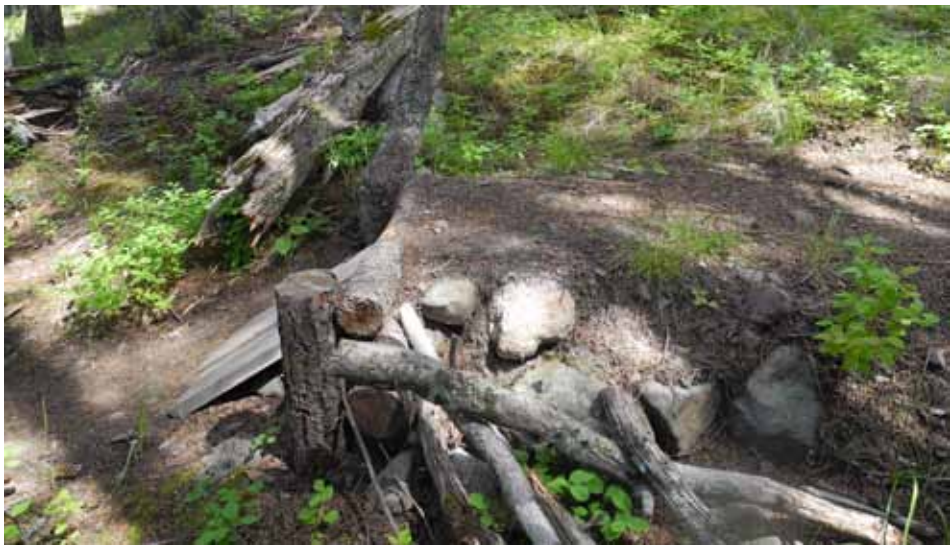
| NO. | ITEM | DIMENSION (MM) | DESCRIPTION | IMPROVEMNT | MEETS STANDARD | LIFE (YEARS) | MANDATORY | FALL_ZONE (1 - POOR, 5 - GOOD) | IMAGE | NORTHING (UTM10) | EASTING (UTM10) | HEIGHT ABOVE MSL (m) |
|---|---|---|---|---|---|---|---|---|---|---|---|---|
| 2 | dirt roll | 1070w x 700h x 1500l | improve | create ride around or clear the fall zone of debris | y | 2 | y | 1 | DSCN6045.JPG | 5550401 | 661331 | 763 |

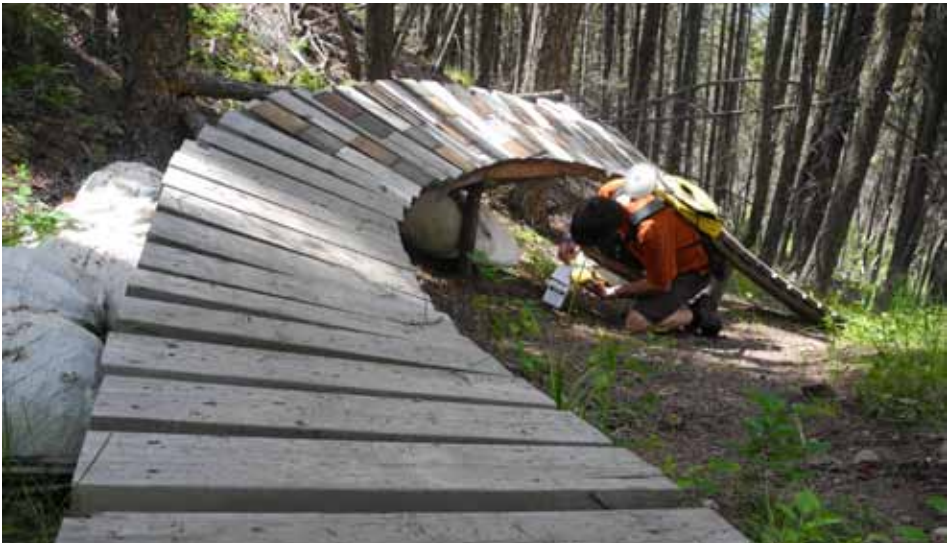
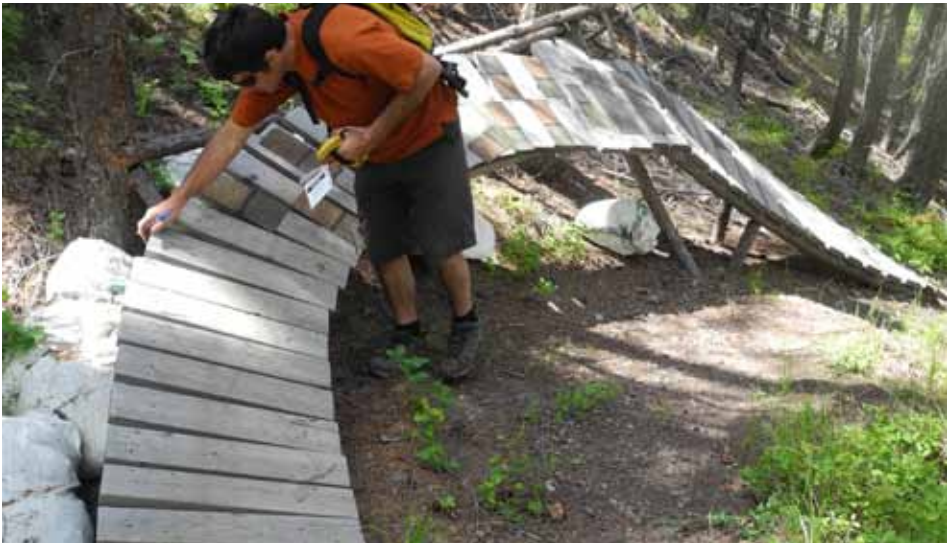
| NO. | ITEM | DIMENSION (MM) | PRESCRIPTION | IMPROVEMNT | MEETS STANDARD | LIFE (YEARS) | MANDATORY | FALL_ZONE (1 - POOR, 5 - GOOD) | IMAGE | NORTHING (UTM10) | EASTING (UTM10) | HEIGHT ABOVE MSL (m) |
|---|---|---|---|---|---|---|---|---|---|---|---|---|
| 3 | wall ride | 692w x 1000h x 9000l | improve | improve by removing shingles on decking and replace non-galv nails | y | 2 | n | 5 | DSCN6068.JPG | 5550388 | 661334 | 770 |

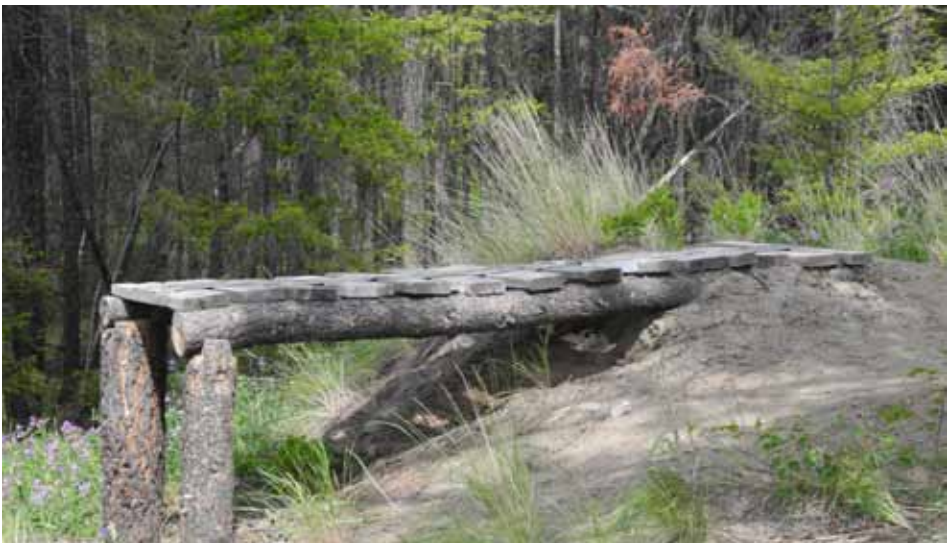
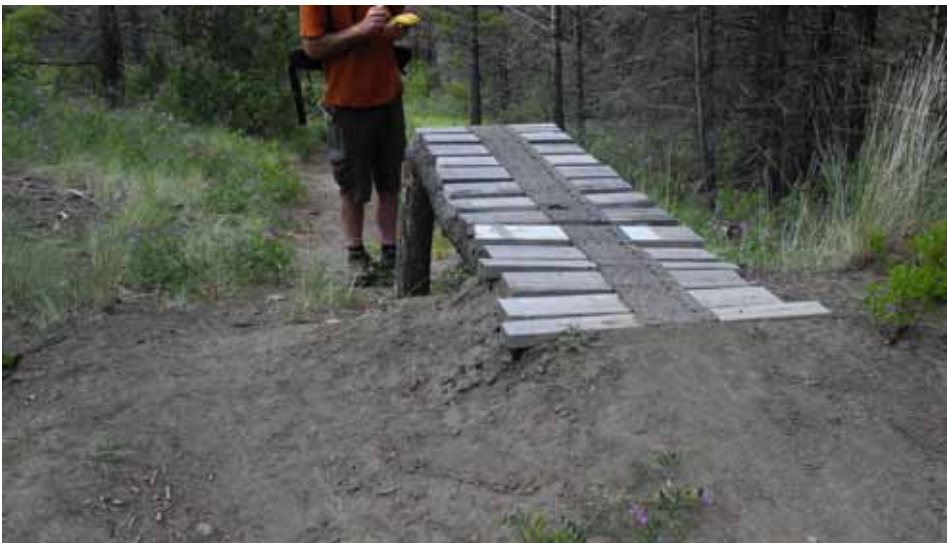
| NO. | ITEM | DIMENSION (MM) | PRESCRIPTION | IMPROVEMNT | MEETS STANDARD | LIFE (YEARS) | MANDATORY | FALL_ZONE (1 - POOR, 5 - GOOD) | IMAGE | NORTHING (UTM10) | EASTING (UTM10) | HEIGHT ABOVE MSL (m) |
|---|---|---|---|---|---|---|---|---|---|---|---|---|
| 4 | elevated bridge drop | 610w x 2460l x 860h | improve | improve by installing four nails per deck board, currently two/board | y | 5 | n | 5 | DSCN6145.JPG | 5549728 | 661470 | 915 |

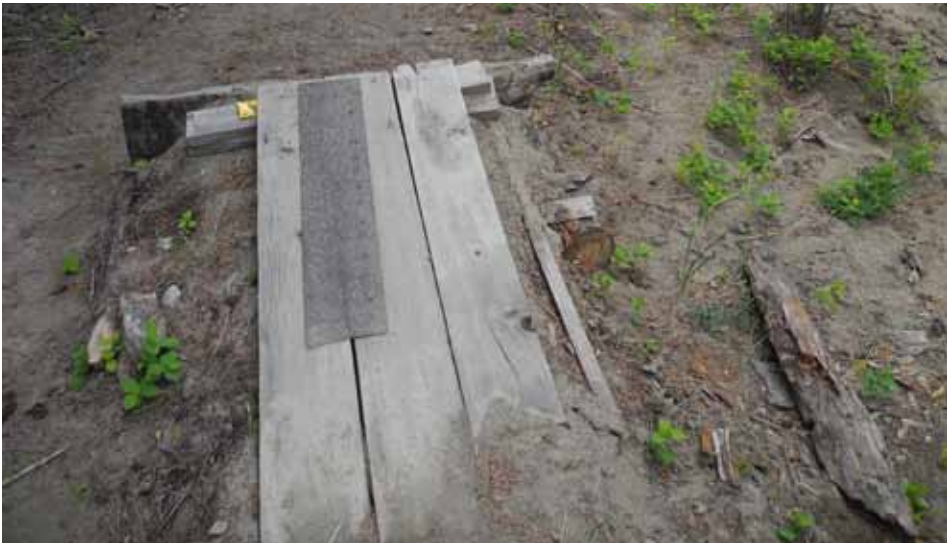
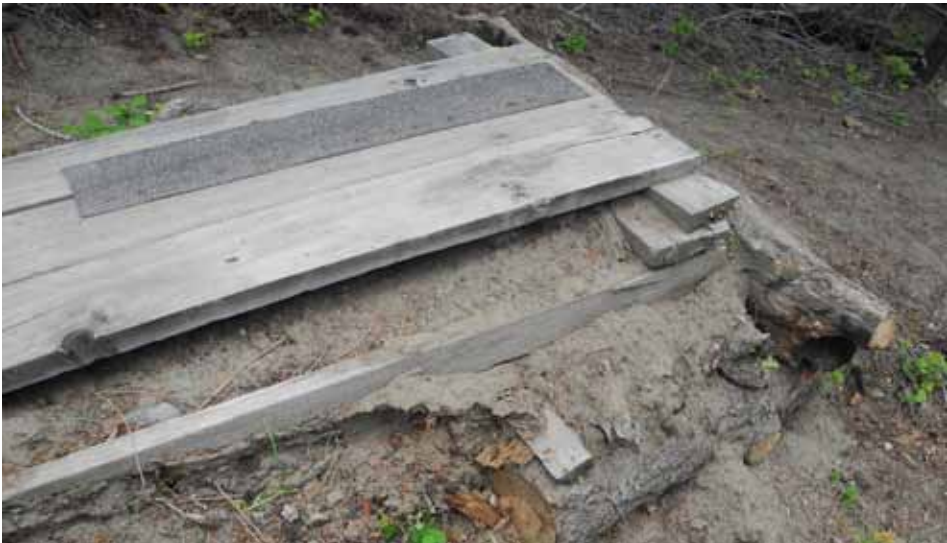
| NO. | ITEM | DIMENSION (MM) | PRESCRIPTION | IMPROVEMNT | MEETS STANDARD | LIFE (YEARS) | MANDATORY | FALL_ZONE (1 - POOR, 5 - GOOD) | IMAGE | NORTHING (UTM10) | EASTING (UTM10) | HEIGHT ABOVE MSL (m) |
|---|---|---|---|---|---|---|---|---|---|---|---|---|
| 5 | elevated bridge drop | 600w x 1500l x 500h | monitor | logs buried in dirt creating drop will rot and should be replaced with rock or dirt, minor movement in takeoff of jump | y | 3 | n | 5 | DSCN6160.JPG | 5549717 | 661497 | 919 |

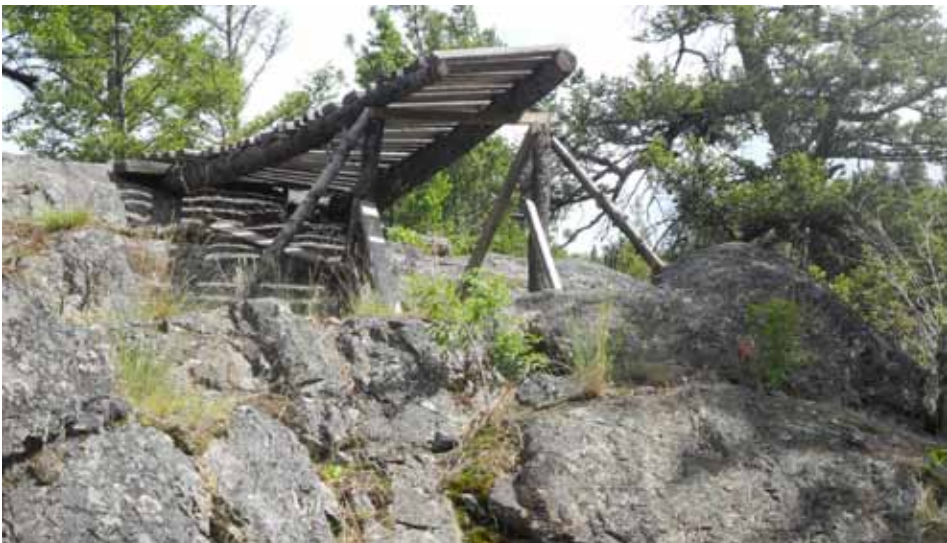
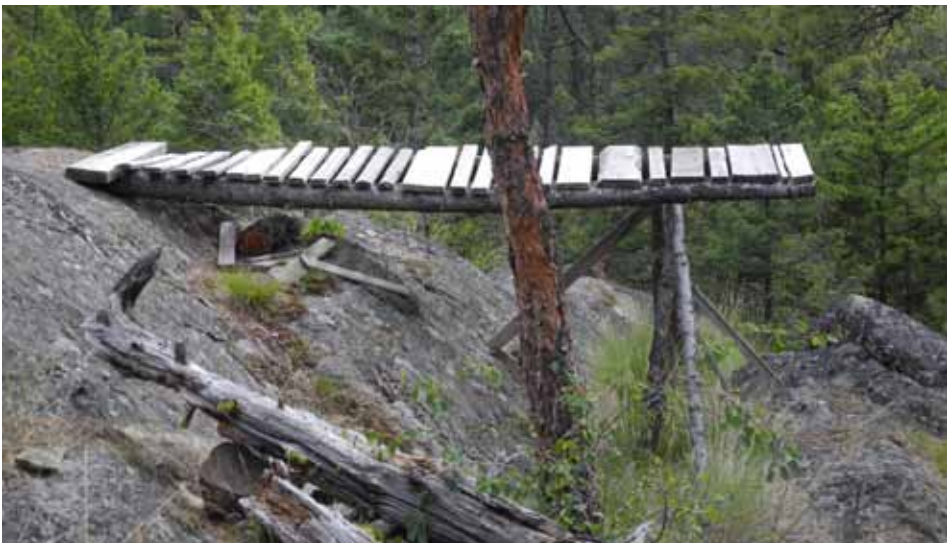
| NO. | ITEM | DIMENSION (MM) | PRESCRIPTION | IMPROVEMNT | MEETS STANDARD | LIFE (YEARS) | MANDATORY | FALL_ZONE (1 - POOR, 5 - GOOD) | IMAGE | NORTHING (UTM10) | EASTING (UTM10) | HEIGHT ABOVE MSL (m) |
|---|---|---|---|---|---|---|---|---|---|---|---|---|
| 6 | elevated bridge drop | 700w x 4080l x 1600h | remove | overspanned stringers, poor fall zones, poorly anchored at base of stunt, existing rock down sufficient stunt | n | 2 | y | 1 | DSCN6181.JPG | 5549538 | 661874 | 974 |

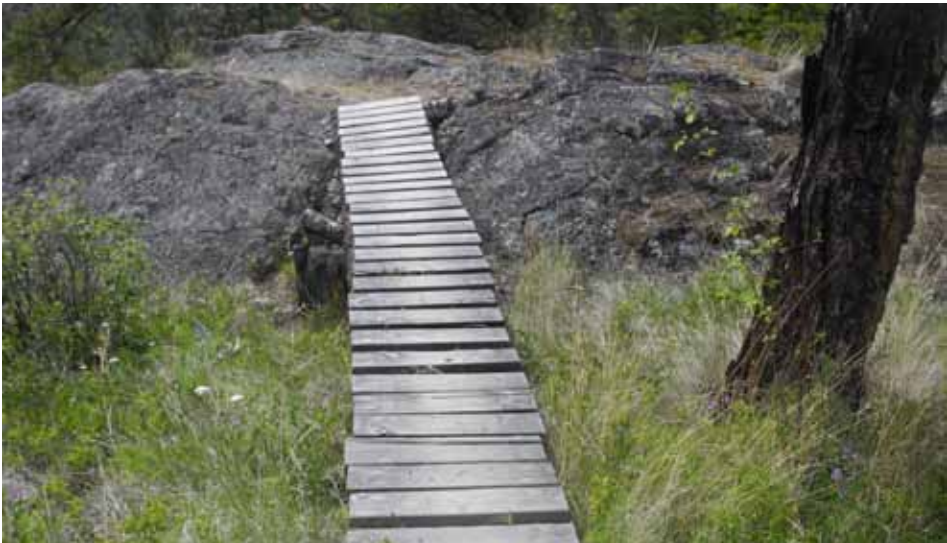
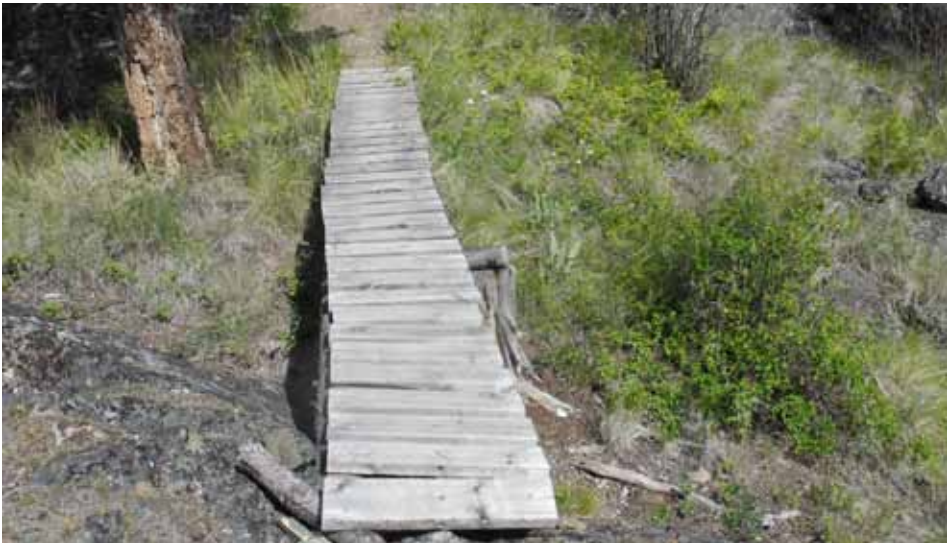
| NO. | ITEM | DIMENSION (MM) | PRESCRIPTION | IMPROVEMNT | MEETS STANDARD | LIFE (YEARS) | MANDATORY | FALL_ZONE (1 - POOR, 5 - GOOD) | IMAGE | NORTHING (UTM10) | EASTING (UTM10) | HEIGHT ABOVE MSL (m) |
|---|---|---|---|---|---|---|---|---|---|---|---|---|
| 7 | elevated bridge | 620w x 7000l x 870h | improve | stringers have a great deal of deflection when walked on, and should be improved by installing better footings or mid-span support | n | 2 | y | 5 | DSCN6195.JPG | 5549544 | 661897 | 979 |

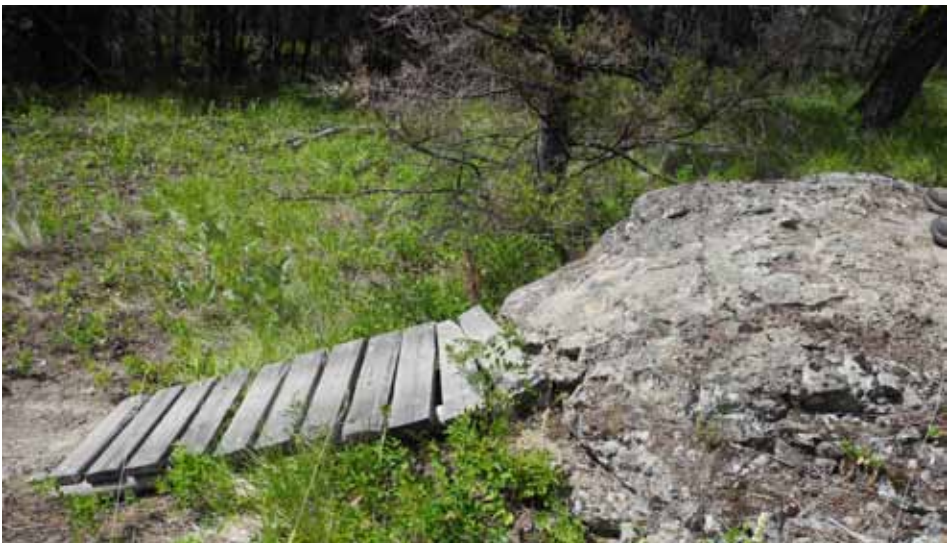
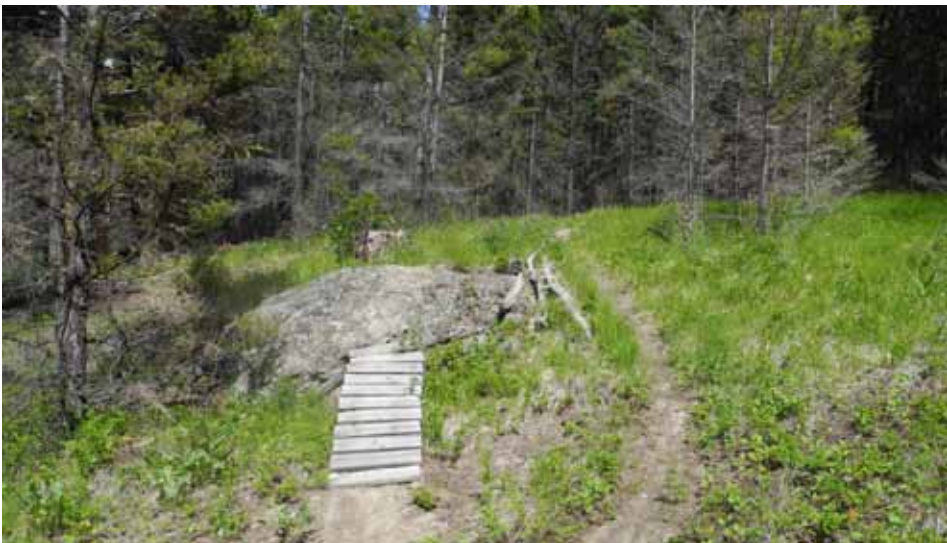
| NO. | ITEM | DIMENSION (MM) | PRESCRIPTION | IMPROVEMNT | MEETS STANDARD | LIFE (YEARS) | MANDATORY | FALL_ZONE (1 - POOR, 5 - GOOD) | IMAGE | NORTHING (UTM10) | EASTING (UTM10) | HEIGHT ABOVE MSL (m) |
|---|---|---|---|---|---|---|---|---|---|---|---|---|
| 8 | rock drop / bridge roll | 610w x 890l x 1500h | monitor | improve by eliminating wood in contact with ground but maintain stunt by building a stone and dirt landing ramp | y | 5 | n | 5 | DSCN6202.JPG | 5549592 | 661950 | 988 |

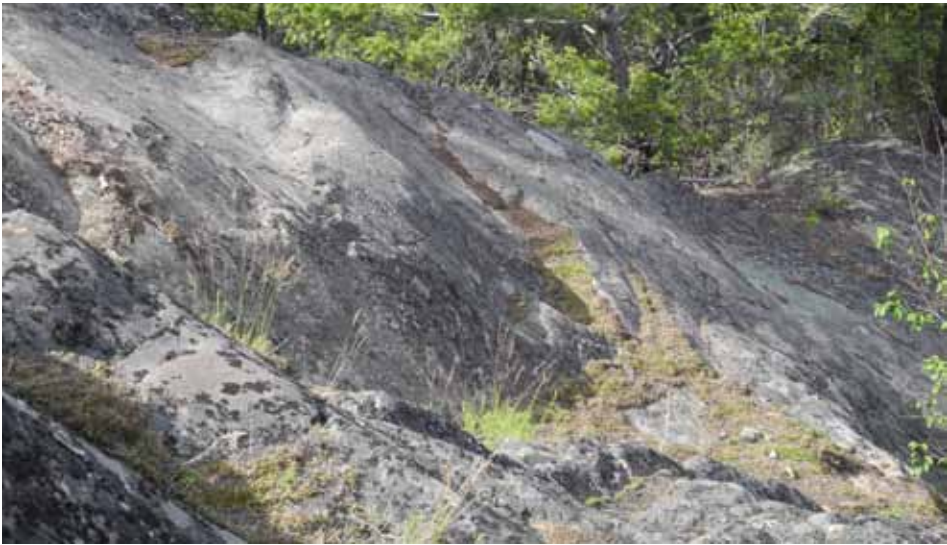
| NO. | ITEM | DIMENSION (MM) | PREScription | IMPROVEMNT | MEETS STANDARD | LIFE (YEARS) | MANDATORY | FALL_ZONE (1 - POOR, 5 - GOOD) | IMAGE | NORTHING (UTM10) | EASTING (UTM10) | HEIGHT ABOVE MSL (m) |
|---|---|---|---|---|---|---|---|---|---|---|---|---|
| 39 | rock roll | | monitor | good natural feature | y | 5 | y | 2 | DSCN6355.JPG | 5549546 | 661869 | 972 |

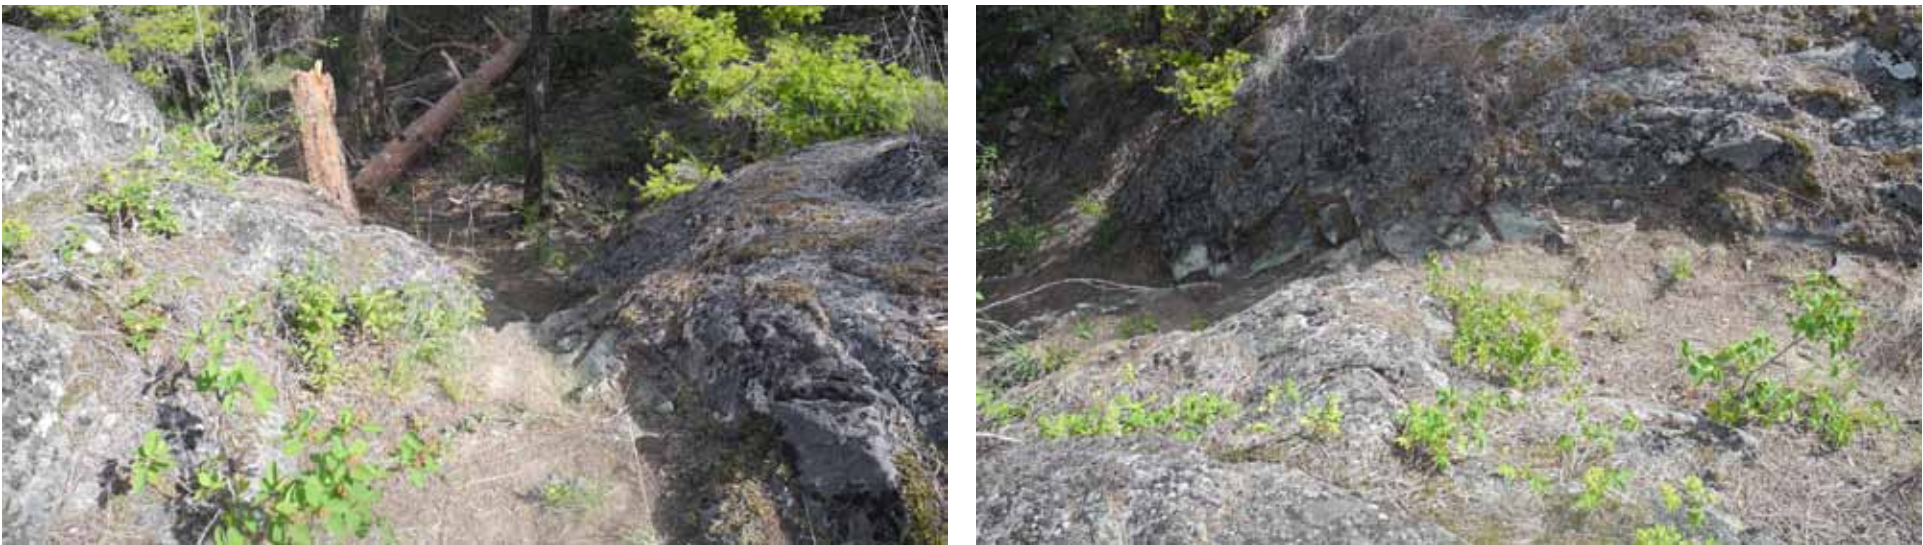
| NO. | ITEM | DIMENSION (MM) | PREScription | IMPROVEMNT | MEETS STANDARD | LIFE (YEARS) | MANDATORY | FALL_ZONE (1 - POOR, 5 - GOOD) | IMAGE | NORTHING (UTM10) | EASTING (UTM10) | HEIGHT ABOVE MSL (m) |
|---|---|---|---|---|---|---|---|---|---|---|---|---|
| 40 | rock roll | | monitor | good natural feature | y | 5 | y | 2 | DSCN6361.JPG | 5549554 | 661899 | 978 |

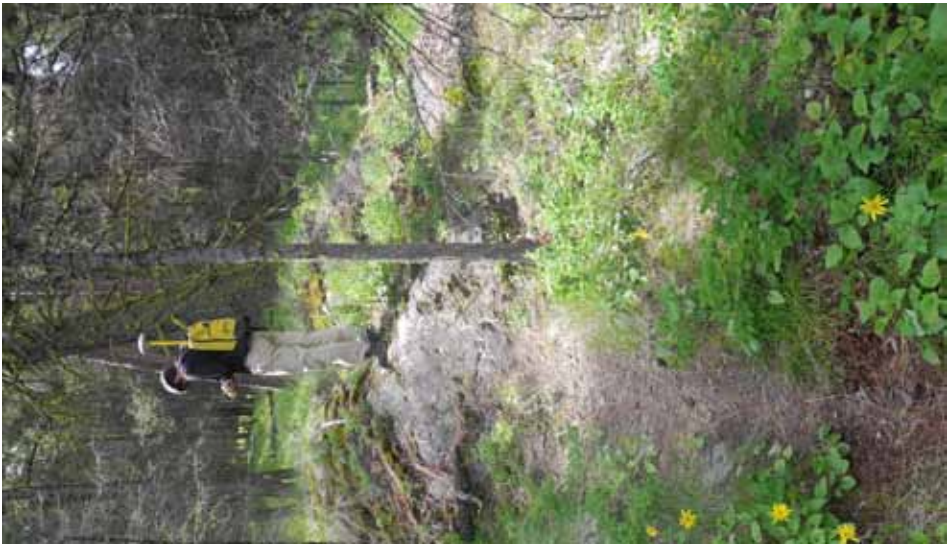
| NO. | ITEM | DIMENSION (MM) | PREScription | IMPROVEMNT | MEETS STANDARD | LIFE (YEARS) | MANDATORY | FALL_ZONE (1 - POOR, 5 - GOOD) | IMAGE | NORTHING (UTM10) | EASTING (UTM10) | HEIGHT ABOVE MSL (M) |
|---|---|---|---|---|---|---|---|---|---|---|---|---|
| 42 | rock roll | 3000h | monitor | good natural feature | y | 5 | y | 2 | DSCN6382.JPG | 5549836 | 662339 | 1059 |

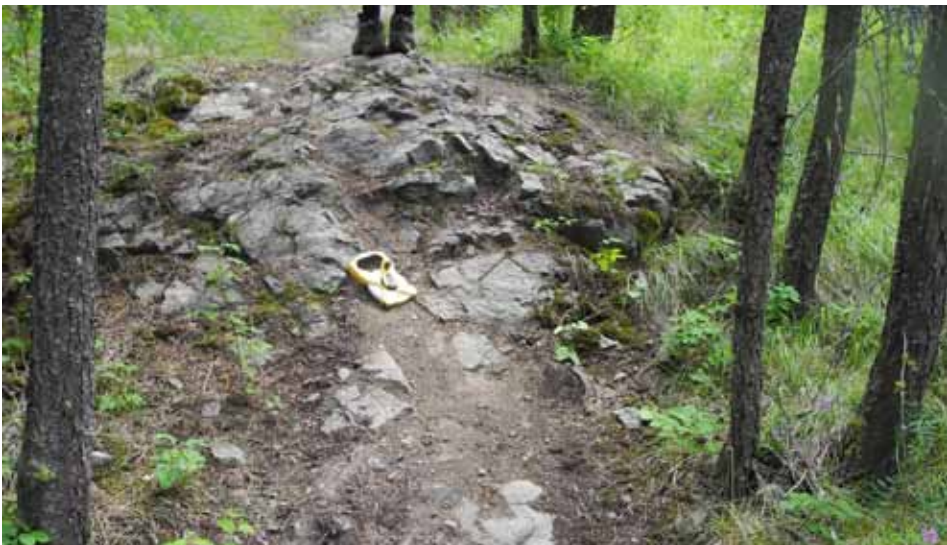
| NO. | ITEM | DIMENSION (MM) | PREScription | IMPROVEMNT | MEETS STANDARD | LIFE (YEARS) | MANDATORY | FALL_ZONE (1 - POOR, 5 - GOOD) | IMAGE | NORTHING (UTM10) | EASTING (UTM10) | HEIGHT ABOVE MSL (M) |
|---|---|---|---|---|---|---|---|---|---|---|---|---|
| 216 | rock roll | | monitor | good natural feature | y | 5 | y | 2 | DSCN6106.JPG | 5549953 | 661289 | 857 |

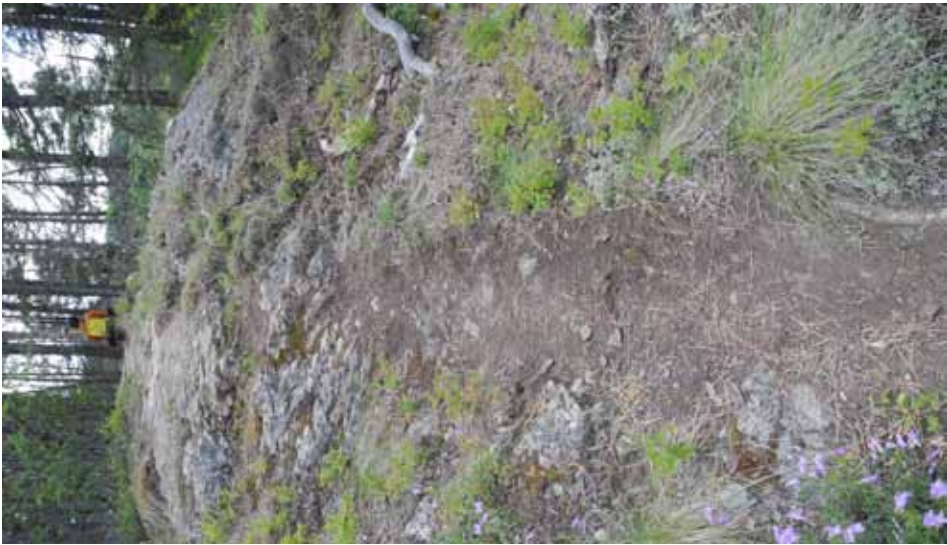
| NO. | ITEM | DIMENSION (MM) | PREScription | IMPROVEMNT | MEETS STANDARD | LIFE (YEARS) | MANDATORY | FALL_ZONE (1 - POOR, 5 - GOOD) | IMAGE | NORTHING (UTM10) | EASTING (UTM10) | HEIGHT ABOVE MSL (M) |
|---|---|---|---|---|---|---|---|---|---|---|---|---|
| 217 | rock roll | | monitor | good natural feature | y | 5 | y | 3 | DSCN6088.JPG | 5550114 | 661195 | 818 |

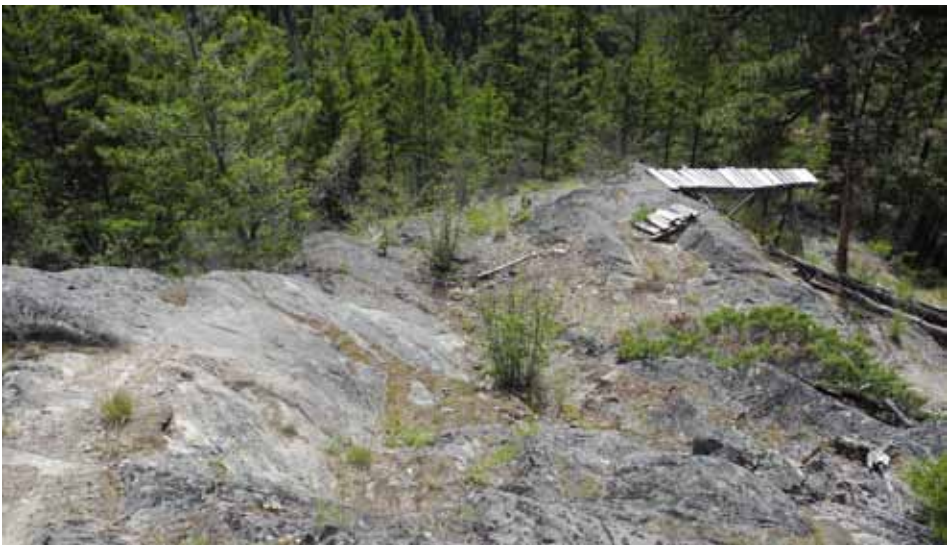
| NO. | ITEM | DIMENSION (MM) | PREScription | IMPROVEMNT | MEETS STANDARD | LIFE (YEARS) | MANDATORY | FALL_ZONE (1 - POOR, 5 - GOOD) | IMAGE | NORTHING (UTM10) | EASTING (UTM10) | HEIGHT ABOVE MSL (M) |
|---|---|---|---|---|---|---|---|---|---|---|---|---|
| 232 | rock roll | | monitor | good natural feature | y | 5 | y | 3 | DSCN6197.JPG | 5549543 | 661894 | 979 |

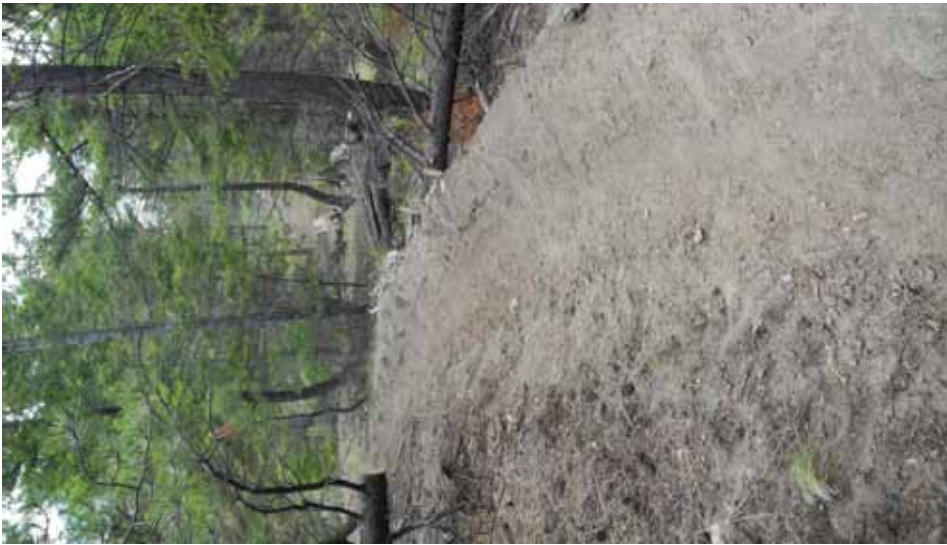
| NO. | ITEM | DIMENSION (MM) | PREScription | IMPROVEMNT | MEETS STANDARD | LIFE (YEARS) | MANDATORY | FALL_ZONE (1 - POOR, 5 - GOOD) | IMAGE | NORTHING (UTM10) | EASTING (UTM10) | HEIGHT ABOVE MSL (m) |
|---|---|---|---|---|---|---|---|---|---|---|---|---|
| 235 | berm corners | | monitor | good feature to ride | y | 5 | n | 2 | DSCN6166.JPG | 5549696 | 661600 | 938 |

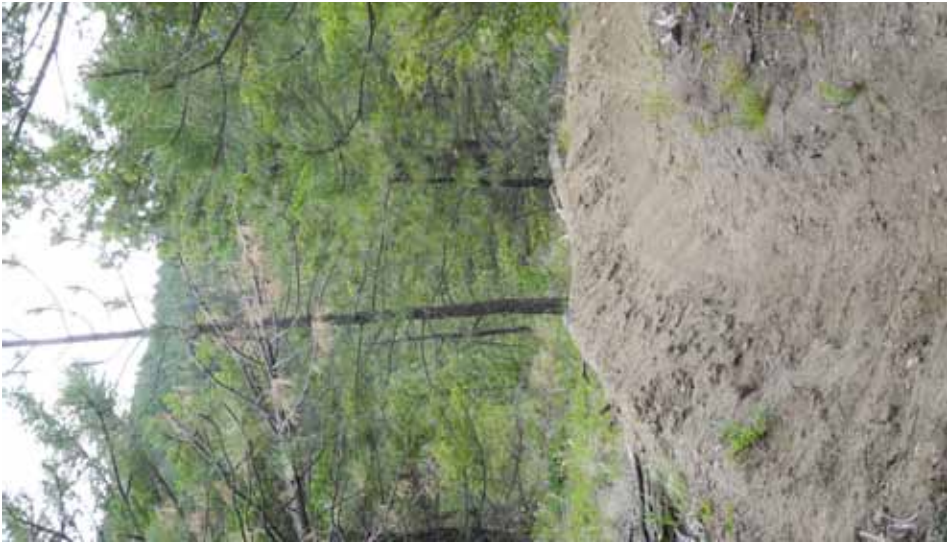
| NO. | ITEM | DIMENSION (MM) | PREScription | IMPROVEMNT | MEETS STANDARD | LIFE (YEARS) | MANDATORY | FALL_ZONE (1 - POOR, 5 - GOOD) | IMAGE | NORTHING (UTM10) | EASTING (UTM10) | HEIGHT ABOVE MSL (m) |
|---|---|---|---|---|---|---|---|---|---|---|---|---|
| 236 | berm corners | | monitor | good natural feature | y | 5 | n | 2 | DSCN6165.JPG | 5549708 | 661511 | 923 |
