# MOUNTAIN BIKE TRAIL & TECHNICAL TRAIL FEATURE INSPECTION

IRON MOUNTAIN, MERRITT, BC

Ministry of Ministry of Forests, Lands and  
Natural Resource Operations

Cascades District – Recreation Sites & Trails  
August 2012

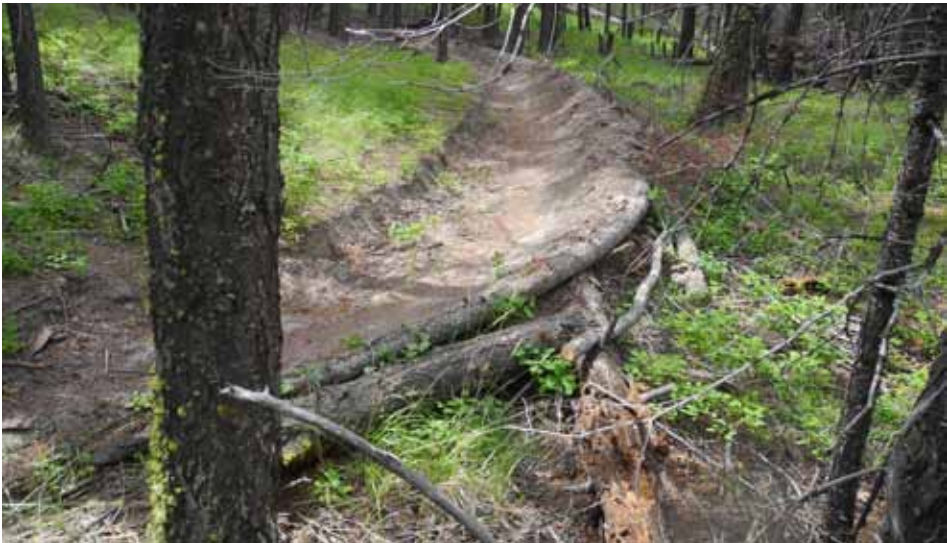
| NO. | ITEM | DIMENSION (MM) | PREScription | IMPROVEMNT | MEETS STANDARD | LIFE (YEARS) | MANDATORY | FALL_ZONE (1 - POOR, 5 - GOOD) | IMAGE | NORTHING (UTM10) | EASTING (UTM10) | HEIGHT ABOVE MSL (m) |
|---|---|---|---|---|---|---|---|---|---|---|---|---|
| 237 | berm | reinforced with log | monitor | good natural feature | y | 5 | n | 2 | DSCN6142.JPG | 5549765 | 661458 | 907 |

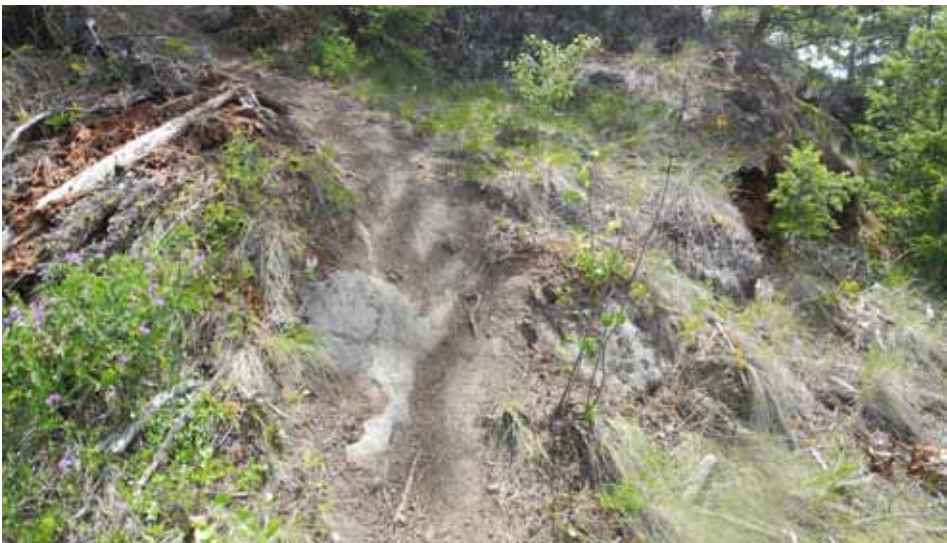
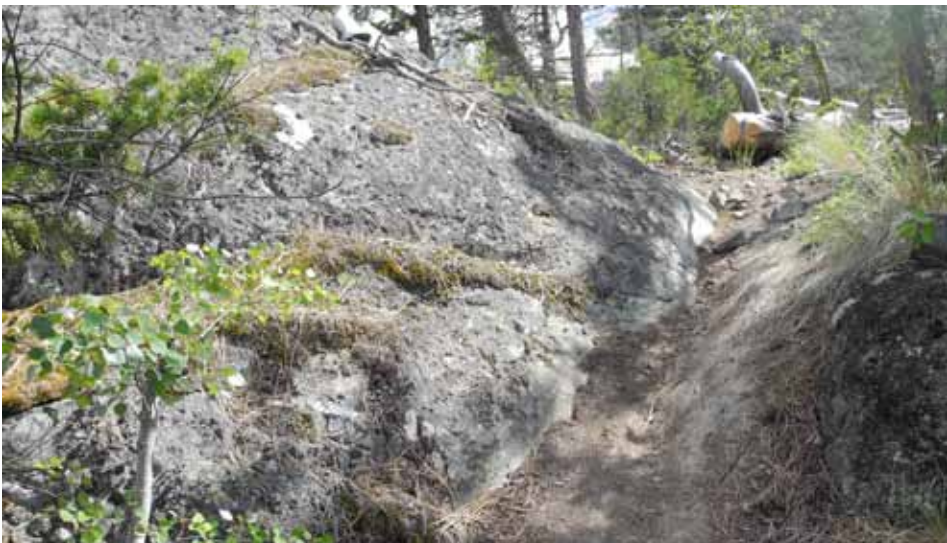
| NO. | ITEM | DIMENSION (MM) | PREScription | IMPROVEMNT | MEETS STANDARD | LIFE (YEARS) | MANDATORY | FALL_ZONE (1 - POOR, 5 - GOOD) | IMAGE | NORTHING (UTM10) | EASTING (UTM10) | HEIGHT ABOVE MSL (m) |
|---|---|---|---|---|---|---|---|---|---|---|---|---|
| 238 | rock roll | | monitor | good natural feature | y | 5 | y | 2 | DSCN6134.JPG | 5549852 | 661342 | 892 |

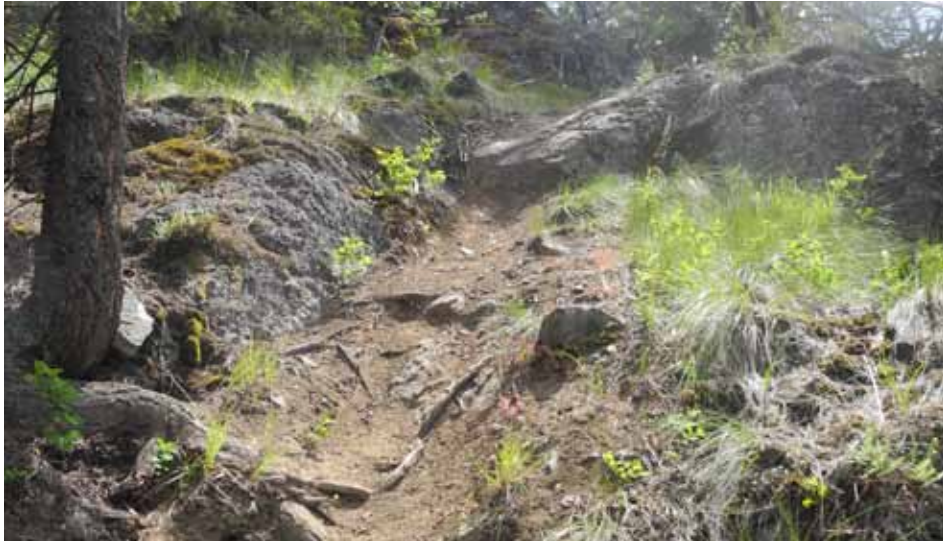
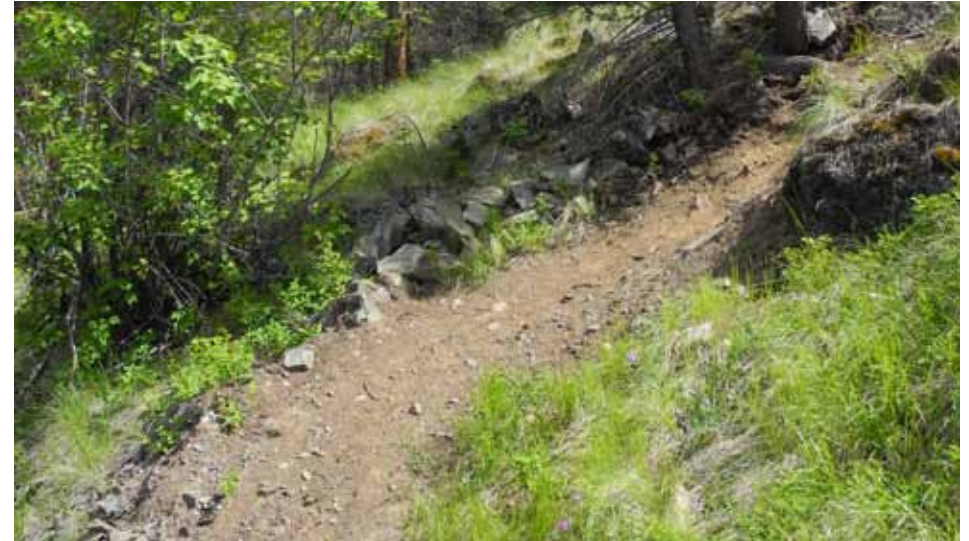
| NO. | ITEM | DIMENSION (MM) | PREScription | IMPROVEMNT | MEETS STANDARD | LIFE (YEARS) | MANDATORY | FALL_ZONE (1 - POOR, 5 - GOOD) | IMAGE | NORTHING (UTM10) | EASTING (UTM10) | HEIGHT ABOVE MSL (m) |
|---|---|---|---|---|---|---|---|---|---|---|---|---|
| 239 | rock roll | | monitor | good natural feature | y | 5 | y | 2 | DSCN6127.JPG | 5549870 | 661322 | 887 |

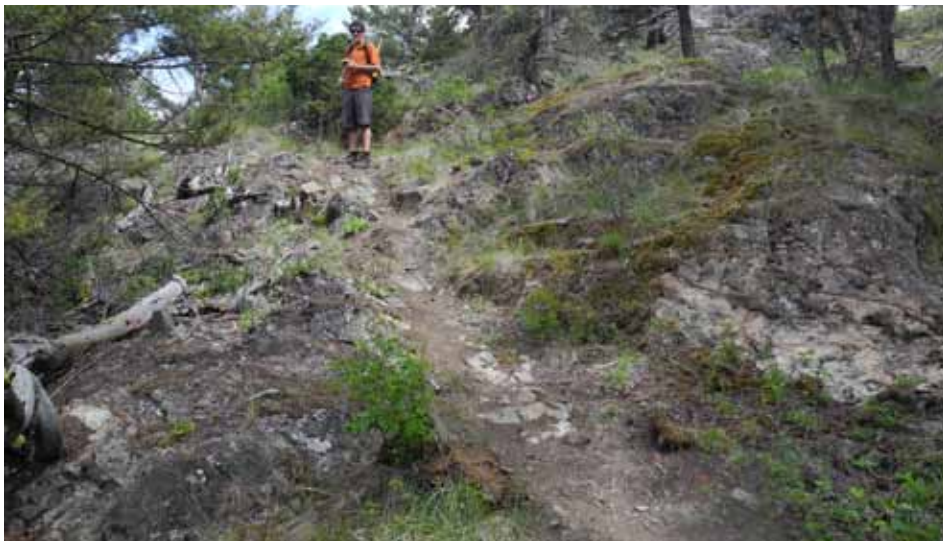
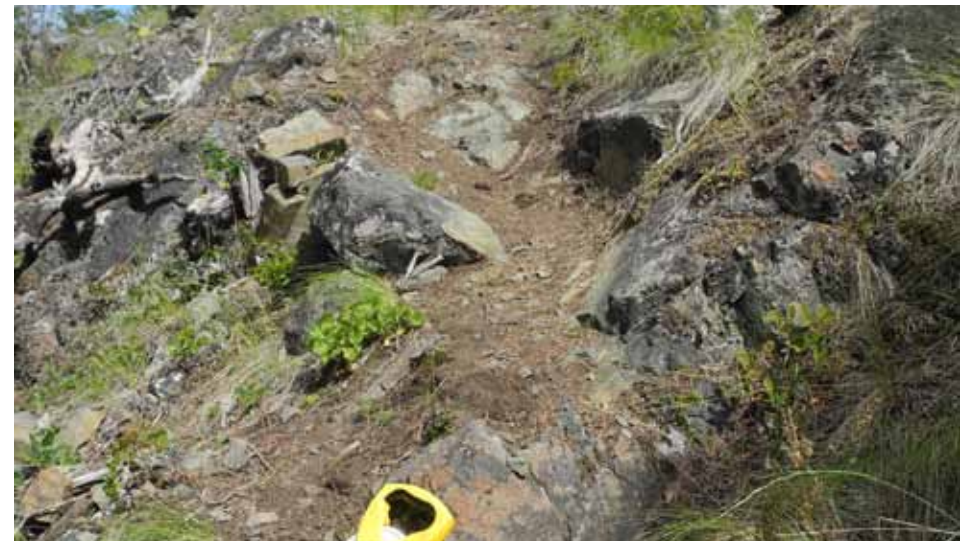
| 240 | rock roll | | monitor | good natural feature | y | 5 | y | 2 | DSCN6121.JPG | 5549879 | 661329 | 883 |

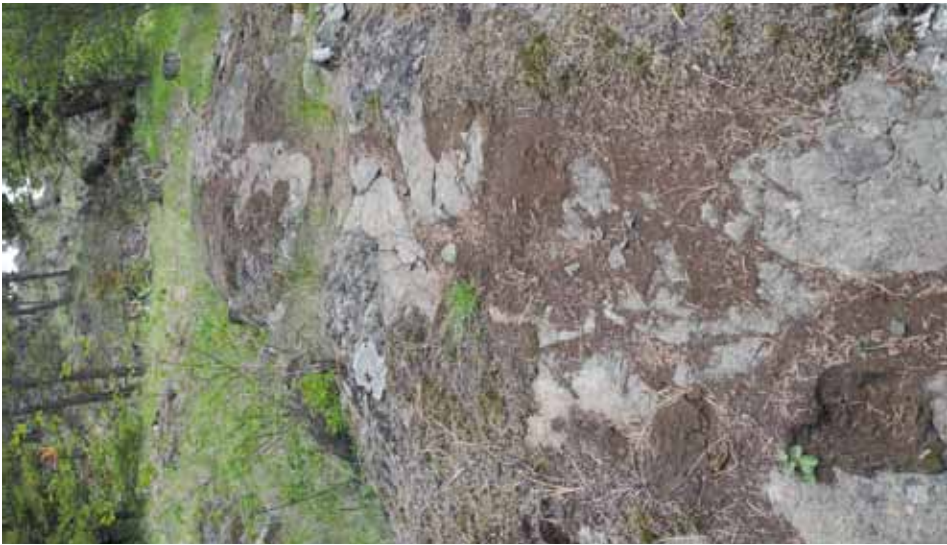
| NO. | ITEM | DIMENSION (MM) | PREScription | IMPROVEMNT | MEETS STANDARD | LIFE (YEARS) | MANDATORY | FALL_ZONE (1 - POOR, 5 - GOOD) | IMAGE | NORTHING (UTM10) | EASTING (UTM10) | HEIGHT ABOVE MSL (M) |
|---|---|---|---|---|---|---|---|---|---|---|---|---|
| 241 | rock roll | | monitor | good natural feature | y | 5 | y | 2 | DSCN6118.JPG | 5549883 | 661304 | 878 |

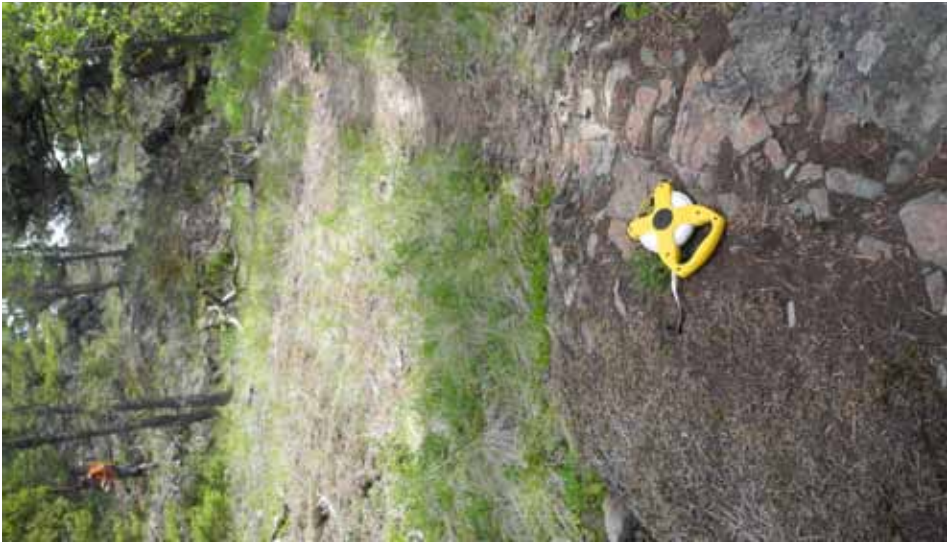
| NO. | ITEM | DIMENSION (MM) | PREScription | IMPROVEMNT | MEETS STANDARD | LIFE (YEARS) | MANDATORY | FALL_ZONE (1 - POOR, 5 - GOOD) | IMAGE | NORTHING (UTM10) | EASTING (UTM10) | HEIGHT ABOVE MSL (M) |
|---|---|---|---|---|---|---|---|---|---|---|---|---|
| 242 | rock roll | | monitor | good natural feature | y | 5 | y | 2 | DSCN6117.JPG | 5549899 | 661289 | 872 |

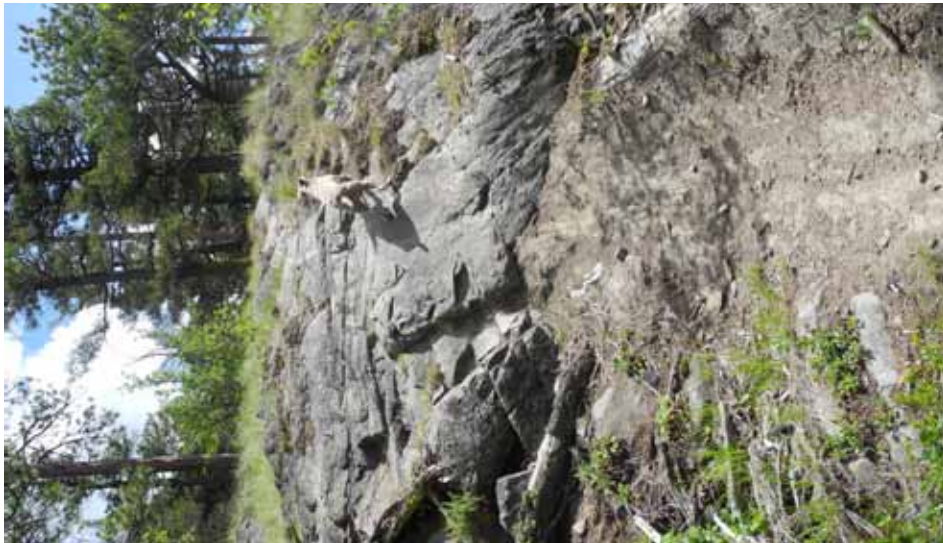
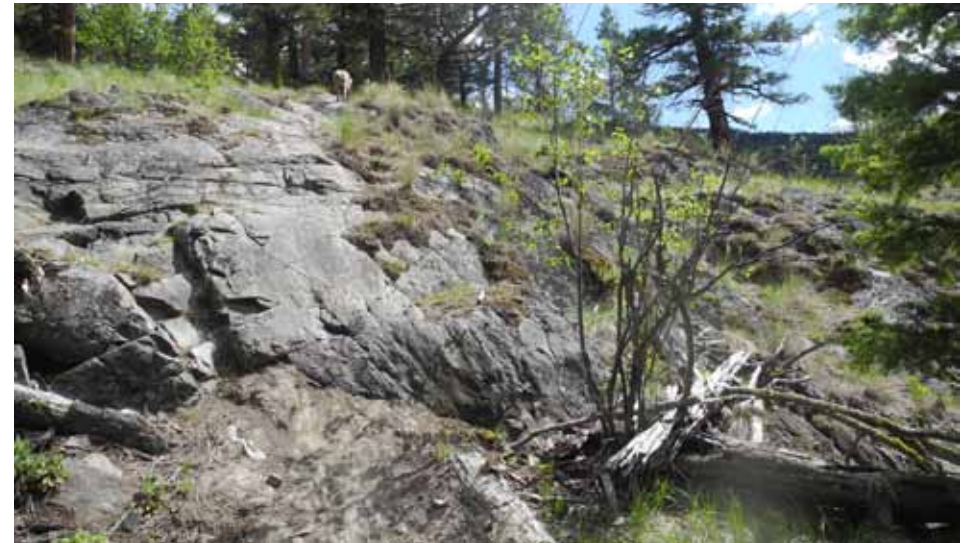
| NO. | ITEM | DIMENSION (MM) | PREScription | IMPROVEMNT | MEETS STANDARD | LIFE (YEARS) | MANDATORY | FALL_ZONE (1 - POOR, 5 - GOOD) | IMAGE | NORTHING (UTM10) | EASTING (UTM10) | HEIGHT ABOVE MSL (m) |
|---|---|---|---|---|---|---|---|---|---|---|---|---|
| 243 | rock roll | | monitor | good natural feature | y | 5 | y | 2 | DSCN6108.JPG | 5549927 | 661278 | 861 |

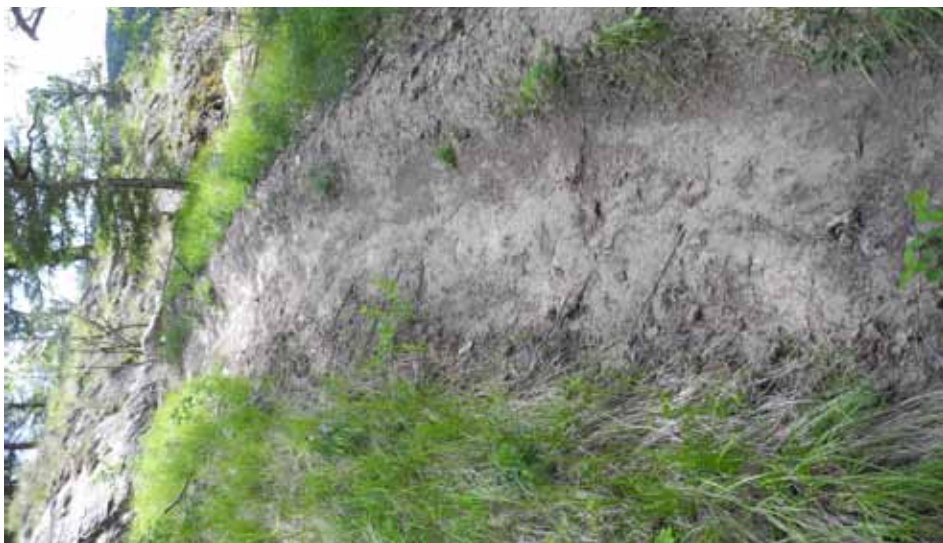
| 244 | dirt roll | | monitor | good natural feature | y | 5 | y | 2 | DSCN6107.JPG | 5549953 | 661289 | 857 |

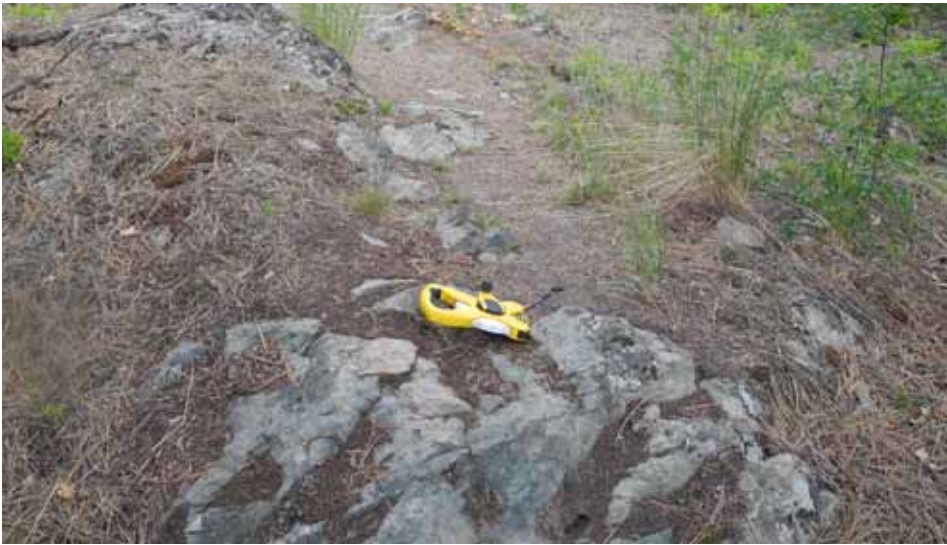
| NO. | ITEM | DIMENSION (MM) | PREScription | IMPROVEMNT | MEETS STANDARD | LIFE (YEARS) | MANDATORY | FALL_ZONE (1 - POOR, 5 - GOOD) | IMAGE | NORTHING (UTM10) | EASTING (UTM10) | HEIGHT ABOVE MSL (M) |
|---|---|---|---|---|---|---|---|---|---|---|---|---|
| 245 | rock roll | | monitor | good natural feature | y | 5 | y | 2 | DSCN6102.JPG | 5550047 | 661202 | 832 |

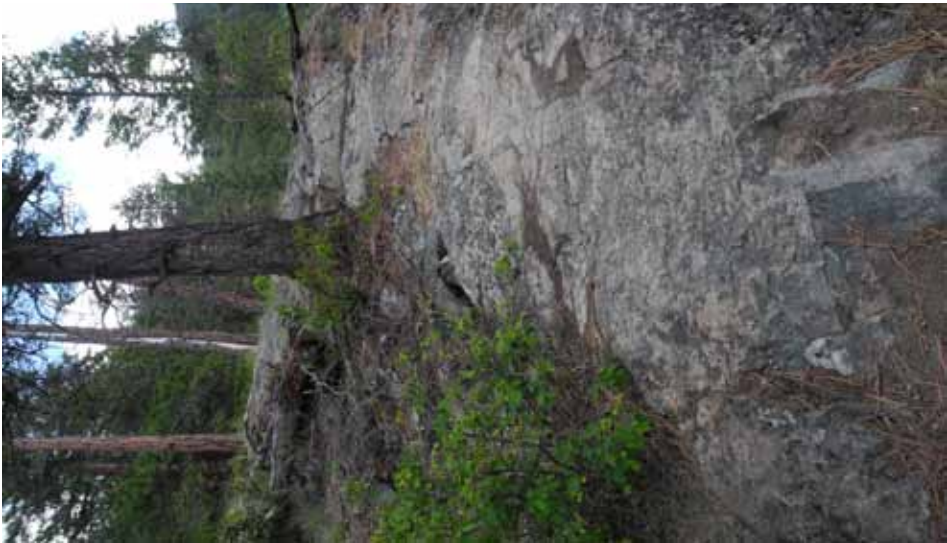
| NO. | ITEM | DIMENSION (MM) | PREScription | IMPROVEMNT | MEETS STANDARD | LIFE (YEARS) | MANDATORY | FALL_ZONE (1 - POOR, 5 - GOOD) | IMAGE | NORTHING (UTM10) | EASTING (UTM10) | HEIGHT ABOVE MSL (M) |
|---|---|---|---|---|---|---|---|---|---|---|---|---|
| 246 | rock roll | | monitor | good natural feature | y | 5 | y | 2 | DSCN6099.JPG | 5550060 | 661185 | 828 |

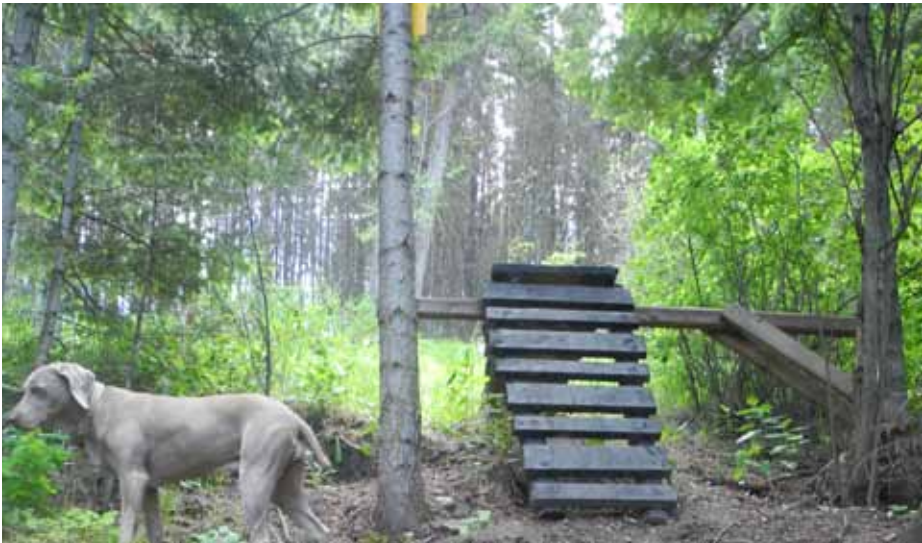
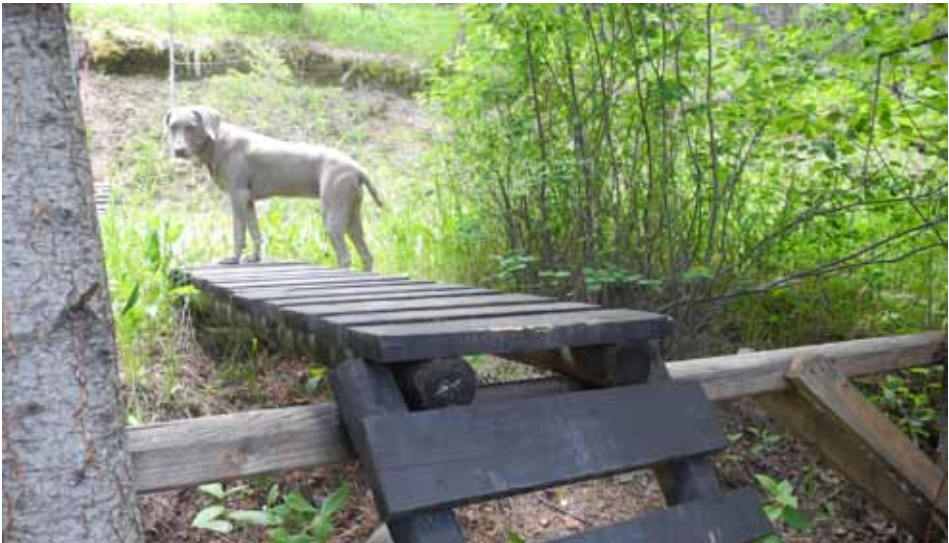
| NO. | ITEM | DIMENSION (MM) | DESCRIPTION | IMPROVEMNT | MEETS STANDARD | LIFE (YEARS) | MANDATORY | FALL_ZONE (1 - POOR, 5 - GOOD) | IMAGE | NORTHING (UTM10) | EASTING (UTM10) | HEIGHT ABOVE MSL (m) |
|---|---|---|---|---|---|---|---|---|---|---|---|---|
| 105 | elevated bridge roll | 500w x 1000h x 4240l | improve | Feature in good condition and should be modified to serve as a gateway | y | 5 | y | 2 | DSCN7036.JPG | 5549111 | 661351 | 980 |

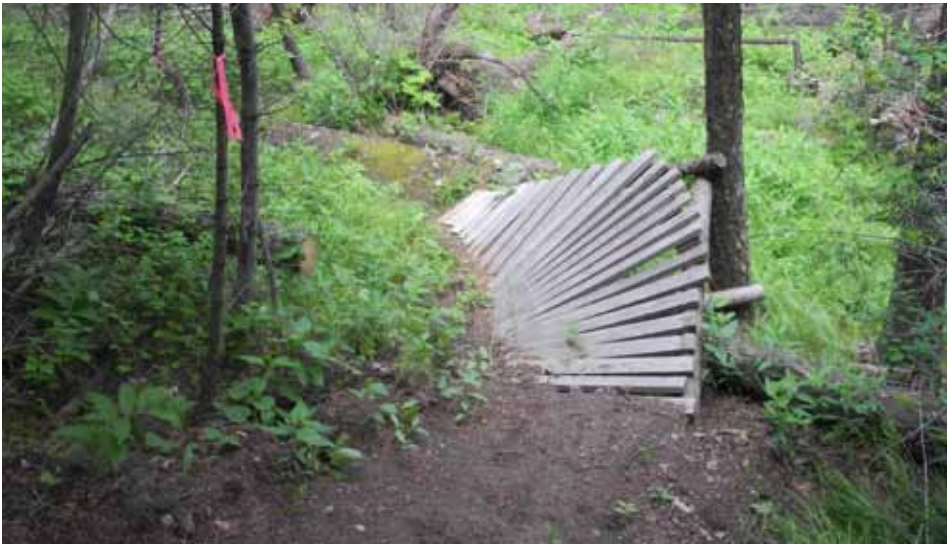
| NO. | ITEM | DIMENSION (MM) | PREScription | IMPROVEMNT | MEETS STANDARD | LIFE (YEARS) | MANDATORY | FALL_ZONE (1 - POOR, 5 - GOOD) | IMAGE | NORTHING (UTM10) | EASTING (UTM10) | HEIGHT ABOVE MSL (m) |
|---|---|---|---|---|---|---|---|---|---|---|---|---|
| 106 | wall ride | 2600l x 1400w | monitor | Ground-level feature in good condition | y | 5 | y | 3 | DSCN7040.JPG | 5549122 | 661347 | 972 |

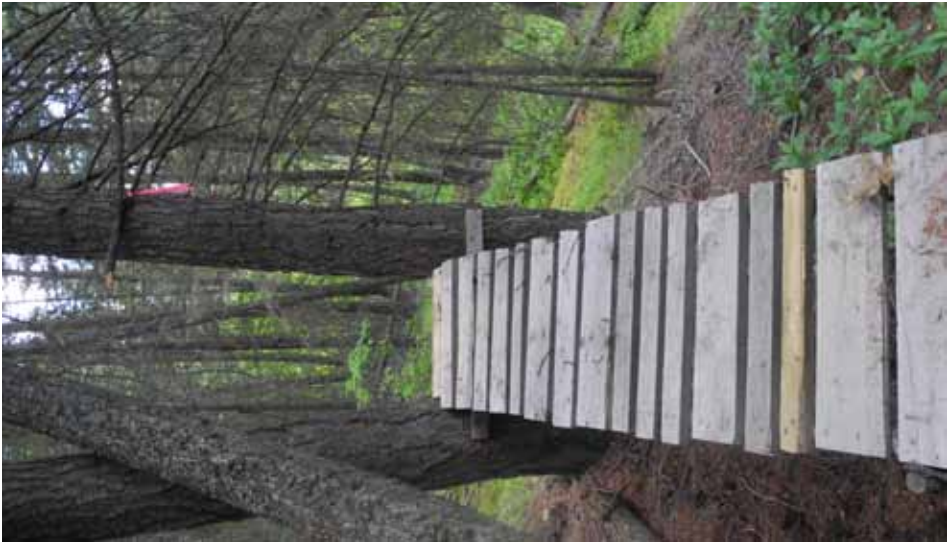
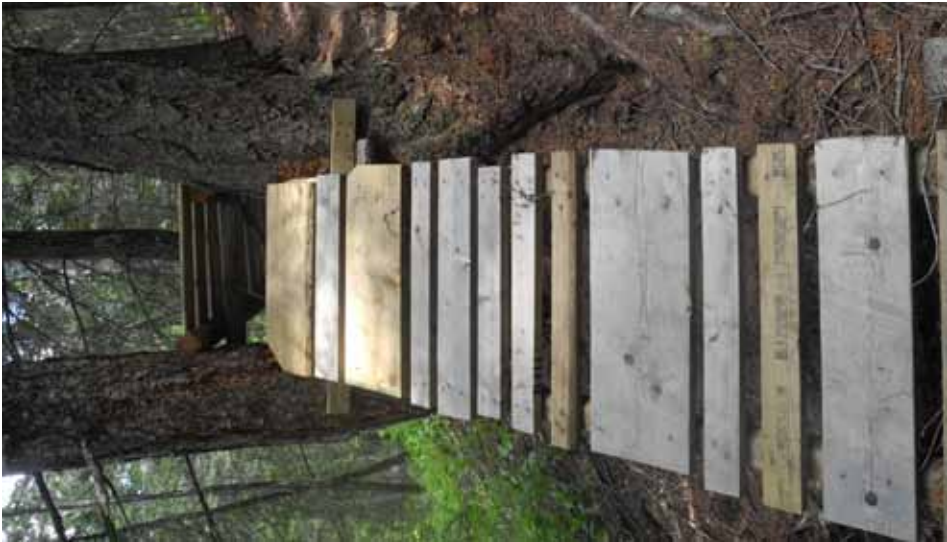
| NO. | ITEM | DIMENSION (MM) | PREScription | IMPROVEMNT | MEETS STANDARD | LIFE (YEARS) | MANDATORY | FALL_ZONE (1 - POOR, 5 - GOOD) | IMAGE | NORTHING (UTM10) | EASTING (UTM10) | HEIGHT ABOVE MSL (m) |
|---|---|---|---|---|---|---|---|---|---|---|---|---|
| 107 | elevated bridge roll | 730w x 1700h x 6640l | monitor | stunt in good condition, improve fall zones | y | 5 | y | 3 | DSCN7046.JPG | 5549179 | 661287 | 944 |

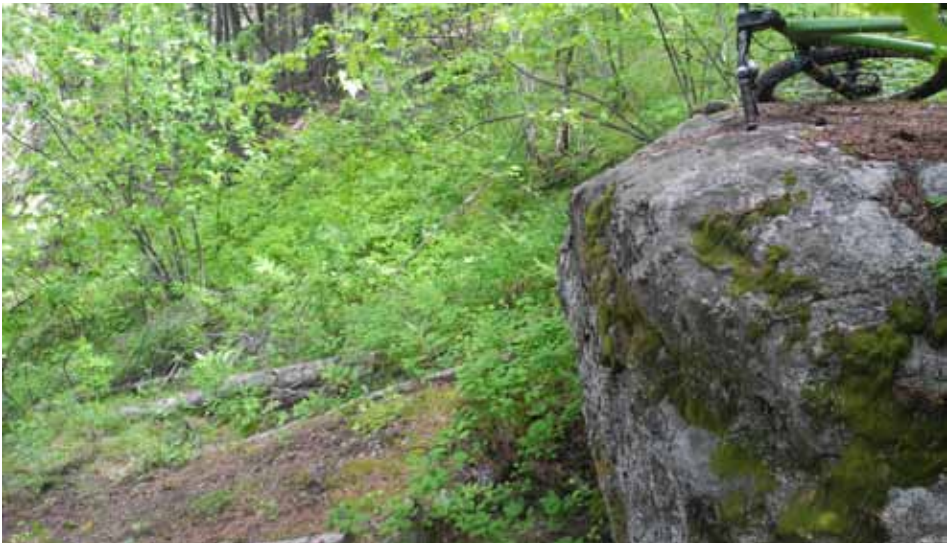
| NO. | ITEM | DIMENSION (MM) | PRESCRIPTION | IMPROVEMNT | MEETS STANDARD | LIFE (YEARS) | MANDATORY | FALL_ZONE (1 - POOR, 5 - GOOD) | IMAGE | NORTHING (UTM10) | EASTING (UTM10) | HEIGHT ABOVE MSL (M) |
|---|---|---|---|---|---|---|---|---|---|---|---|---|
| 108 | rock drop | 1500h | monitor | good natural feature with okay fall zones, but imperative the gateway deters certain riders as this is a committing stunt | n | 5 | y | 3 | DSCN7049.JPG | 5549194 | 661269 | 944 |

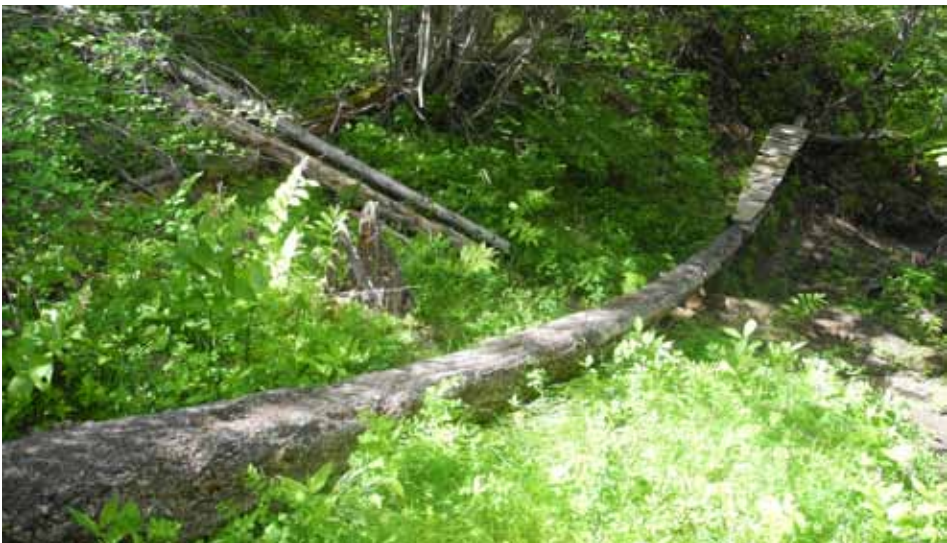
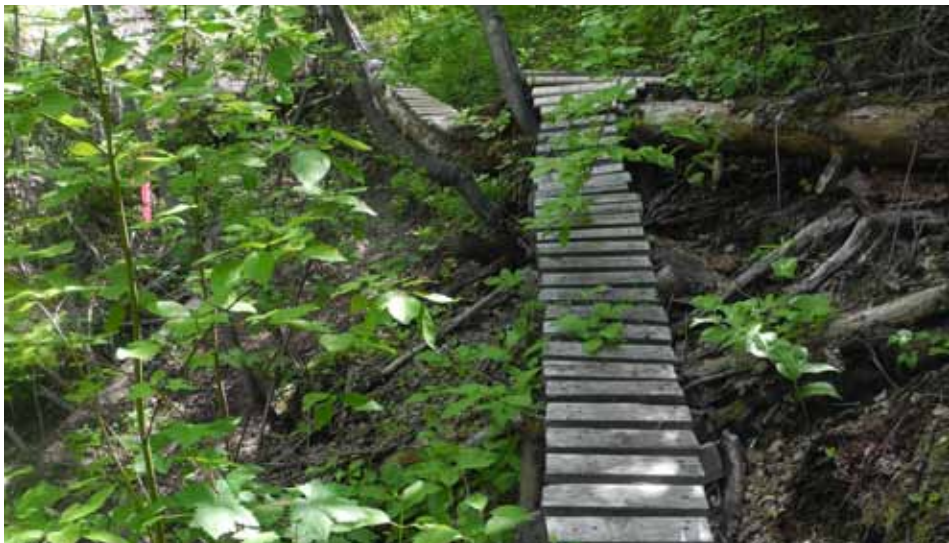
| NO. | ITEM | DIMENSION (MM) | PRESCRIPTION | IMPROVEMNT | MEETS STANDARD | LIFE (YEARS) | MANDATORY | FALL_ZONE (1 - POOR, 5 - GOOD) | IMAGE | NORTHING (UTM10) | EASTING (UTM10) | HEIGHT ABOVE MSL (M) |
|---|---|---|---|---|---|---|---|---|---|---|---|---|
| 109 | log drop | | replace | complex stunt on fallen log, decking is decaying and stringers deflecting greatly. Recommend replacing or improving dirt trail adjacent to stunt. | n | 2 | n | 2 | DSCN7054.JPG | 5549255 | 661292 | 926 |

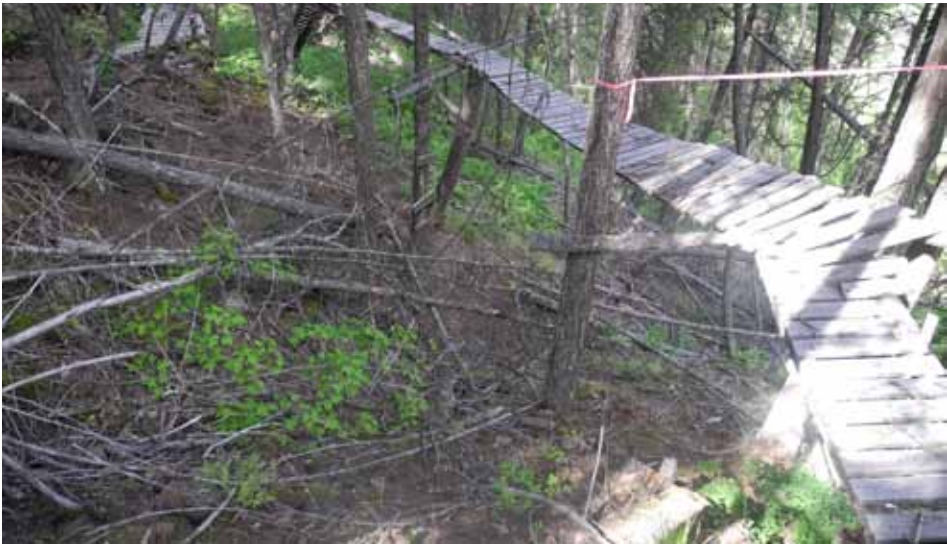
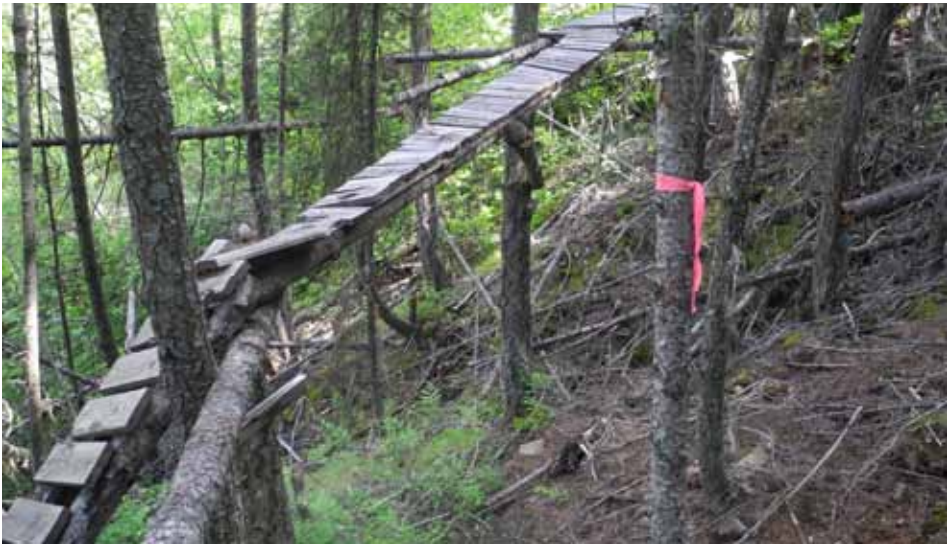
| NO. | ITEM | DIMENSION (MM) | PRESCRIPTION | IMPROVEMNT | MEETS STANDARD | LIFE (YEARS) | MANDATORY | FALL_ZONE (1 - POOR, 5 - GOOD) | IMAGE | NORTHING (UTM10) | EASTING (UTM10) | HEIGHT ABOVE MSL (m) |
|---|---|---|---|---|---|---|---|---|---|---|---|---|
| 111 | elevated bridge roll | | remove | pink tape denotes stunt is closed but stunt should be removed | n | 1 | n | 1 | DSCN7070.JPG | 5549332 | 661285 | 881 |

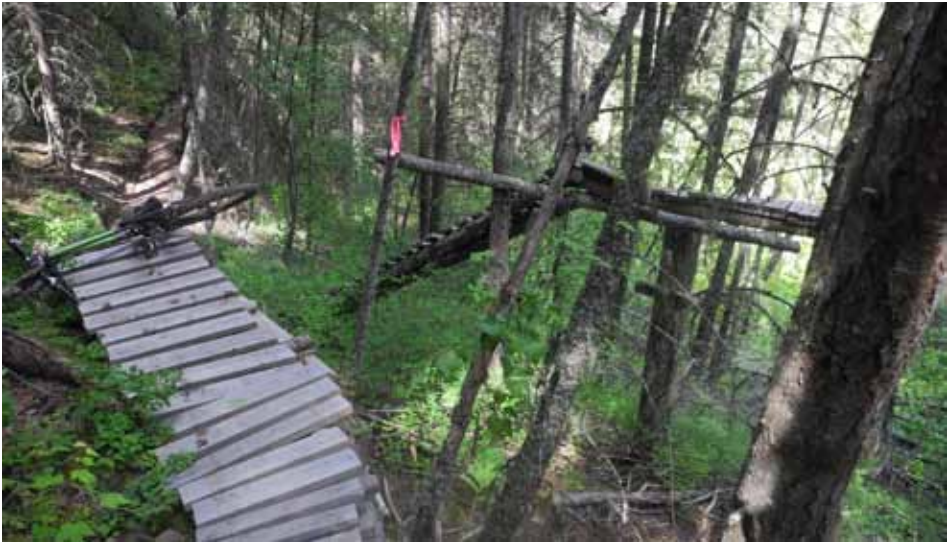
| NO. | ITEM | DIMENSION (MM) | PRESCRIPTION | IMPROVEMNT | MEETS STANDARD | LIFE (YEARS) | MANDATORY | FALL_ZONE (1 - POOR, 5 - GOOD) | IMAGE | NORTHING (UTM10) | EASTING (UTM10) | HEIGHT ABOVE MSL (m) |
|---|---|---|---|---|---|---|---|---|---|---|---|---|
| 112 | elevated bridge drop | 800w x 800h x 4200l | monitor | stunt is adjacent to the elevated stunt number 111 and is good shape, improve fall zones | y | 3 | y | 2 | DSCN7065.JPG | 5549332 | 661279 | 881 |

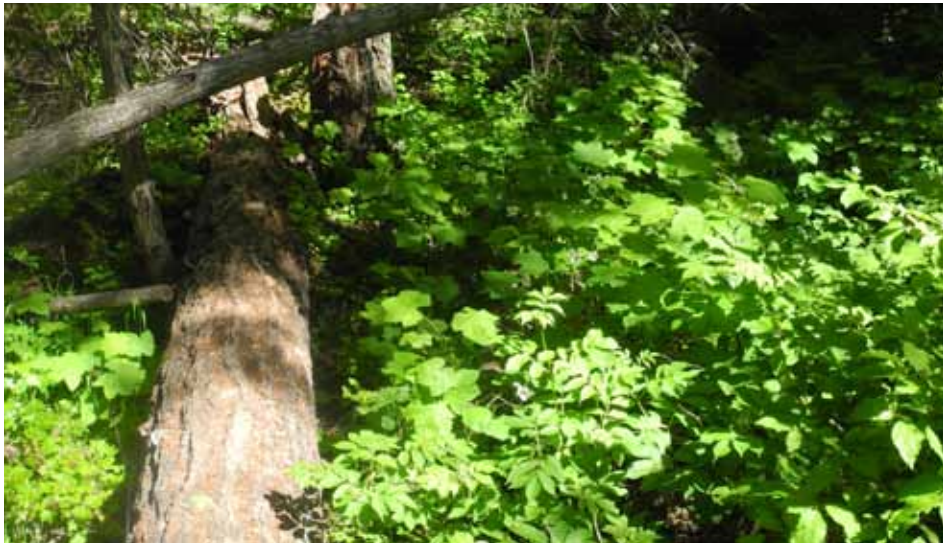
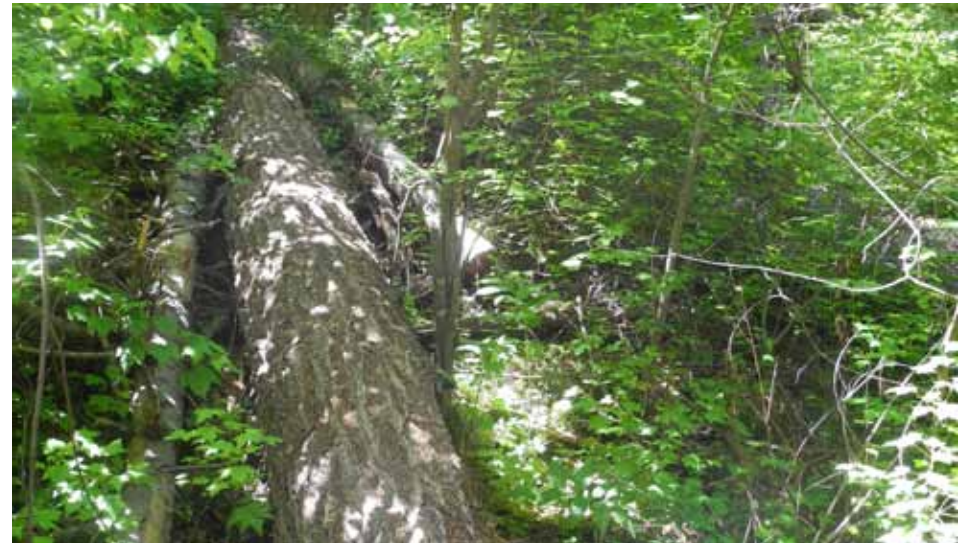
| NO. | ITEM | DIMENSION (MM) | PREScription | IMPROVEMNT | MEETS STANDARD | LIFE (YEARS) | MANDATORY | FALL_ZONE (1 - POOR, 5 - GOOD) | IMAGE | NORTHING (UTM10) | EASTING (UTM10) | HEIGHT ABOVE MSL (m) |
|---|---|---|---|---|---|---|---|---|---|---|---|---|
| 113 | log drop | 760w x 1200h | improve | improve fall zone | n | 5 | y | 1 | DSCN7076.JPG | 5549504 | 661266 | 802 |

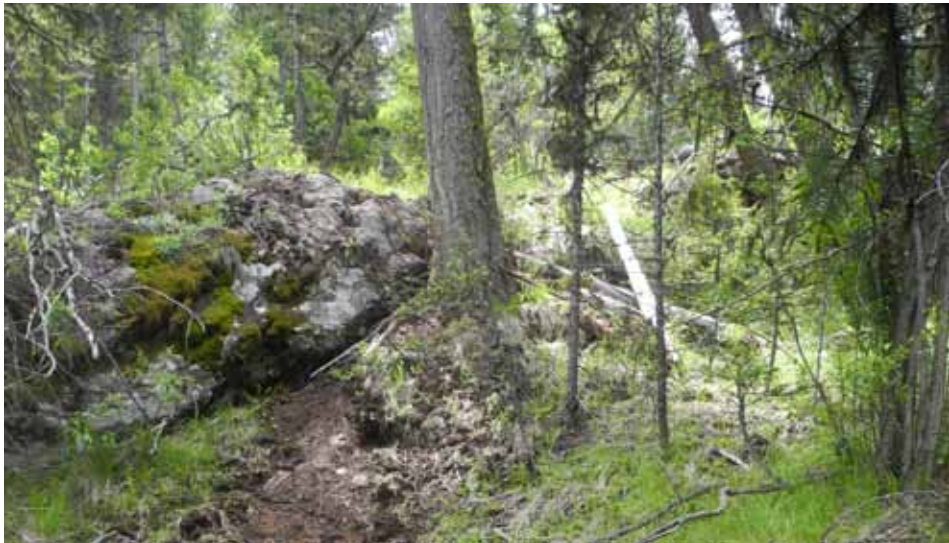
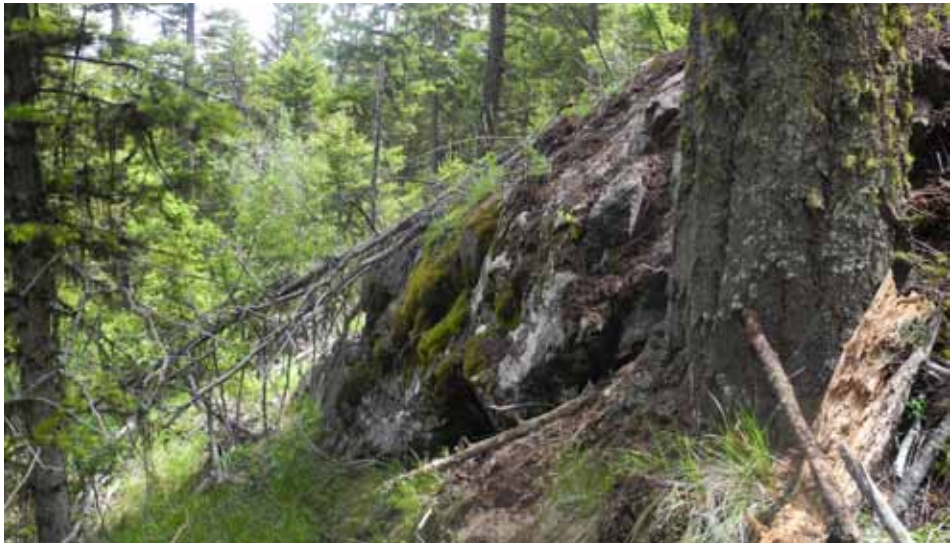
| NO. | ITEM | DIMENSION (MM) | DESCRIPTION | IMPROVEMNT | MEETS STANDARD | LIFE (YEARS) | MANDATORY | FALL_ZONE (1 - POOR, 5 - GOOD) | IMAGE | NORTHING (UTM10) | EASTING (UTM10) | HEIGHT ABOVE MSL (m) |
|---|---|---|---|---|---|---|---|---|---|---|---|---|
| 141 | rock roll | | monitor | good natural feature, create ridearound or trail requires gateway | y | 5 | y | 2 | | 5548639 | 661494 | 1108 |

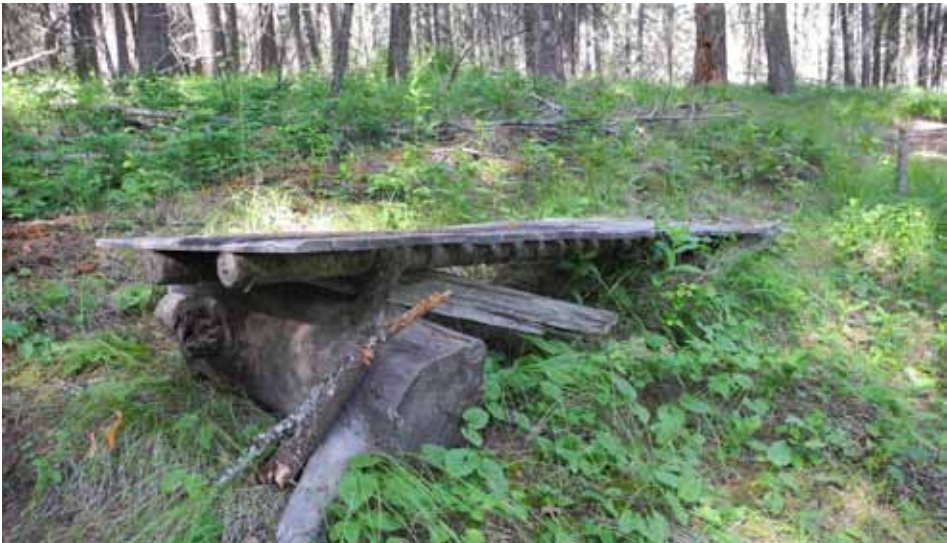
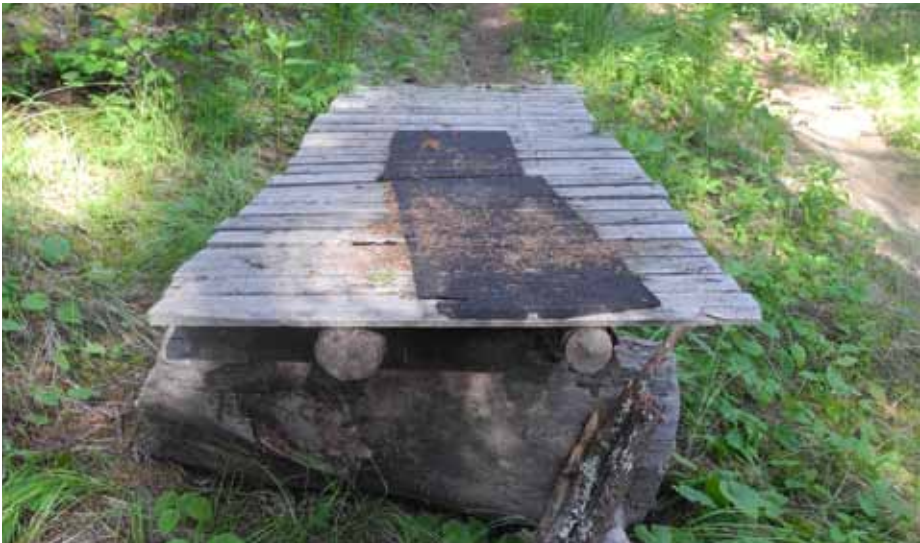
| 36 | elevated bridge drop | 870w x 2790l x 600h | remove | stunt is deflecting too much with foot traffic, remove and build dirt jump | n | 1 | n | 3 | DSCN6306.JPG | 5549876 | 661752 | 929 |

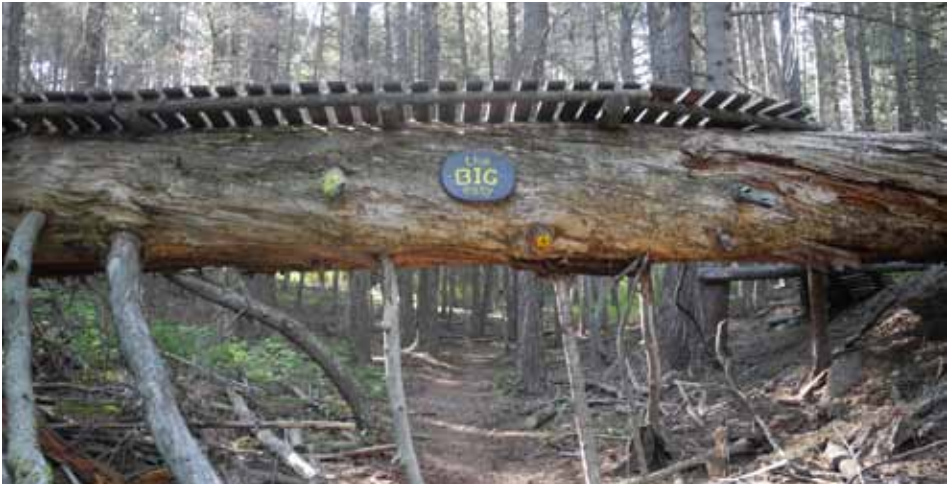
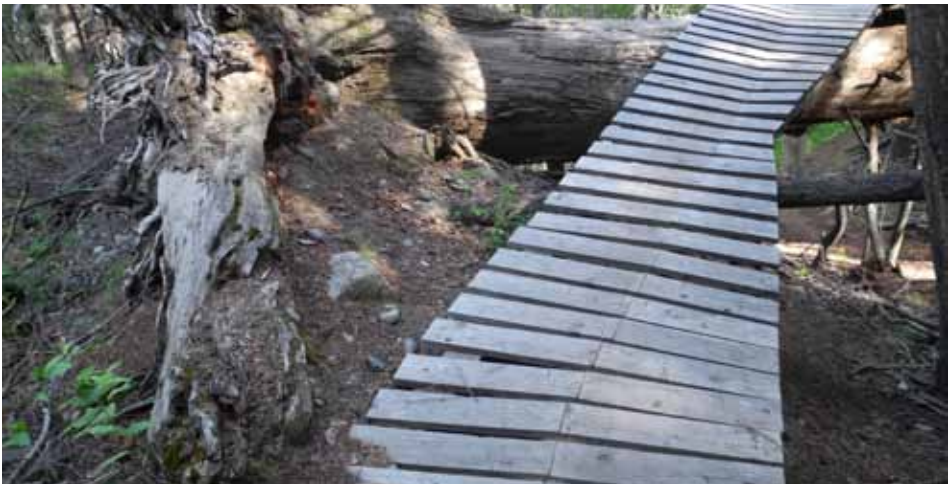
| 37 | elevated bridge | 1220w x 18800l x 3100h | improve | stringers on approach ramps are overspanned, decking is split in middle and it's unclear of how purlins are fastened. Recommend replacing decking with one-piece 2"x4" and increase diameter of stringers on the approach ramp | n | 1 | n | 1 | DSCN6322.JPG | 5549835 | 661958 | 959 |

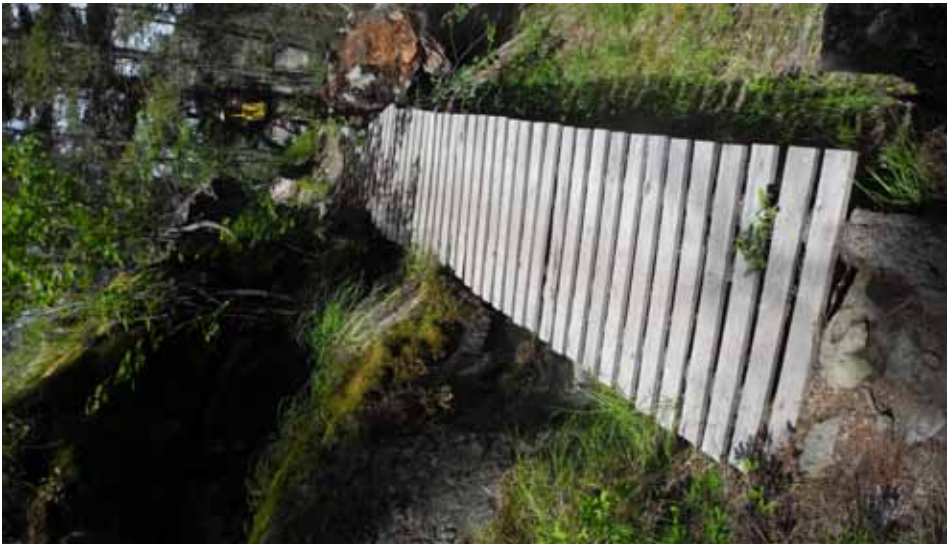
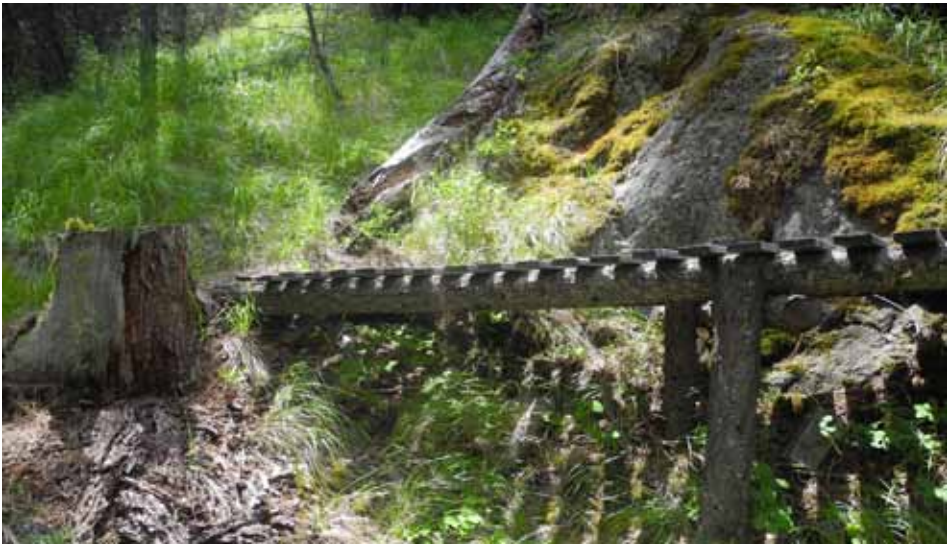
| NO. | ITEM | DIMENSION (MM) | PREScription | IMPROVEMNT | MEETS STANDARD | LIFE (YEARS) | MANDATORY | FALL_ZONE (1 - POOR, 5 - GOOD) | IMAGE | NORTHING (UTM10) | EASTING (UTM10) | HEIGHT ABOVE MSL (m) |
|---|---|---|---|---|---|---|---|---|---|---|---|---|
| 44 | bridge | 900w x 5030l x 950h | improve | improve by supporting inside stringer and replacing the decking to 2"x4" or greater | y | 2 | y | 2 | DSCN6404.JPG | 5549903 | 661330 | 871 |

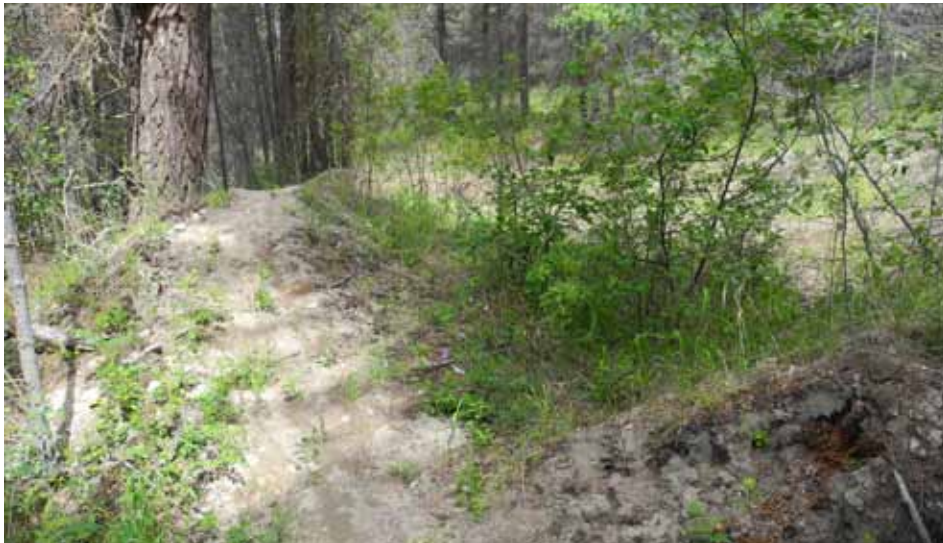
| NO. | ITEM | DIMENSION (MM) | PREScription | IMPROVEMNT | MEETS STANDARD | LIFE (YEARS) | MANDATORY | FALL_ZONE (1 - POOR, 5 - GOOD) | IMAGE | NORTHING (UTM10) | EASTING (UTM10) | HEIGHT ABOVE MSL (M) |
|---|---|---|---|---|---|---|---|---|---|---|---|---|
| 184 | dirt roll | | monitor | dirt feature in good condition | y | 5 | y | 2 | DSCN6447.JPG | 5550035 | 661280 | 842 |

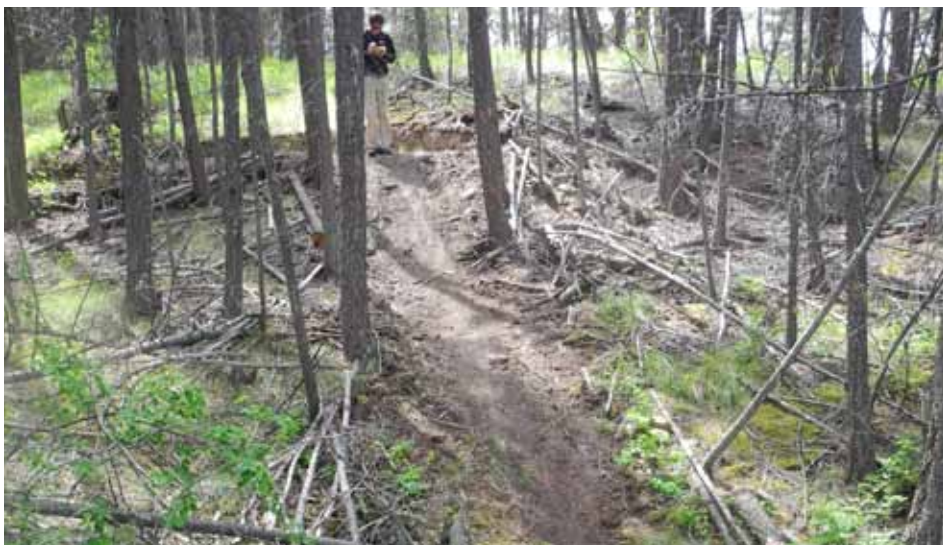
| 185 | dirt roll | | monitor | dirt feature in good condition | y | 5 | y | 2 | DSCN6446.JPG | 5550026 | 661295 | 841 |

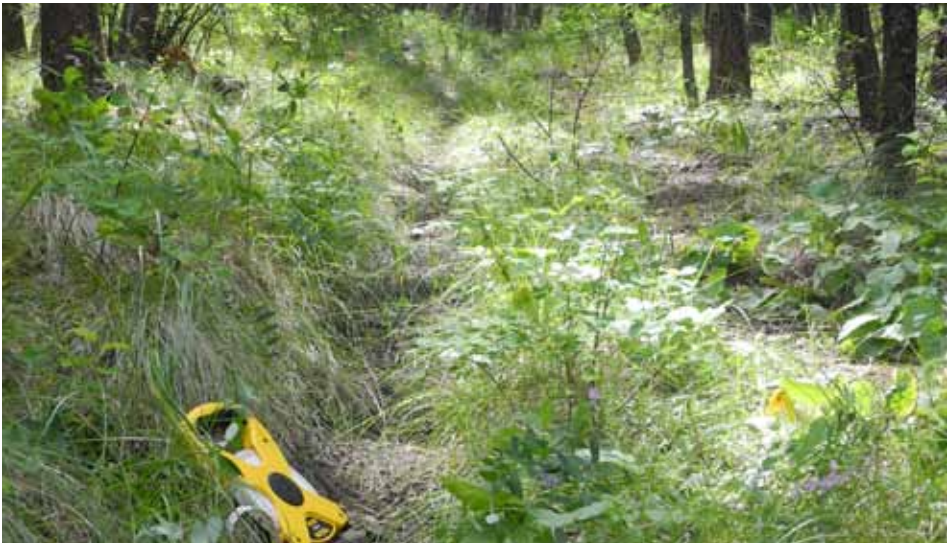
| 201 | dirt roll | 42% slope | improve | trail is gullyng and slope should be reduced | y | 5 | y | 2 | DSCN6418.JPG | 5550385 | 661492 | 802 |

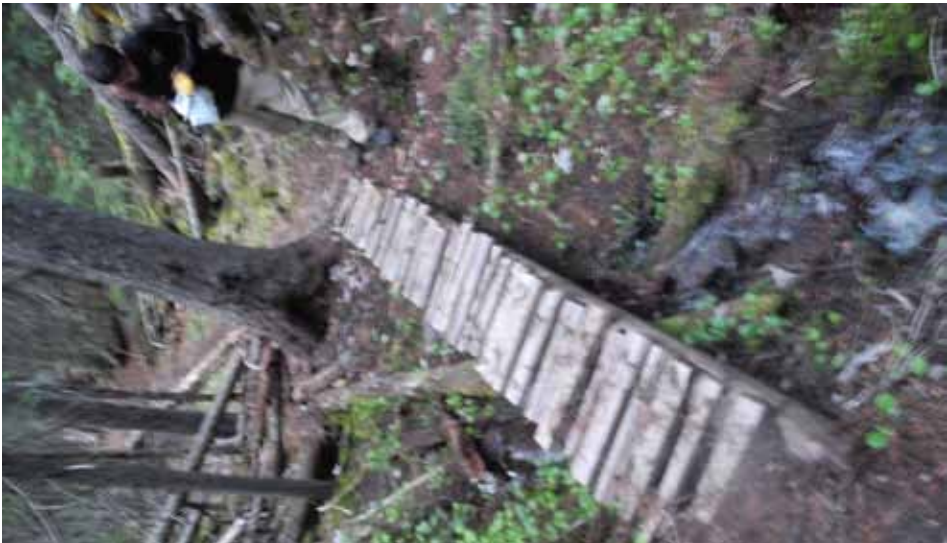
| NO. | ITEM | DIMENSION (MM) | PREScription | IMPROVEMNT | MEETS STANDARD | LIFE (YEARS) | MANDATORY | FALL_ZONE (1 - POOR, 5 - GOOD) | IMAGE | NORTHING (UTM10) | EASTING (UTM10) | HEIGHT ABOVE MSL (M) |
|---|---|---|---|---|---|---|---|---|---|---|---|---|
| 48 | bridge | 300w x 6000l x 500h | improve | improve deck fastening by replacing non-galvanized nails and replace 1x4 decking with 2" or greater | y | 1 | y | 2 | DSCN6600.JPG | 5546953 | 660445 | 1570 |
