# MOUNTAIN BIKE TRAIL & TECHNICAL TRAIL FEATURE INSPECTION

IRON MOUNTAIN, MERRITT, BC

Ministry of Ministry of Forests, Lands and  
Natural Resource Operations

Cascades District – Recreation Sites & Trails  
August 2012

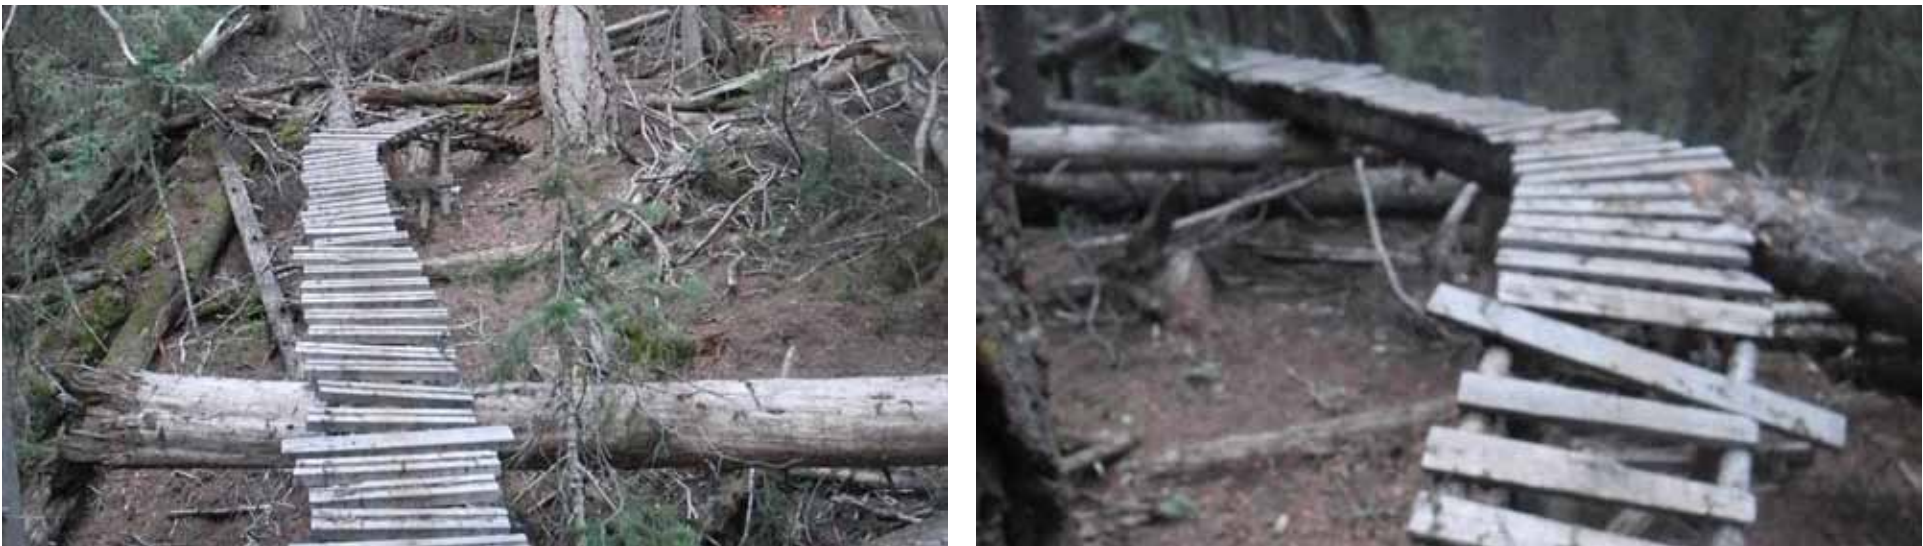
| NO. | ITEM | DIMENSION (MM) | PREScription | IMPROVEMNT | MEETS STANDARD | LIFE (YEARS) | MANDATORY | FALL_ZONE (1 - POOR, 5 - GOOD) | IMAGE | NORTHING (UTM10) | EASTING (UTM10) | HEIGHT ABOVE MSL (M) |
|---|---|---|---|---|---|---|---|---|---|---|---|---|
| 49 | elevated bridge drop | 200w x 2000h x 15000l | remove | major deflection in stringers, uneven riding surface, 1x4 and 2x4 decking failing, recommend removal of stunt | n | 1 | y | 1 | DSCN6609.JPG | 5547000 | 660451 | 1551 |

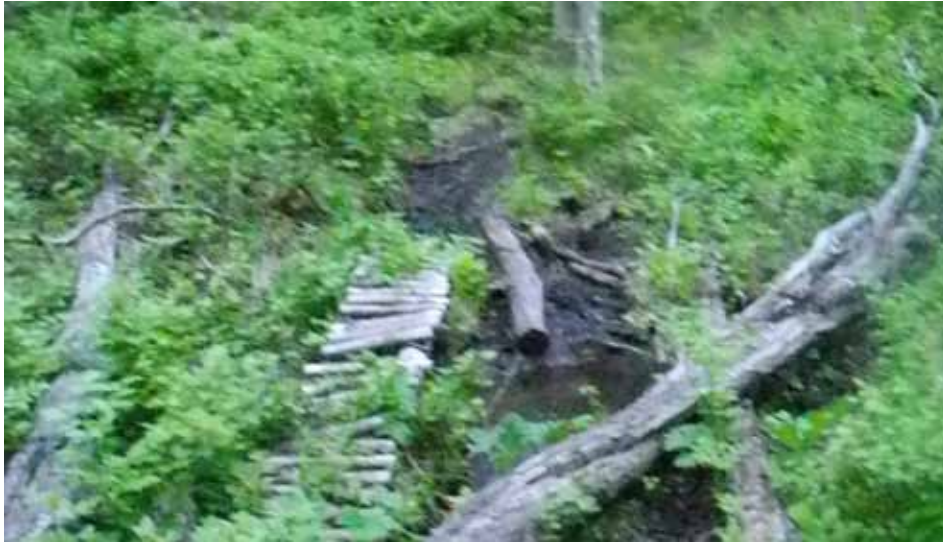
| NO. | ITEM | DIMENSION (MM) | PRESCRIPTION | IMPROVEMNT | MEETS STANDARD | LIFE (YEARS) | MANDATORY | FALL_ZONE (1 - POOR, 5 - GOOD) | IMAGE | NORTHING (UTM10) | EASTING (UTM10) | HEIGHT ABOVE MSL (M) |
|---|---|---|---|---|---|---|---|---|---|---|---|---|
| 50 | bridge | 500w x 750h x 10000l | remove | delapitated old bridge should be replaced or removed | y | 1 | n | 2 | DSCN6631.JPG | 5547627 | 660827 | 1381 |

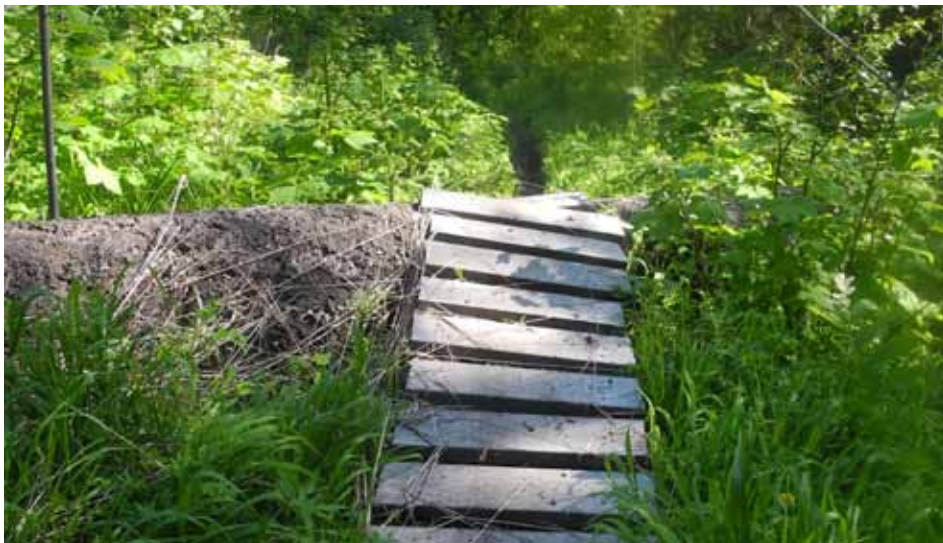
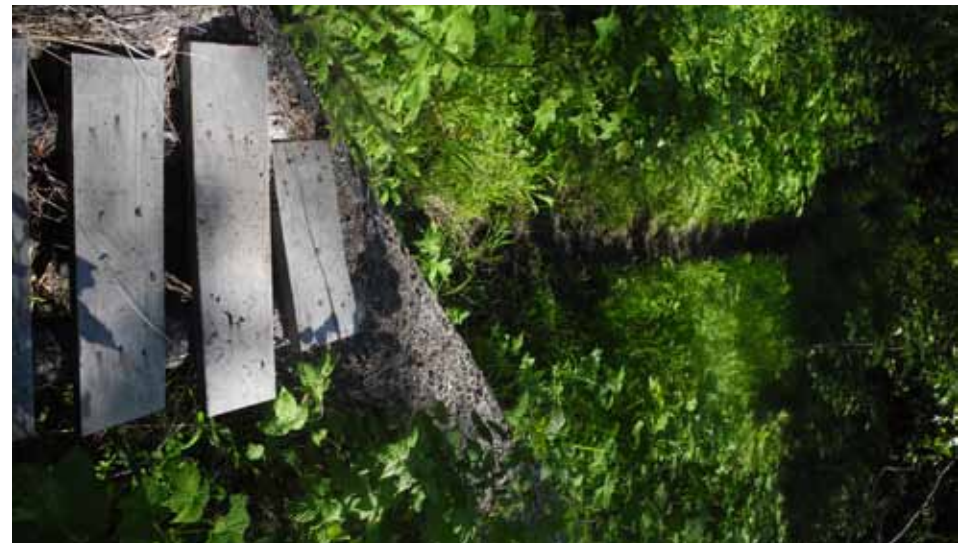
| 51 | elevated bridge drop | 600w x 910h x 34000l | improve | improve by levelling decking, and using galvanized nails to fasten decking | y | 2 | y | 2 | DSCN6645.JPG | 5548478 | 661336 | 1150 |

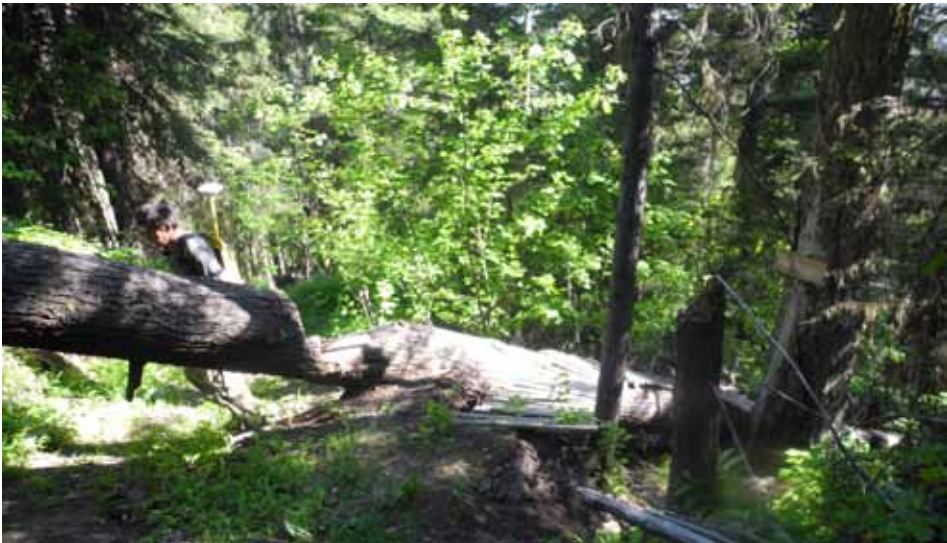
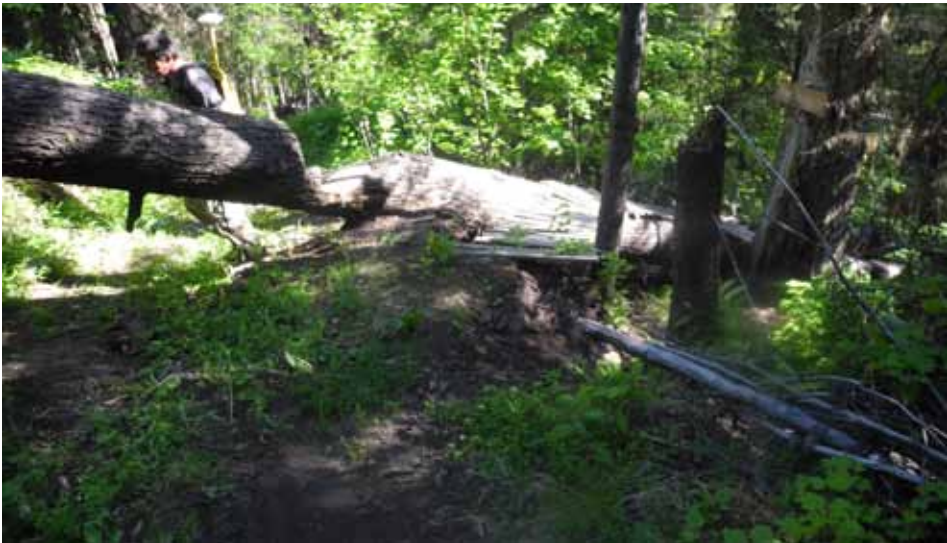
| NO. | ITEM | DIMENSION (MM) | PRESCRIPTION | IMPROVEMNT | MEETS STANDARD | LIFE (YEARS) | MANDATORY | FALL_ZONE (1 - POOR, 5 - GOOD) | IMAGE | NORTHING (UTM10) | EASTING (UTM10) | HEIGHT ABOVE MSL (m) |
|---|---|---|---|---|---|---|---|---|---|---|---|---|
| 52 | elevated bridge drop | | monitor | poor fall zone, can walk under log, recommend removing log from trail, although log is used for entrance to the Dungeon | y | 5 | n | 2 | DSCN6654.JPG | 5548358 | 661336 | 1193 |

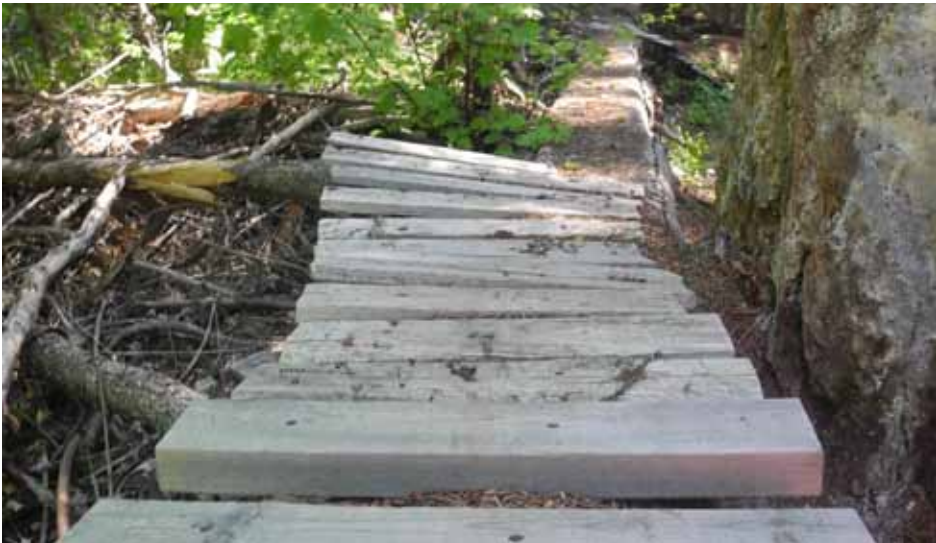
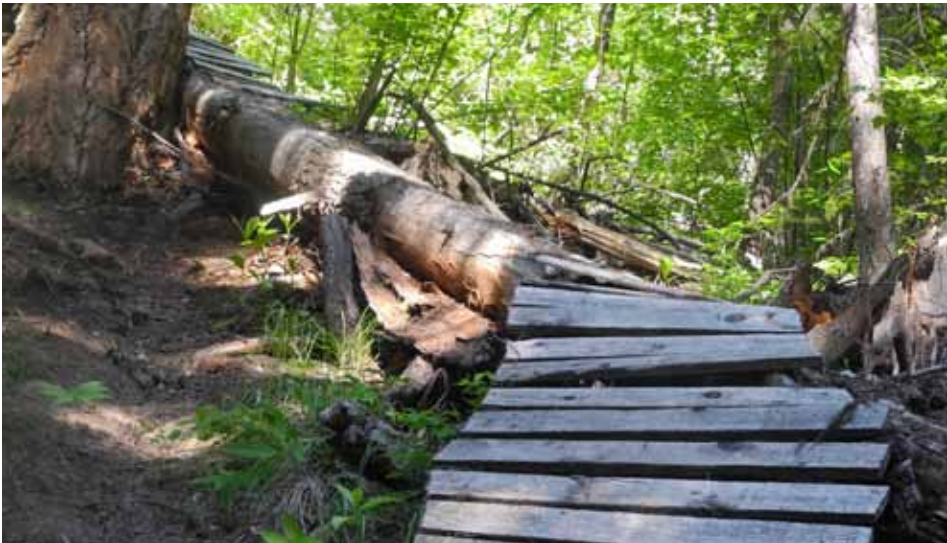
| NO. | ITEM | DIMENSION (MM) | PRESCRIPTION | IMPROVEMNT | MEETS STANDARD | LIFE (YEARS) | MANDATORY | FALL_ZONE (1 - POOR, 5 - GOOD) | IMAGE | NORTHING (UTM10) | EASTING (UTM10) | HEIGHT ABOVE MSL (m) |
|---|---|---|---|---|---|---|---|---|---|---|---|---|
| 53 | log ride | 530w x 1170h x 15000l | improve | improve by levelling the decking, increasing the diameter of the stringers, and adding 2x4 decking, | n | 1 | n | 1 | DSCN6659.JPG | 5548358 | 661338 | 1197 |

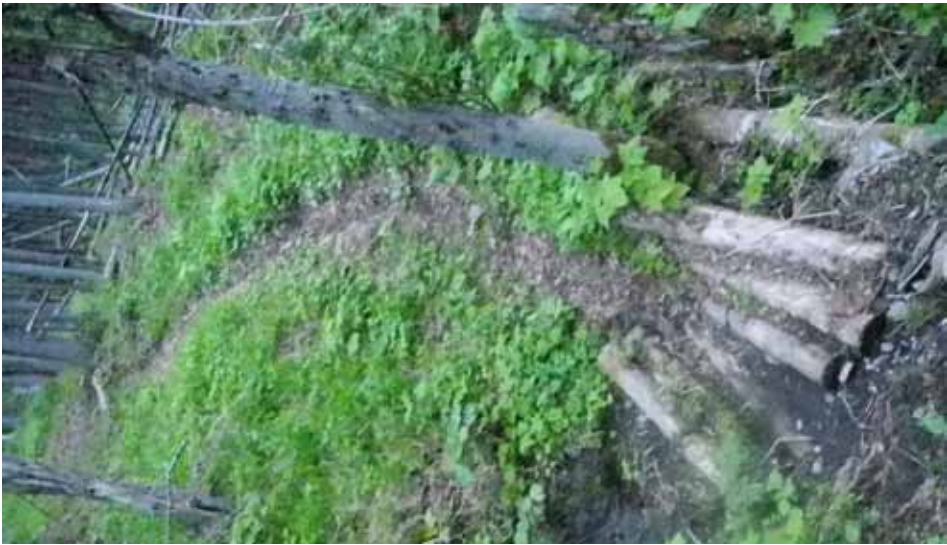
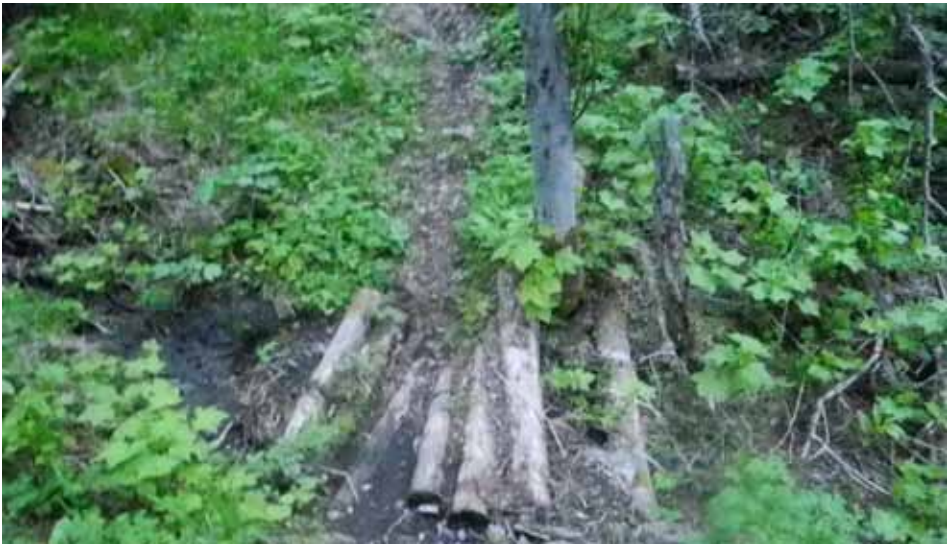
| NO. | ITEM | DIMENSION (MM) | PREScription | IMPROVEMNT | MEETS STANDARD | LIFE (YEARS) | MANDATORY | FALL_ZONE (1 - POOR, 5 - GOOD) | IMAGE | NORTHING (UTM10) | EASTING (UTM10) | HEIGHT ABOVE MSL (m) |
|---|---|---|---|---|---|---|---|---|---|---|---|---|
| 153 | bridge | | improve | stringer bridge should be removed, decked, or stringers placed perpendicular to direction of travel | y | 2 | y | 2 | DSCN6625.JPG | 5547555 | 660665 | 1418 |

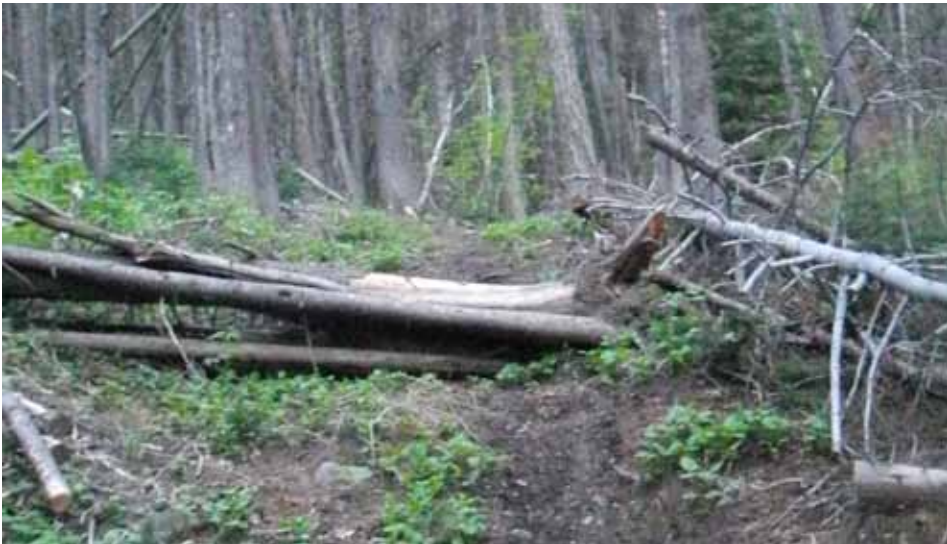
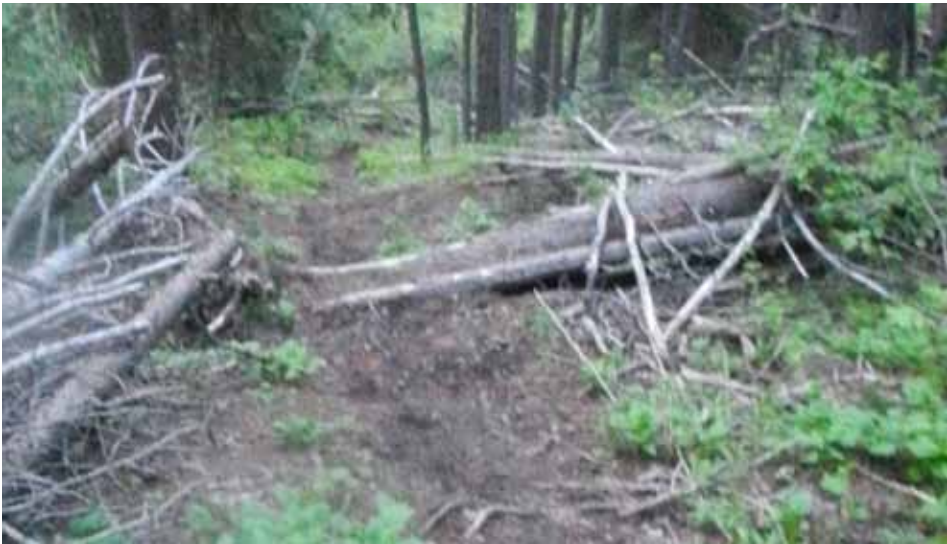
| NO. | ITEM | DIMENSION (MM) | PREScription | IMPROVEMNT | MEETS STANDARD | LIFE (YEARS) | MANDATORY | FALL_ZONE (1 - POOR, 5 - GOOD) | IMAGE | NORTHING (UTM10) | EASTING (UTM10) | HEIGHT ABOVE MSL (M) |
|---|---|---|---|---|---|---|---|---|---|---|---|---|
| 156 | log drop | | monitor | good natural feature but will decay over time | y | 2 | y | 2 | DSCN6620.JPG | 5547298 | 660611 | 1476 |

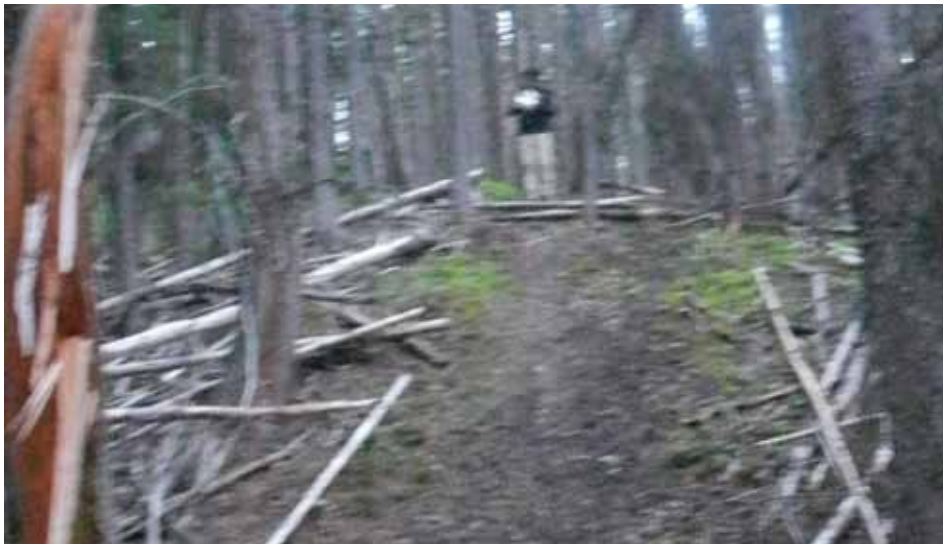
| 157 | Rock drop | | Monitor | Mandatory rock drop, "Elephant Head" | Y | 5 | Y | 2 | DSCN6617.JPG | 5547155 | 660596 | 1526 |

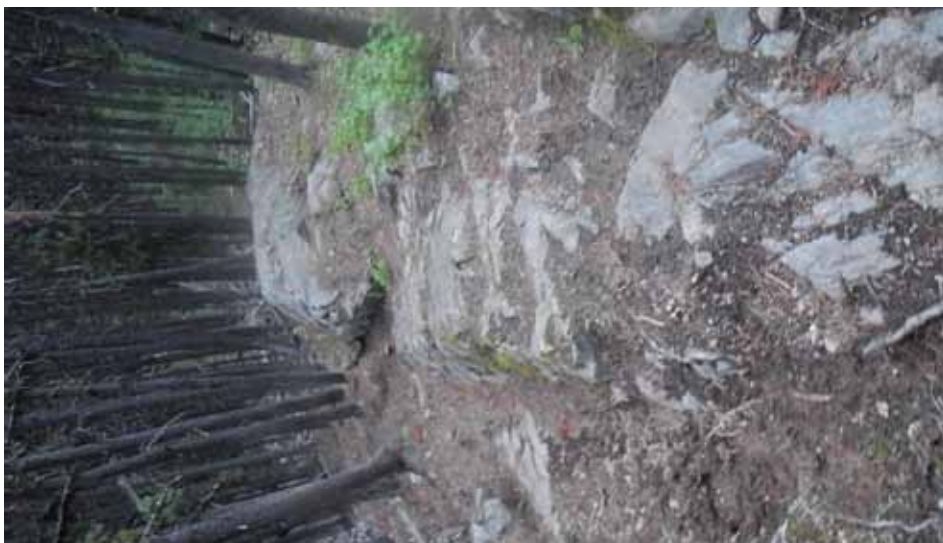
| NO. | ITEM | DIMENSION (MM) | PREScription | IMPROVEMNT | MEETS STANDARD | LIFE (YEARS) | MANDATORY | FALL_ZONE (1 - POOR, 5 - GOOD) | IMAGE | NORTHING (UTM10) | EASTING (UTM10) | HEIGHT ABOVE MSL (M) |
|---|---|---|---|---|---|---|---|---|---|---|---|---|
| 158 | rock drop | | monitor | mandatory rock drop | y | 5 | y | 1 | DSCN6591.JPG | 5546717 | 660342 | 1636 |

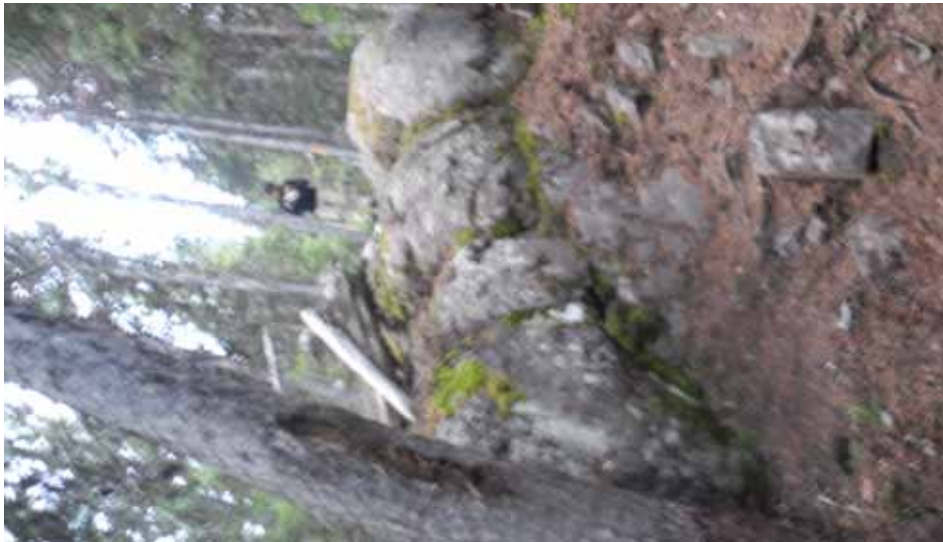
| 159 | rock drop | | monitor | mandatory rock drop | y | 5 | y | 1 | DSCN6588.JPG | 5546709 | 660336 | 1641 |

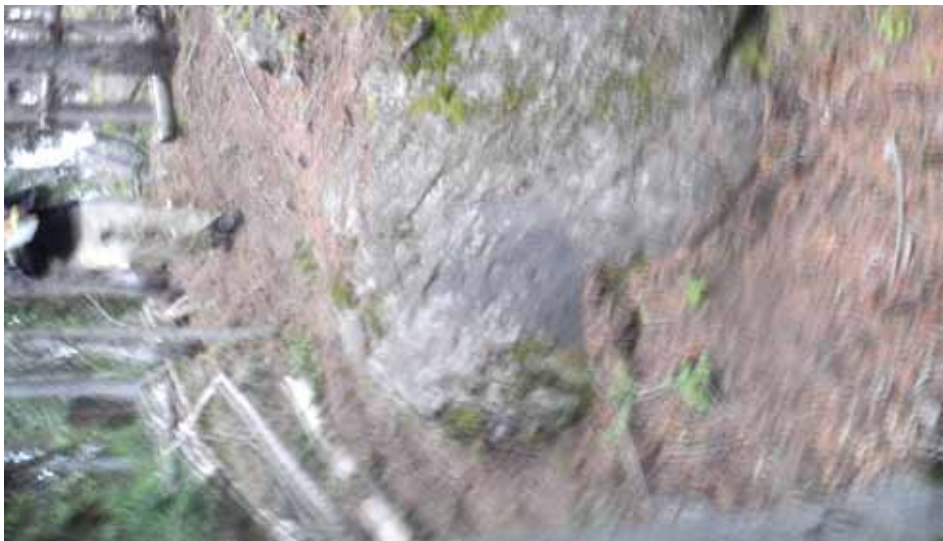
| 160 | rock drop | | monitor | mandatory rock drop | y | 5 | y | 1 | DSCN6586.JPG | 5546702 | 660331 | 1642 |

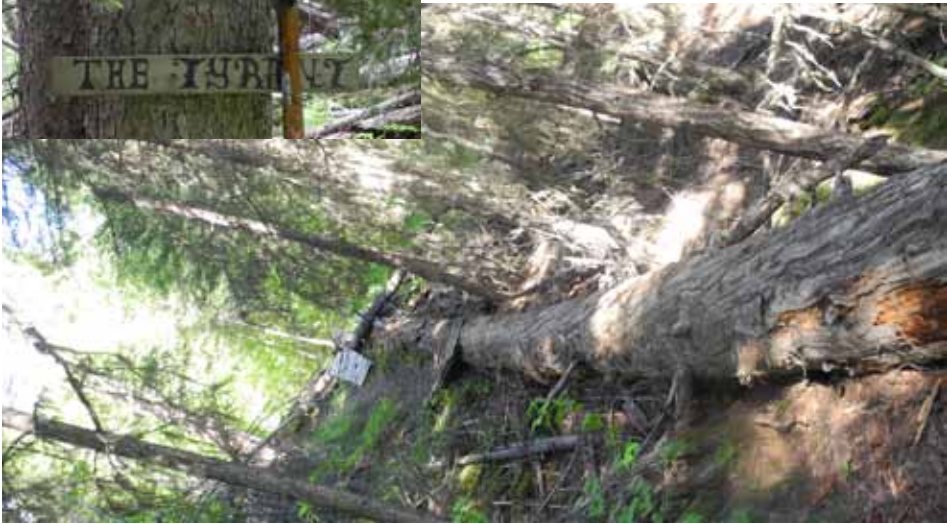
| NO. | ITEM | DIMENSION (MM) | DESCRIPTION | IMPROVEMNT | MEETS STANDARD | LIFE (YEARS) | MANDATORY | FALL_ZONE (1 - POOR, 5 - GOOD) | IMAGE | NORTHING (UTM10) | EASTING (UTM10) | HEIGHT ABOVE MSL (m) |
|---|---|---|---|---|---|---|---|---|---|---|---|---|
| 54 | log ride | 300w x 2000h x 22000l | remove | improve by replacing the rotting on-ramp, increasing the decking dimension from 1x4 decking, level the riding surface and clear the fall zones | n | 1 | y | 1 | DSCN6674.JPG | 5548364 | 661364 | 1184 |

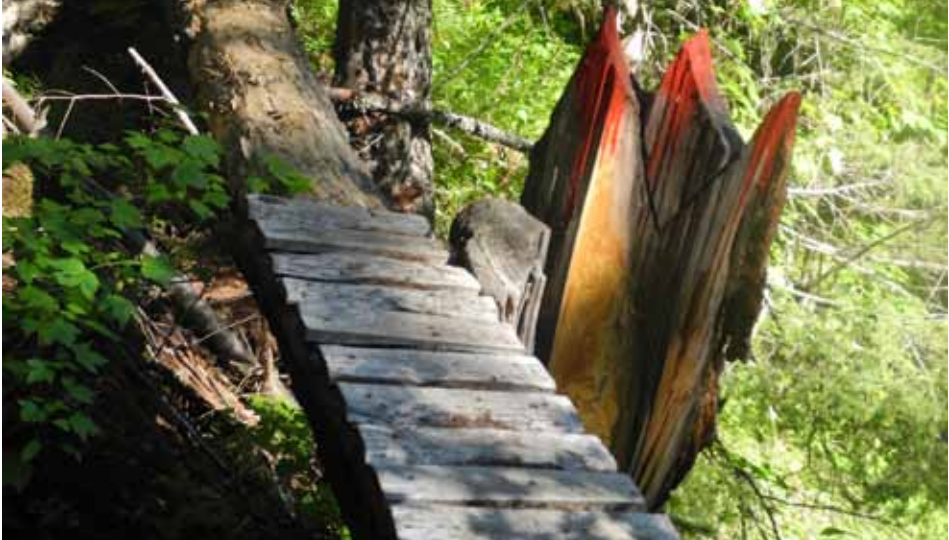
| NO. | ITEM | DIMENSION (MM) | DESCRIPTION | IMPROVEMNT | MEETS STANDARD | LIFE (YEARS) | MANDATORY | FALL_ZONE (1 - POOR, 5 - GOOD) | IMAGE | NORTHING (UTM10) | EASTING (UTM10) | HEIGHT ABOVE MSL (m) |
|---|---|---|---|---|---|---|---|---|---|---|---|---|
| 55 | log ride | 350w x 30000l x 1500h | remove | Remove log as it moves under foot traffic and build a dirt trail | n | 1 | y | 1 | DSCN6679.JPG | 5548399 | 661360 | 1170 |

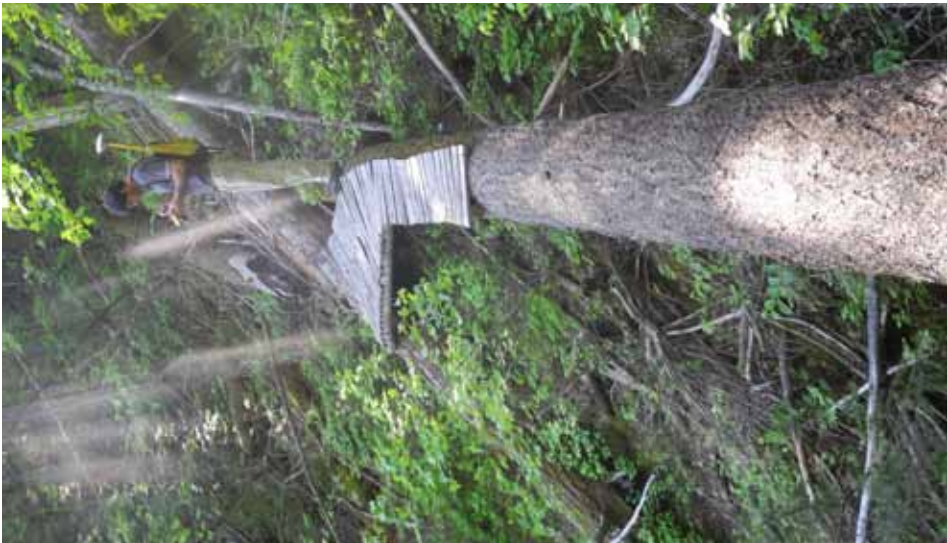
| NO. | ITEM | DIMENSION (MM) | PRESCRIPTION | IMPROVEMNT | MEETS STANDARD | LIFE (YEARS) | MANDATORY | FALL_ZONE (1 - POOR, 5 - GOOD) | IMAGE | NORTHING (UTM10) | EASTING (UTM10) | HEIGHT ABOVE MSL (m) |
|---|---|---|---|---|---|---|---|---|---|---|---|---|
| 56 | log ride | 700w x 20000l x 4000h | remove | rotting log, narrow riding surface to height above ground, overspanned stringers on entry and exit-ramp | n | 1 | n | 1 | DSCN6696.JPG | 5548427 | 661375 | 1157 |

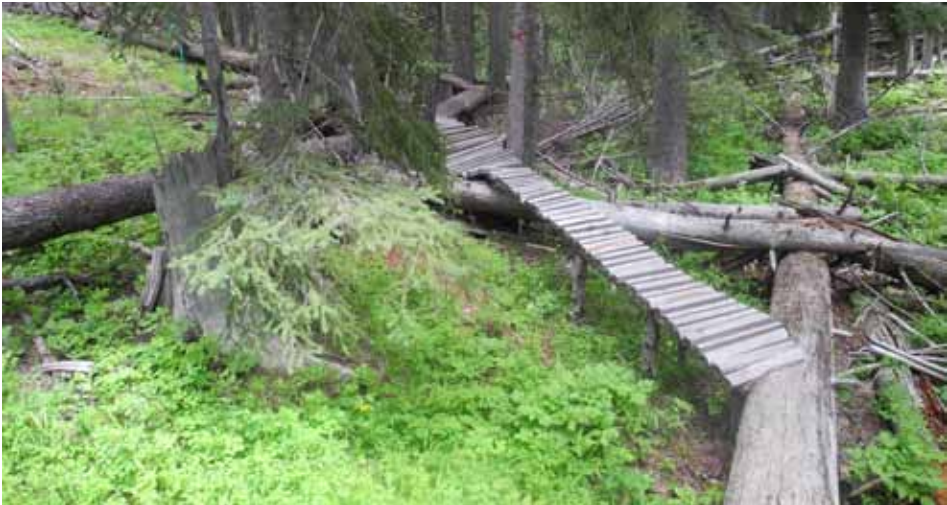
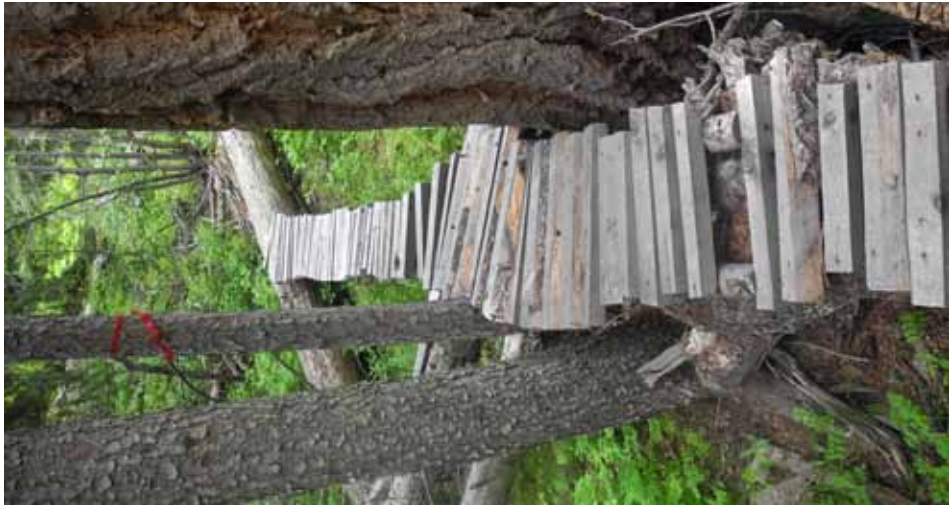
| NO. | ITEM | DIMENSION (MM) | PRESCRIPTION | IMPROVEMNT | MEETS STANDARD | LIFE (YEARS) | MANDATORY | FALL_ZONE (1 - POOR, 5 - GOOD) | IMAGE | NORTHING (UTM10) | EASTING (UTM10) | HEIGHT ABOVE MSL (m) |
|---|---|---|---|---|---|---|---|---|---|---|---|---|
| 98 | elevated bridge roll / log ride | | improve | complex stunt consisting of fallen logs, and boardwalk. Recommend replacing stringer on entry-ramp and increasing the size of stringers to minimize deflection. Improve fall zones. | n | 1 | y | 1 | DSCN6997.JPG | 5547968 | 661299 | 1320 |

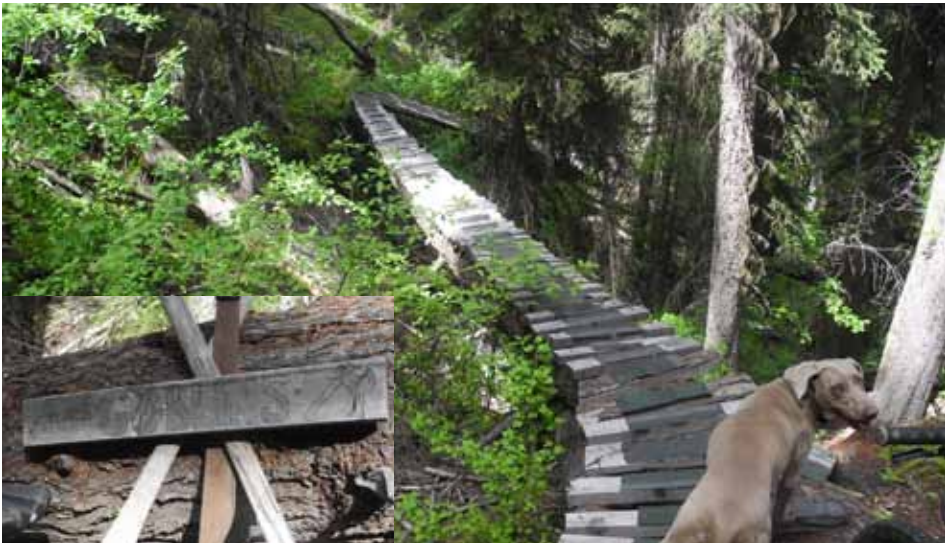
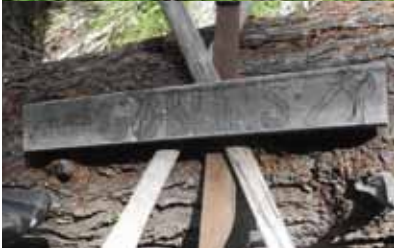
| NO. | ITEM | DIMENSION (MM) | PRESCRIPTION | IMPROVEMNT | MEETS STANDARD | LIFE (YEARS) | MANDATORY | FALL_ZONE (1 - POOR, 5 - GOOD) | IMAGE | NORTHING (UTM10) | EASTING (UTM10) | HEIGHT ABOVE MSL (M) |
|---|---|---|---|---|---|---|---|---|---|---|---|---|
| 100 | elevated bridge roll / log ride | 690w x 4200h | remove | complex stunt, recommend replacing decaying deck boards, cleating the boardwalk, and improving fall zones: "The Goblins". | n | 1 | y | 1 | DSCN7020.JPG | 5548236 | 661403 | 1225 |

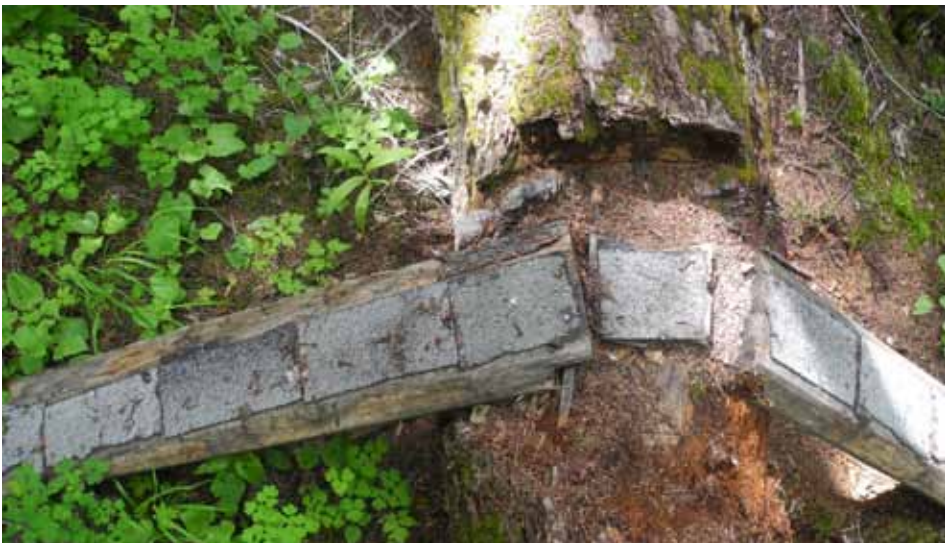
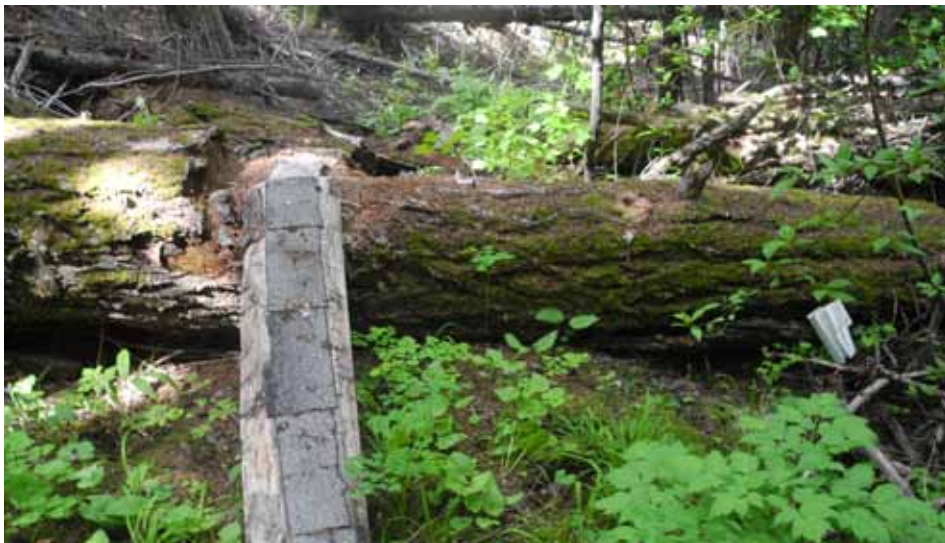
| NO. | ITEM | DIMENSION (MM) | PRESCRIPTION | IMPROVEMNT | MEETS STANDARD | LIFE (YEARS) | MANDATORY | FALL_ZONE (1 - POOR, 5 - GOOD) | IMAGE | NORTHING (UTM10) | EASTING (UTM10) | HEIGHT ABOVE MSL (M) |
|---|---|---|---|---|---|---|---|---|---|---|---|---|
| 101 | a-frame | 200w x 1000h x 3000l | monitor | narrow ramp over fallen log, remove log and ride on ground level | n | 2 | y | 1 | DSCN7024.JPG | 5548275 | 661390 | 1204 |

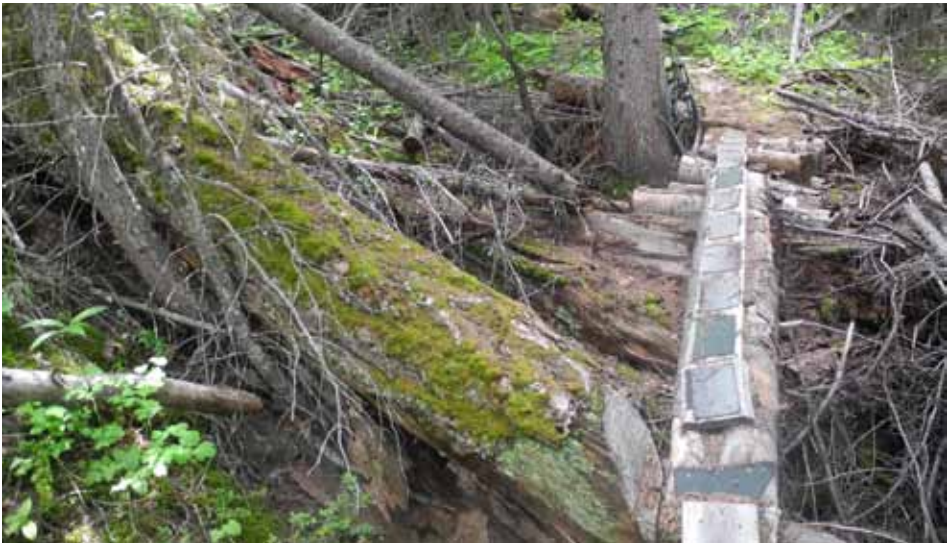
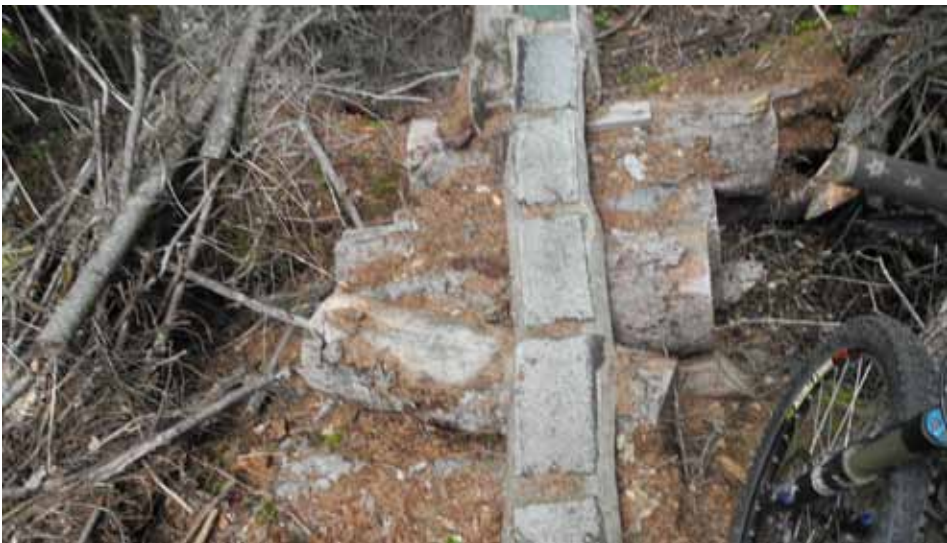
| NO. | ITEM | DIMENSION (MM) | PRESCRIPTION | IMPROVEMNT | MEETS STANDARD | LIFE (YEARS) | MANDATORY | FALL_ZONE (1 - POOR, 5 - GOOD) | IMAGE | NORTHING (UTM10) | EASTING (UTM10) | HEIGHT ABOVE MSL (m) |
|---|---|---|---|---|---|---|---|---|---|---|---|---|
| 102 | bridge | 300w x 1200h x 3000l | replace | Replace stringers and decking | n | 1 | y | 1 | DSCN7030.JPG | 5548284 | 661391 | 1200 |

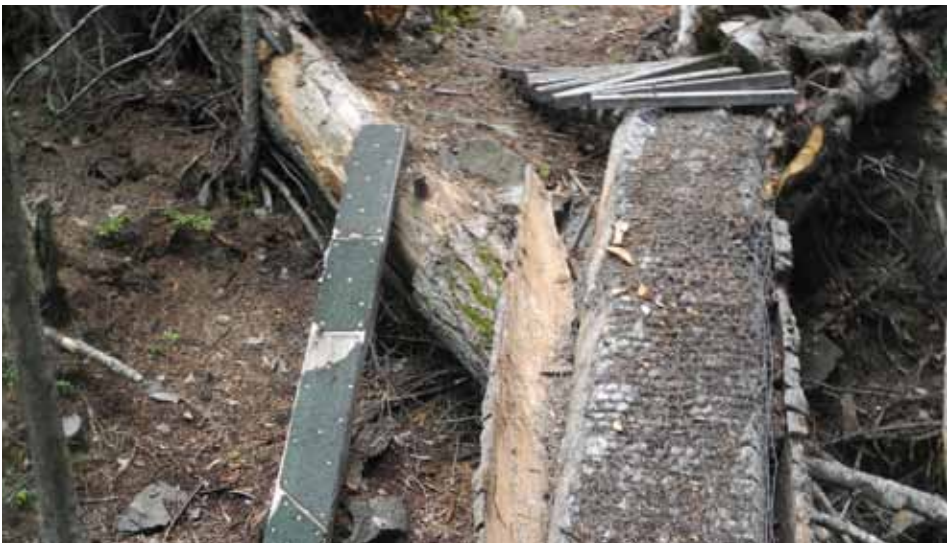
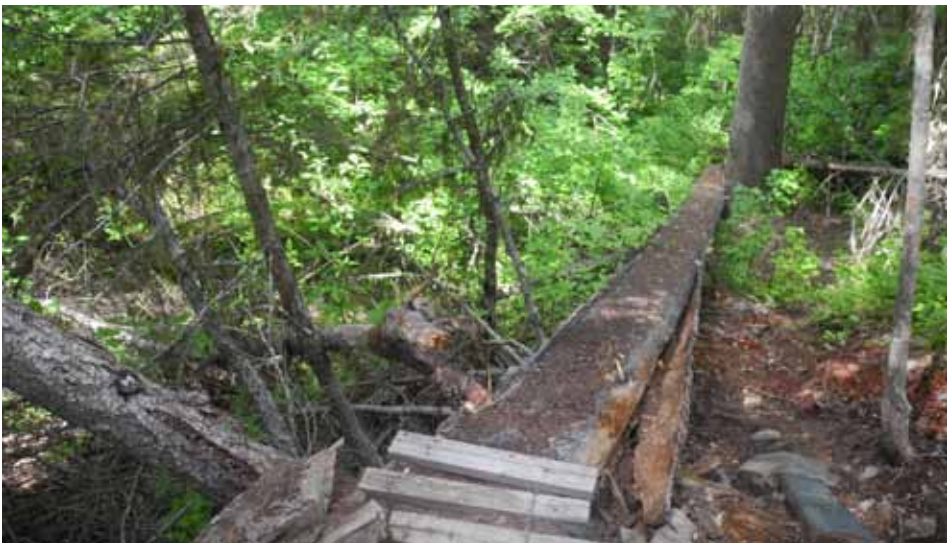
| NO. | ITEM | DIMENSION (MM) | PRESCRIPTION | IMPROVEMNT | MEETS STANDARD | LIFE (YEARS) | MANDATORY | FALL_ZONE (1 - POOR, 5 - GOOD) | IMAGE | NORTHING (UTM10) | EASTING (UTM10) | HEIGHT ABOVE MSL (m) |
|---|---|---|---|---|---|---|---|---|---|---|---|---|
| 103 | log ride | 300w x 1330h x 13000l | improve | improve stunt by cleating the tread and creating a safe exit from the stunt. | n | 3 | y | 1 | DSCN7034.JPG | 5548296 | 661390 | 1195 |

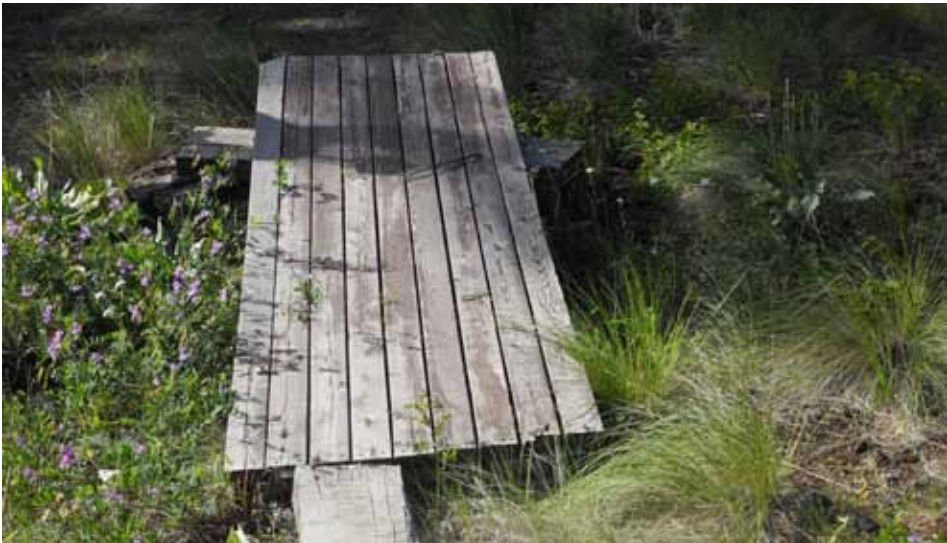
| NO. | ITEM | DIMENSION (MM) | DESCRIPTION | IMPROVEMNT | MEETS STANDARD | LIFE (YEARS) | MANDATORY | FALL_ZONE (1 - POOR, 5 - GOOD) | IMAGE | NORTHING (UTM10) | EASTING (UTM10) | HEIGHT ABOVE MSL (m) |
|---|---|---|---|---|---|---|---|---|---|---|---|---|
| 32 | elevated bridge drop | 840w x 4056l x 400h | improve | appears temporary, improve by firmly securing stunt to the ground, and fastening entry-ramp | y | 2 | n | 3 | DSCN6270.JPG | 5550515 | 661514 | 783 |

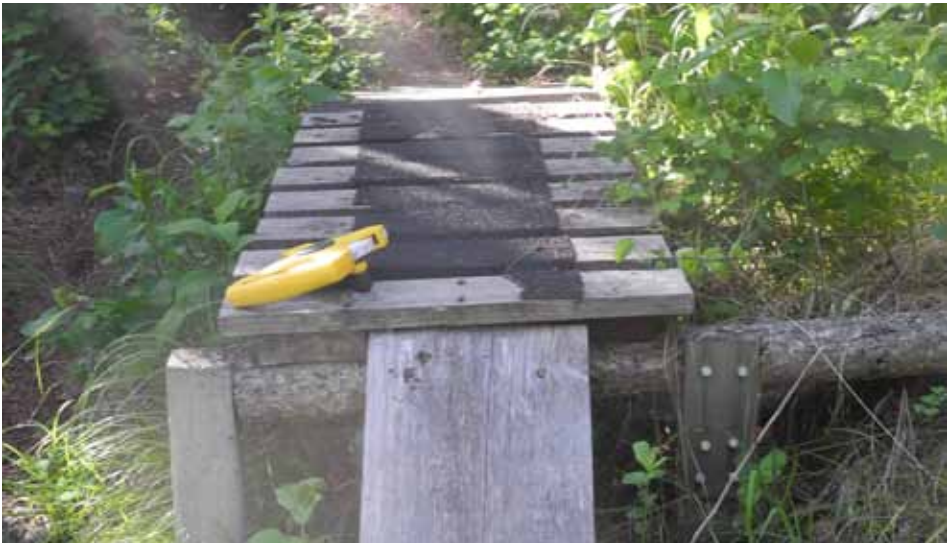
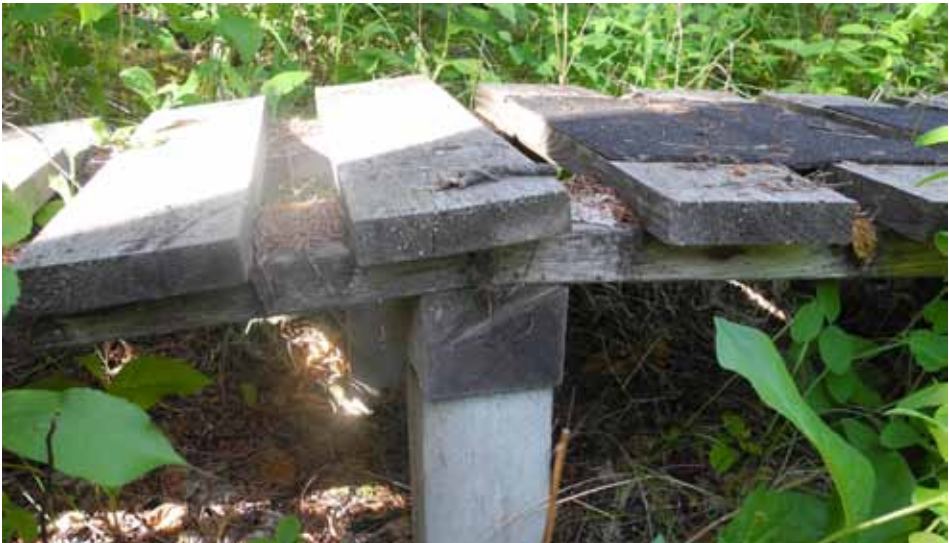
| 34 | elevated bridge roll | 610w x 3060l x 700h | remove | shakey structure because posts are rotting where touching the ground, shingles are loose - remove or rebuild | y | 2 | n | 2 | DSCN6287.JPG | 5550011 | 661710 | 899 |

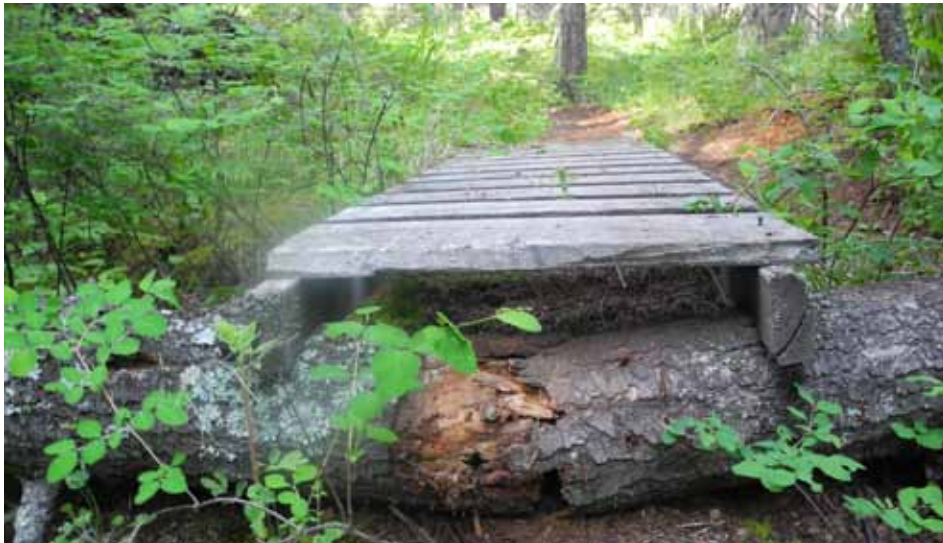
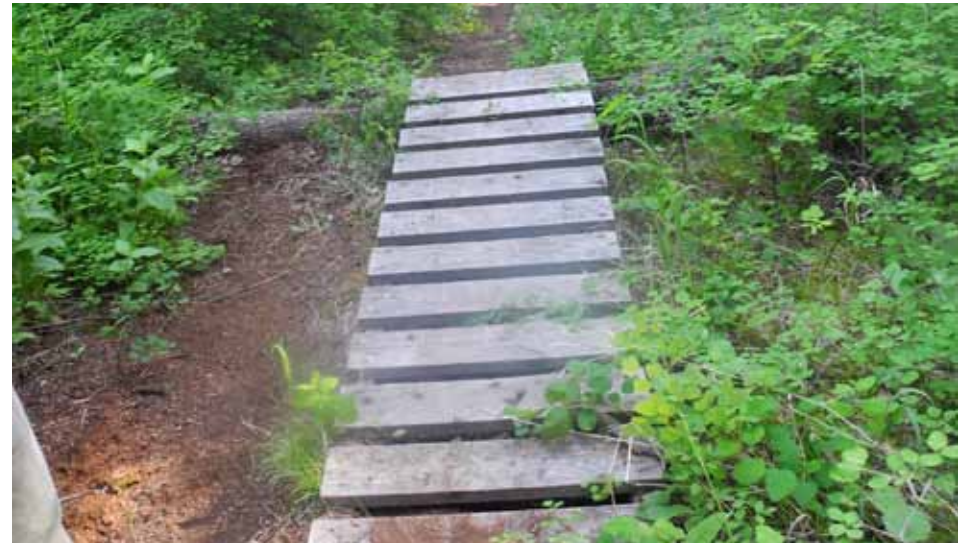
| NO. | ITEM | DIMENSION (MM) | PRESCRIPTION | IMPROVEMNT | MEETS STANDARD | LIFE (YEARS) | MANDATORY | FALL_ZONE (1 - POOR, 5 - GOOD) | IMAGE | NORTHING (UTM10) | EASTING (UTM10) | HEIGHT ABOVE MSL (m) |
|---|---|---|---|---|---|---|---|---|---|---|---|---|
| 35 | elevated bridge drop | 650w x 2430l x 350h | improve | log on which stunt is situated is broken, recommend removing log and stunt | n | 1 | y | 2 | DSCN6295.JPG | 5549981 | 661750 | 905 |
