QC-7004

HONNA-STANLEY FSR 1.7km

2019 Inspection

Crossing Name Turundle Creek

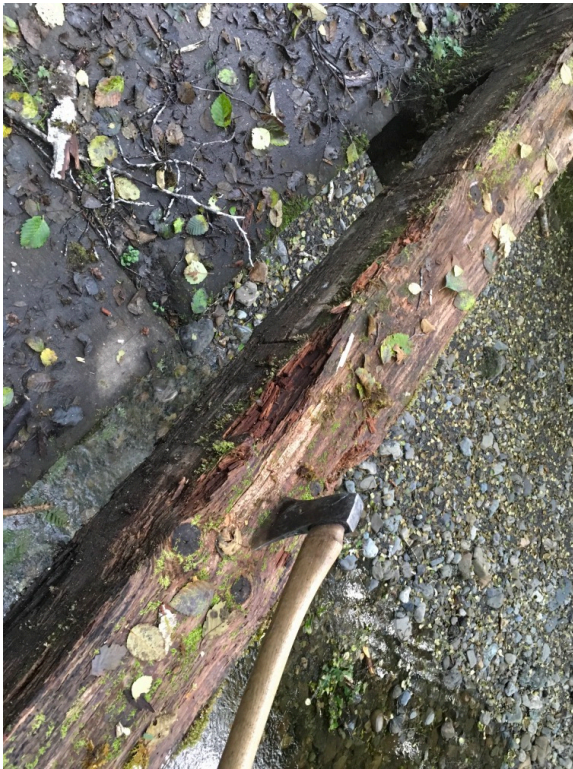
Guard Rail

Guardrails still have some firm wood at centres but heavy rot on outer edges. No lag bolts in bearing plates and one missing tie clip under downstream deck panel.

Guardrails need replacement prior to industrial activity

| Repair Item | Priority | Repair Description |
|---|---|---|
| 1 | Medium | Replace guardrails in 2 years or less. |
