QC-7037

BONANZA 8.4km

2019 Inspection

| Crossing Name | Beaverguard Creek | | |

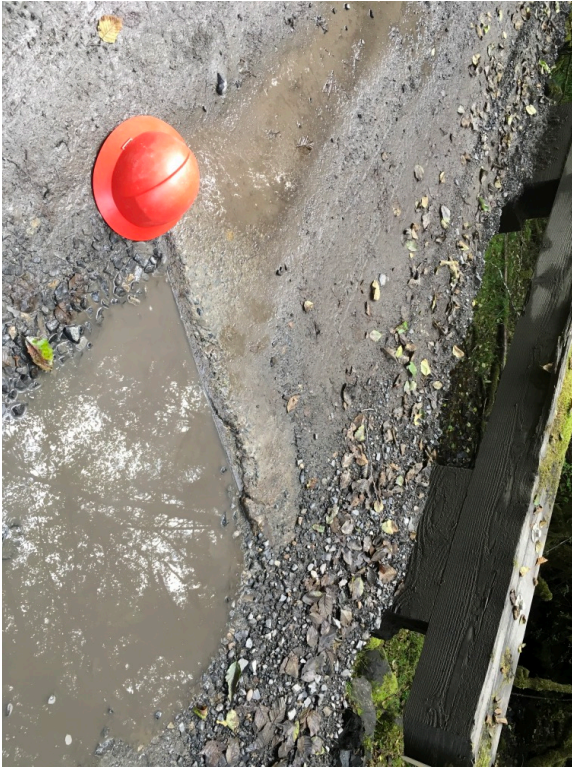
End of girder, right bank

| Repair Item | Priority | Repair Description |
|---|---|---|
| 1 | Medium | Add fill to patch pot holes on approaches in an attempt to limit further damage to ends of slab girders. Patch ends as required. |

| Item | Monitor Description | Frequency |
|---|---|---|
| 1 | Monitor further damage to ends of girders. | Routine Inspection |
