QC-7040

QC MAIN 0.75km

2019 Inspection

Crossing Name Crabapple Creek

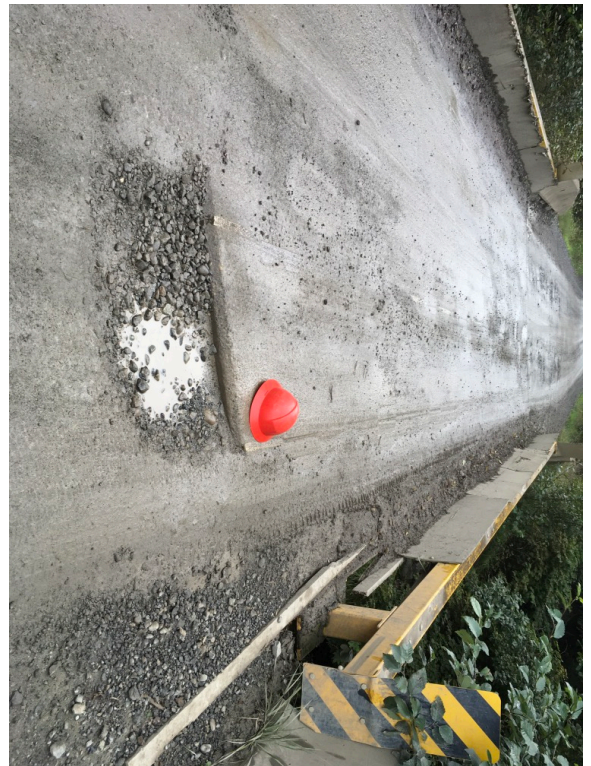
| Concrete Deck | Good | Approach fill is punching out on town side and should be patched to limit long term damage to ends of girders. |
| Curb Rail/Blocks/Posts | Poor | Steel guardrails are fine but plywood/boards used to control sediment are damaged and should be replaced. |

| Item | Priority | Repair Description |
|---|---|---|
| 1 | Medium | Replace sediment catch boards on upstream and downstream sides of bridge deck. |
| 2 | Medium | Add fill to town approach to prevent long term damage to ends of slab girders. |
