QC-7105

HANGOVER 10.7km

2019 Inspection

Crossing Name Bonanza Creek

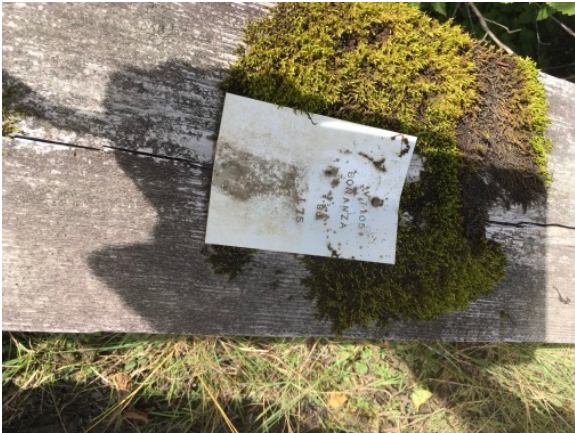
Guard Rail

Guardrails need replacement. Large impact on upstream side and significant rot observed throughout. Replace sediment catch boards on sides as well.

Replace all guardrails and timber components

| Repair Item | Priority | Repair Description |
|---|---|---|
| 1 | High | Replace all timber guardrail components. |
