QC-7131

CHADSEY MAIN 1.7km

2019 Inspection

Inspection Company Chartwell Consultants Ltd.

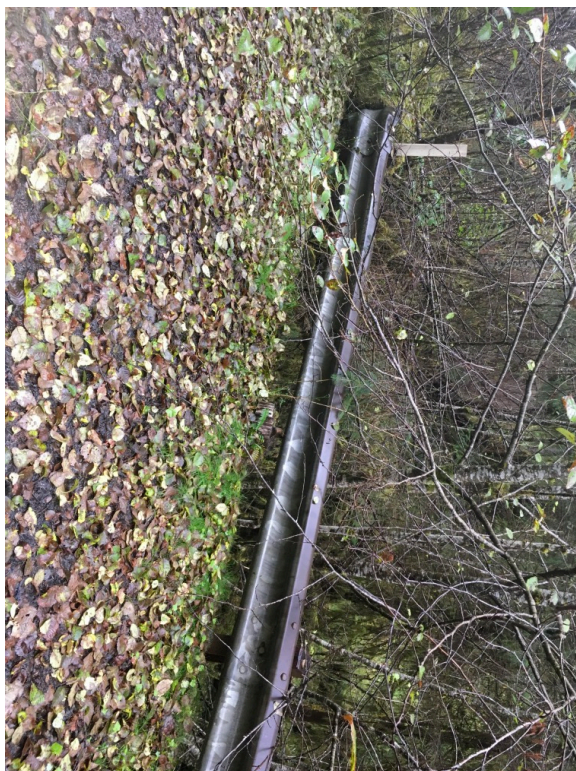
Fender Condition Fair Riser posts missing.

| Curb Rail/Blocks/Posts | Poor | Downstream guardrail is only connected by two bolts and missing a riser post. |

Guard Rail missing riser post

| Item | Priority | Repair Description |
|---|---|---|
| 1 | Low | Repair guardrails. Replace guidelogs once industrial activity resumes. |
